## **Defect Listing**

Pipe Segment Refere		City		Street	Material		Location C	Sewer Use	
A-1_PS-1		Oliver Springs		Pump Station	Fibreglass Reinforc		Easement/R	Sanitary	
Upstream MH		Total Length		Year Laid	Shape		Location Details		
A-1		34.7			Circular				
DS Manhole		Length surveyed		Year Renewed	Height	Width	Pipe Joint		
PS-1		34.7			21	21	N/A		
SPR	N/A	MPR	N/A	PO Number	7-03		Customer GRW Purpose		
ODDI	NI/A	MDDI		4397-03					
SPRI	N/A	MPRI	N/A	Work Order					
QSR	N/A	QMR	N/A	4397-02		Pre-		Rehabilitation Survey	
OF	PR	Surveyed By		Direction	Date		Media label		
N/	Ά	Charlie_Gordon		Downstream	20151007				
OPRI		Certificate Number		Pre-Cleaning	Time		Weather		
N/A		U-615-07000491		No Pre-Cleaning	12:47		Damp		
		Date C	leaned		End Time		Addition	Additional Info	
						12:51

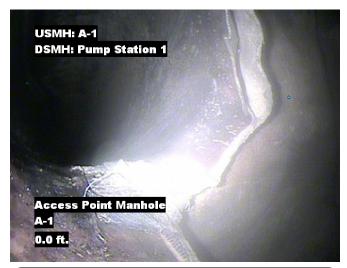
Distance: 0.0 ft. Grade: 0

Condition: Access Point Manhole

Remarks: A-1

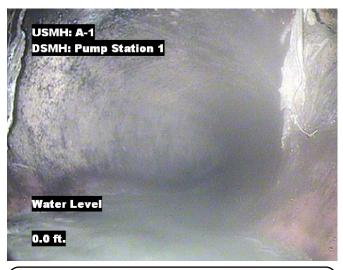
Distance: 0.0 ft. Grade: 0

Condition: Water Level

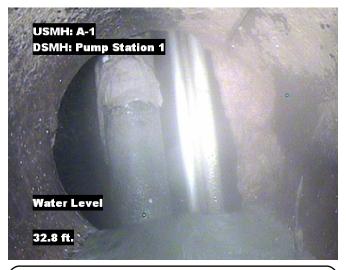
Distance: 32.8 ft. Grade: 0

Condition: Water Level Remarks: N/A
