## Defect Listing

Pipe Segment Refere... <b>A-10_A-9</b>	City <b>Oliver Springs</b>	Street <b>Old harriman highwa...</b>	Material <b>Fibreglass Reinforc...</b>	Location C... <b>Easement/R...</b>	Sewer Use <b>Sanitary</b>
Upstream MH <b>A-10</b>	Total Length <b>251.3</b>	Year Laid	Shape <b>Circular</b>	Location Details	
DS Manhole <b>A-9</b>	Length surveyed <b>251.3</b>	Year Renewed	Height <b>15</b>	Width <b>15</b>	Pipe Joint... <b>N/A</b>

## Image Report 4/Page

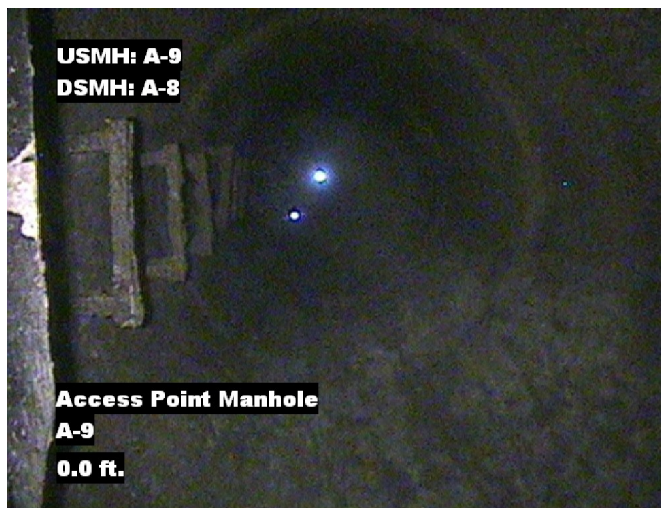
Distance: 0.0 ft. Grade: 0  
Condition: Access Point Manhole  
Remarks: A-10

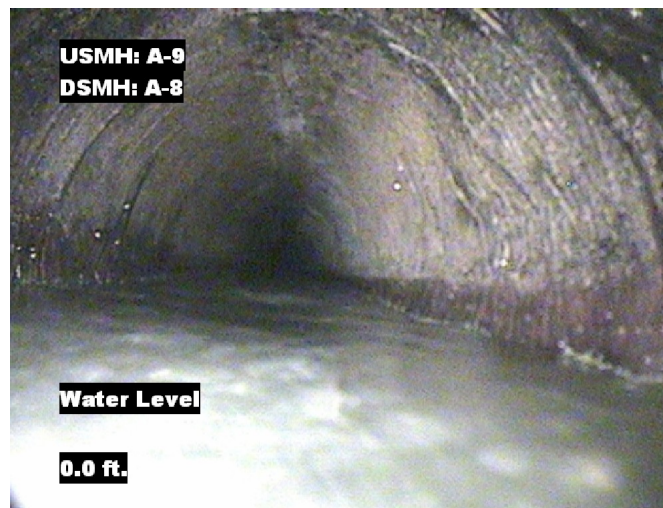
Distance: 0.0 ft. Grade: 0  
Condition: Water Level  
Remarks: N/A

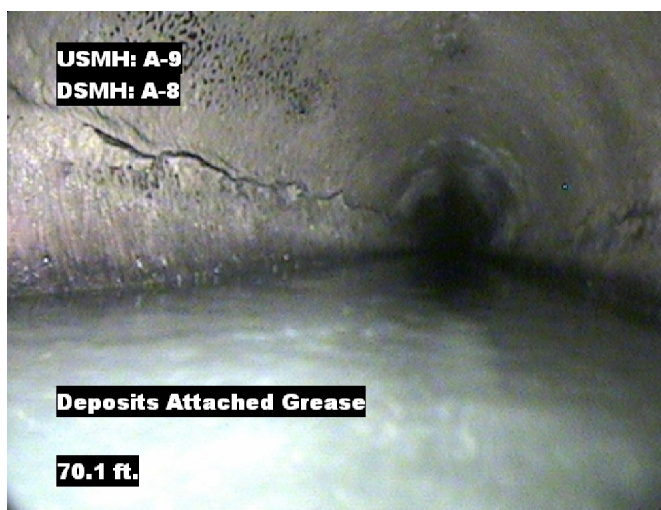
Distance: 70.1 ft. Grade: 2  
Condition: Deposits Attached Grease  
Remarks: N/A

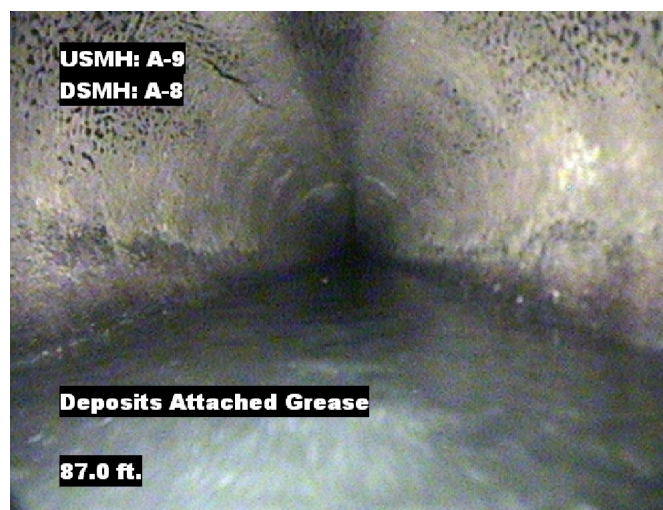
Distance: 86.8 ft. Grade: 2  
Condition: Deposits Attached Grease  
Remarks: N/A

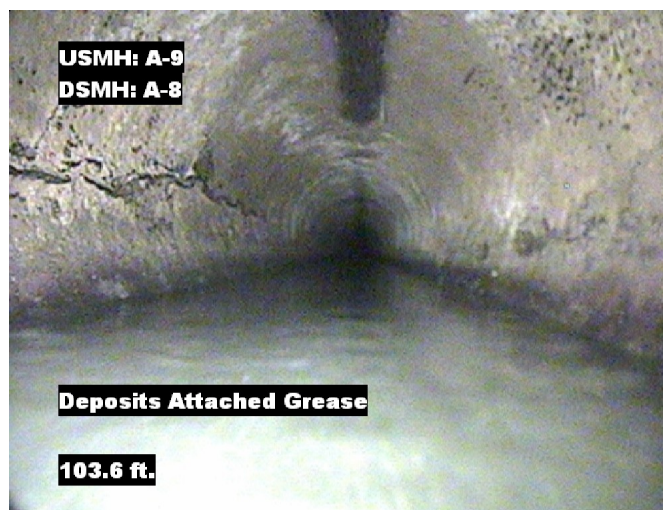
Distance: 103.6 ft. Grade: 2  
Condition: Deposits Attached Grease  
Remarks: N/A

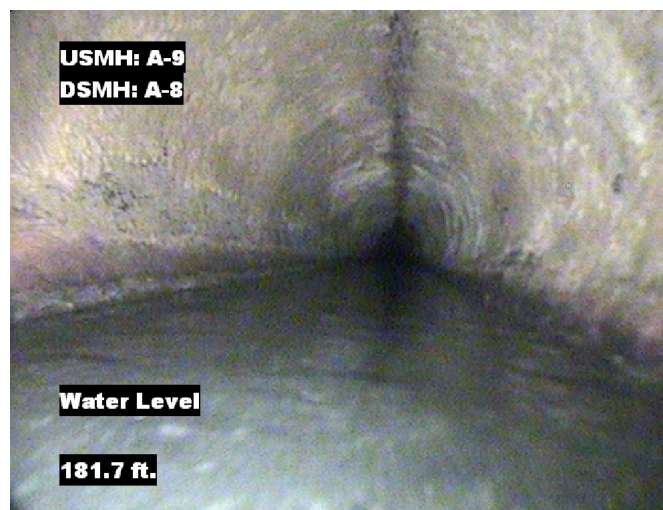
Distance: 181.6 ft. Grade: 0  
Condition: Water Level  
Remarks: N/A

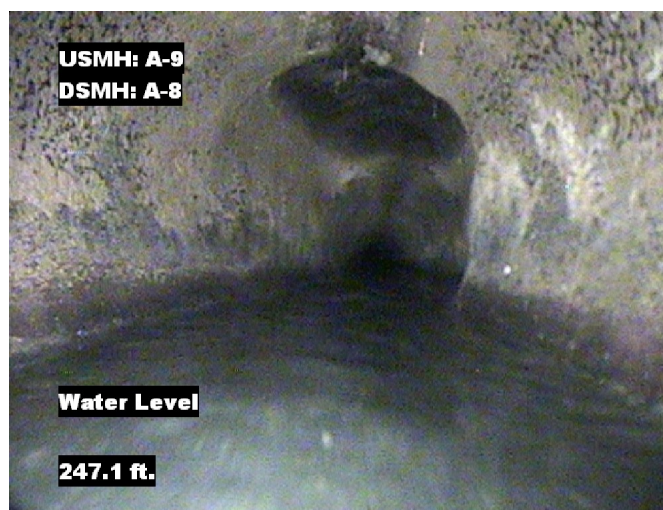
Distance: 247.1 ft. Grade: 0  
Condition: Water Level  
Remarks: N/A

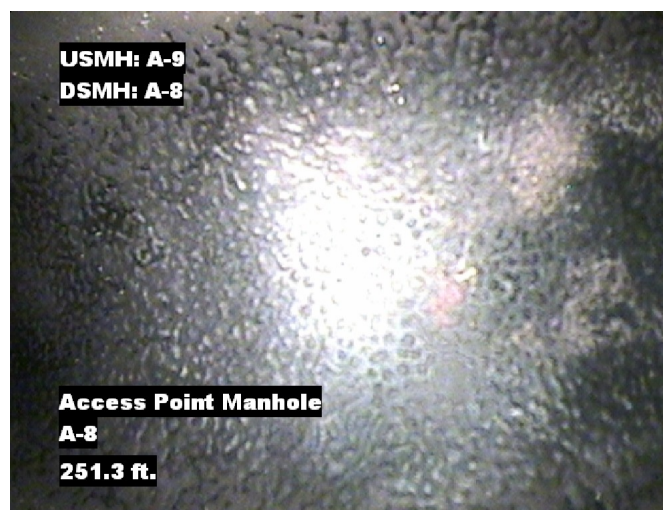
Distance: 251.3 ft. Grade: 0  
Condition: Access Point Manhole  
Remarks: A-9
