Defect Listing

Pipe Segment Refere... A-11_A-10	City Oliver Springs	Street Old Harriman highwa...	Material Fibreglass Reinf...	Location C... Easement/R...	Sewer Use Sanitary
Upstream MH A-11	Total Length 301.3	Year Laid	Shape Circular	Location Details	
DS Manhole A-10	Length surveyed 301.3	Year Renewed	Height 15	Width 15	Pipe Joint... N/A

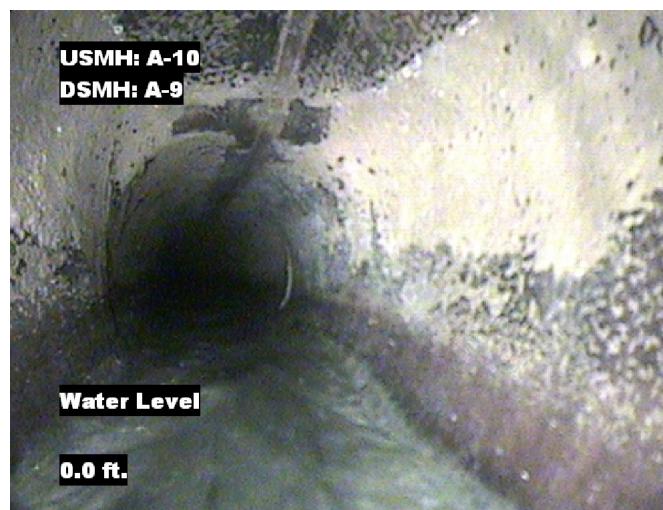
Distance: 0.0 ft. Grade: 0
Condition: Water Level
Remarks: N/A

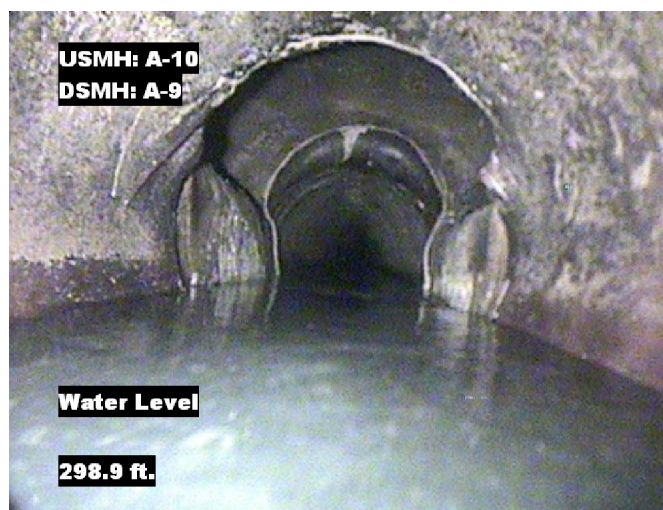
Distance: 298.7 ft. Grade: 0
Condition: Water Level
Remarks: N/A
