Defect Listing

Pipe Segment Refere... A-12_A-11	City Oliver Springs	Street Old Harriman Highwa...	Material Fibreglass Reinf...	Location C... Easement/R...	Sewer Use Sanitary
Upstream MH A-12	Total Length 277.4	Year Laid	Shape Circular	Location Details	
DS Manhole A-11	Length surveyed 277.4	Year Renewed	Height 15	Width 15	Pipe Joint... N/A

Image Report 4/Page

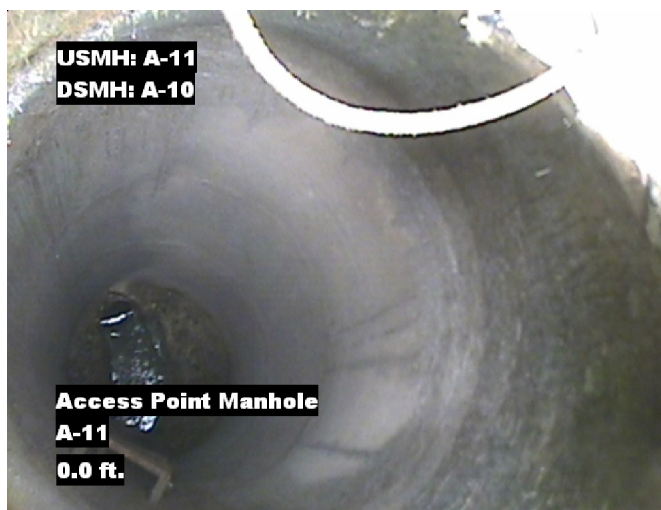
Distance: 0.0 ft. Grade: 0
Condition: Access Point Manhole
Remarks: A-12

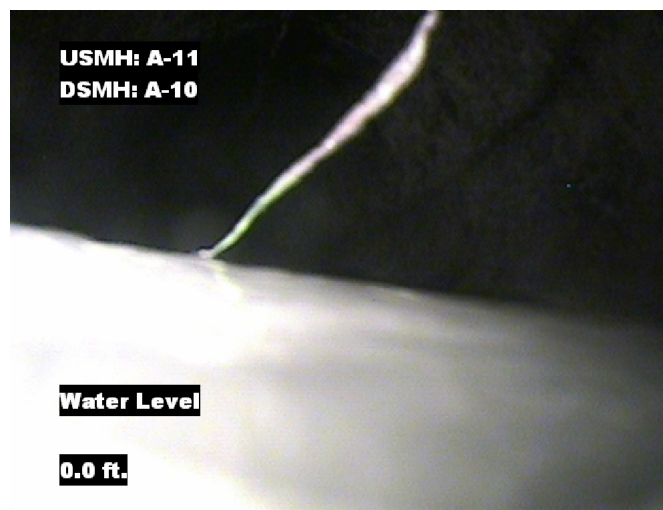
Distance: 0.0 ft. Grade: 0
Condition: Water Level
Remarks: N/A

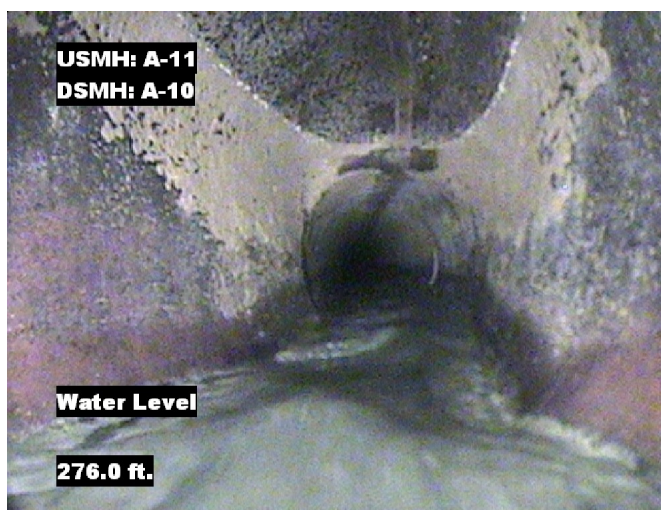
Distance: 276.0 ft. Grade: 0
Condition: Water Level
Remarks: N/A

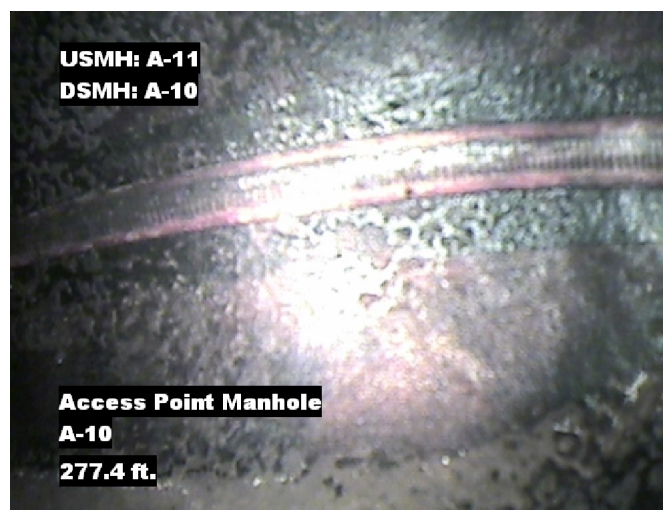
Distance: 277.4 ft. Grade: 0
Condition: Access Point Manhole
Remarks: A-11
