Defect Listing

Pipe Segment Refere... A-13_A-12	City Oliver Springs	Street Old harriman Highwa...	Material Fibreglass Reinforc...	Location C... Easement/R...	Sewer Use Sanitary
Upstream MH A-13	Total Length 349.5	Year Laid	Shape Circular	Location Details	
DS Manhole A-12	Length surveyed 349.5	Year Renewed	Height 15	Width 15	Pipe Joint... N/A

SPR N/A	MPR 41	PO Number 4397-03	Customer GRW
SPRI N/A	MPRI 2.3	Work Order 4397-02	Purpose Pre-Rehabilitation Survey
QSR N/A	QMR 4231		
OPR 41	Surveyed By Charlie Gordon	Direction Downstream	Date 20151012
OPRI 2.3	Certificate Number U-615-07000491	Pre-Cleaning No Pre-Cleaning	Time 09:14
	Date Cleaned	End Time 09:28	Weather Damp
		Additional Info

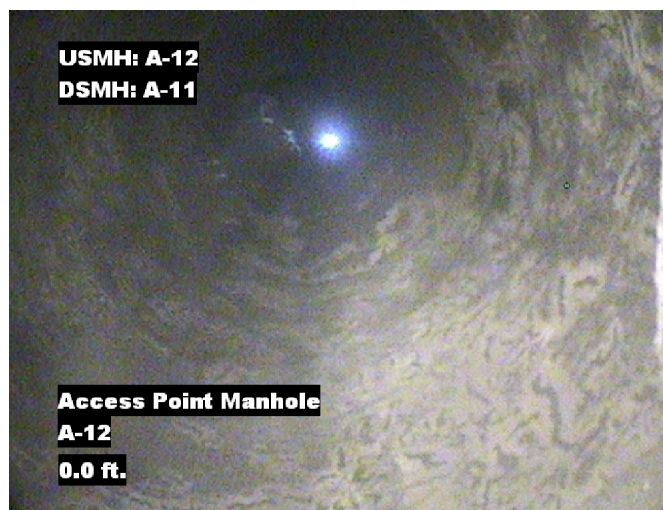
Distance: 0.0 ft. Grade: 0
Condition: Access Point Manhole
Remarks: A-13

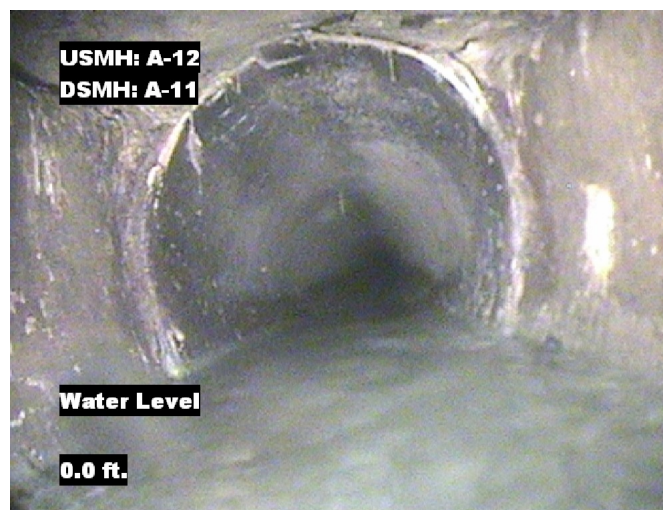
Distance: 0.0 ft. Grade: 0
Condition: Water Level
Remarks: N/A

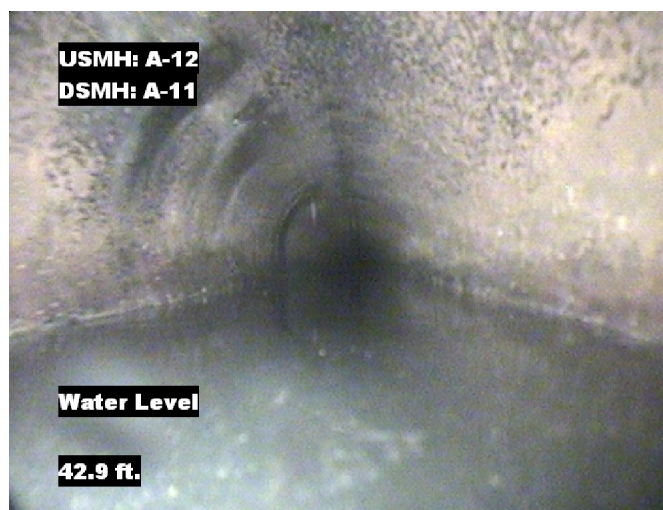
Distance: 42.6 ft. Grade: 0
Condition: Water Level
Remarks: N/A

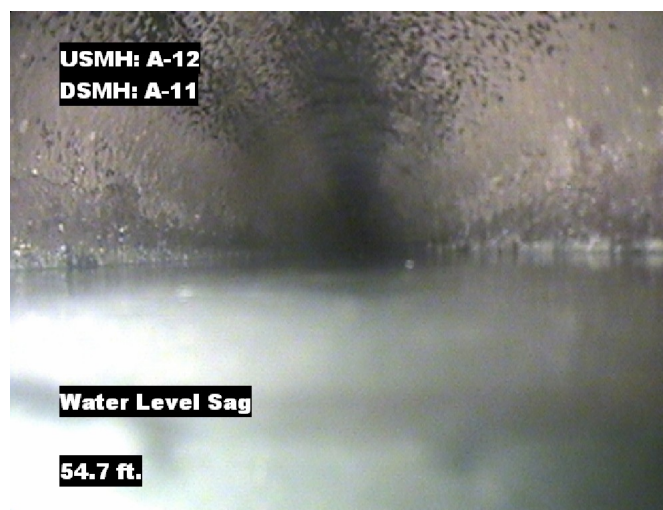
Distance: 54.7 ft. Grade: 2
Condition: Water Level Sag
Remarks: N/A

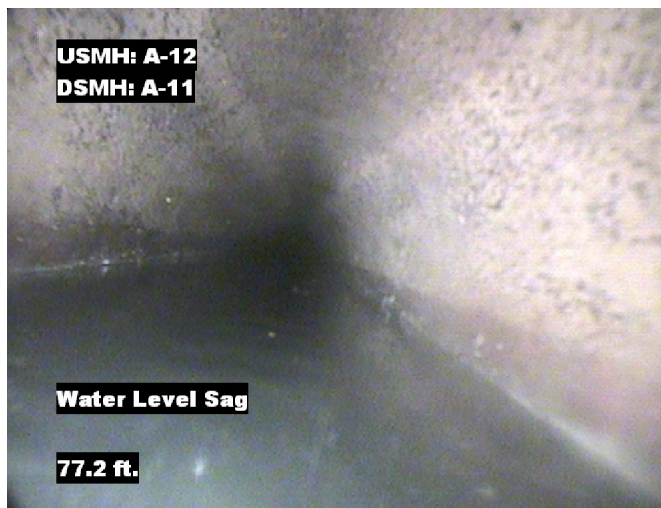
Distance: 76.7 ft. Grade: 2
Condition: Water Level Sag
Remarks: N/A

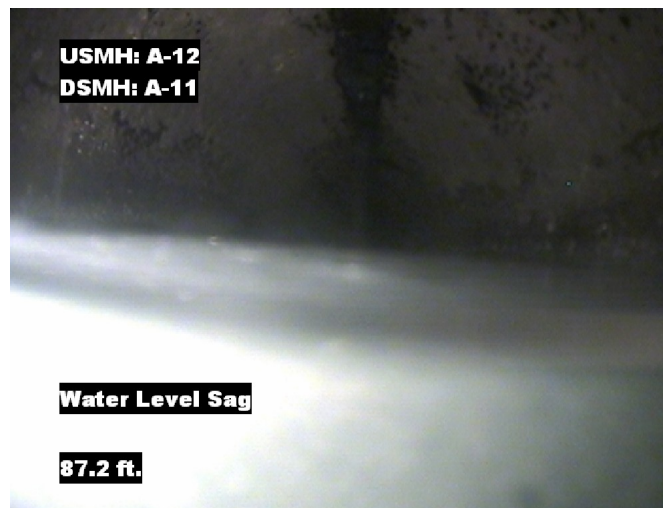
Distance: 87.2 ft. Grade: 2
Condition: Water Level Sag
Remarks: N/A

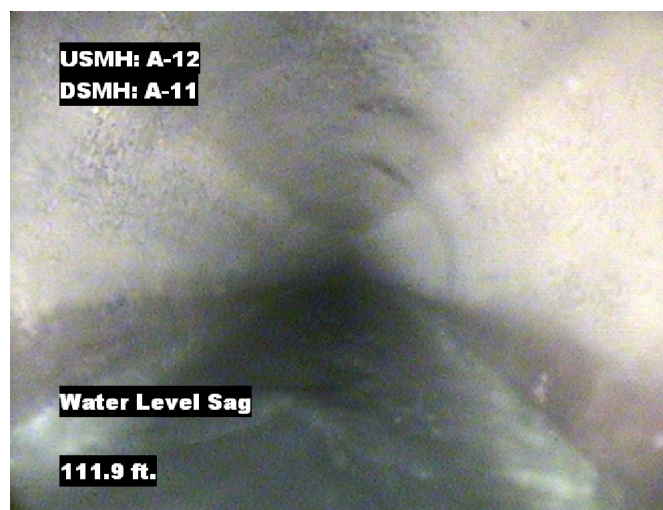
Distance: 111.9 ft. Grade: 2
Condition: Water Level Sag
Remarks: N/A

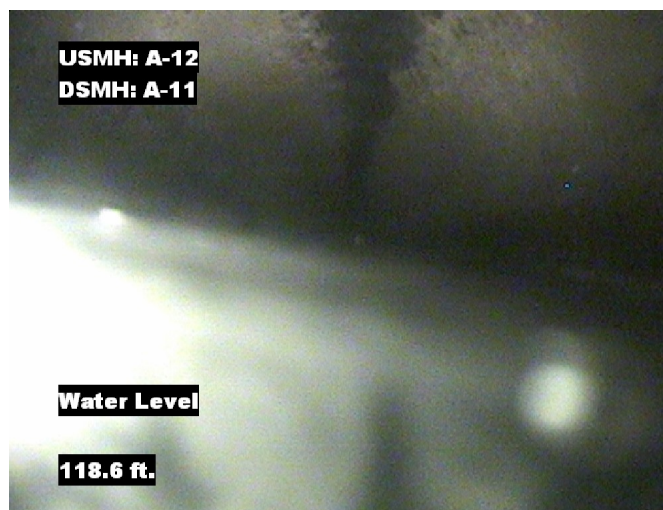
Distance: 118.6 ft. Grade: 0
Condition: Water Level
Remarks: N/A

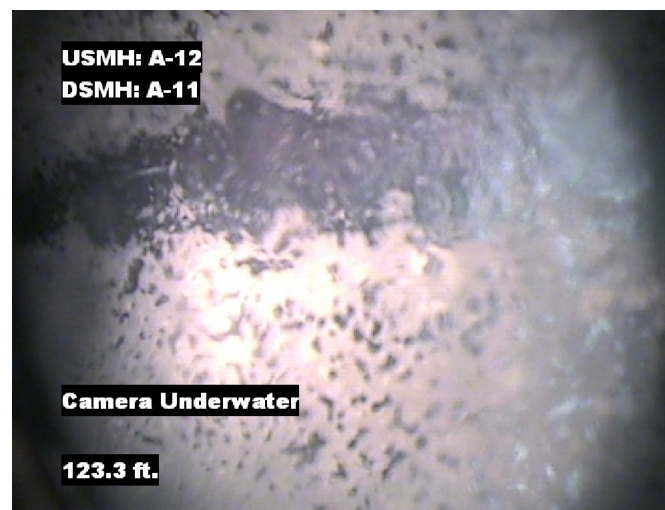
Distance: 123.3 ft. Grade: 4
Condition: Camera Underwater
Remarks: N/A

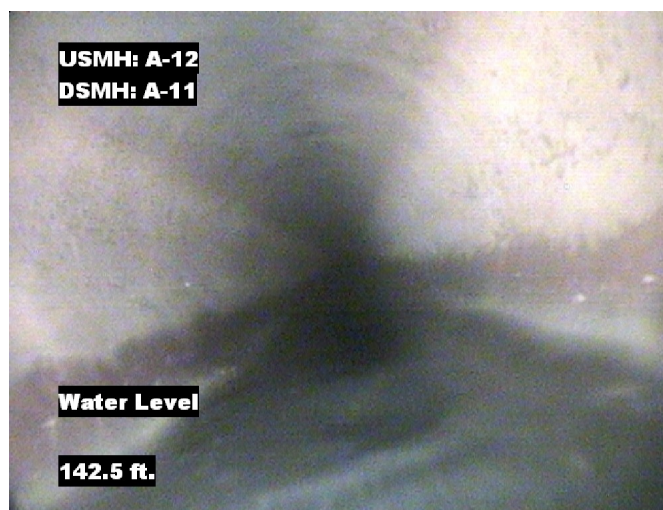
Distance: 142.5 ft. Grade: 0
Condition: Water Level
Remarks: N/A

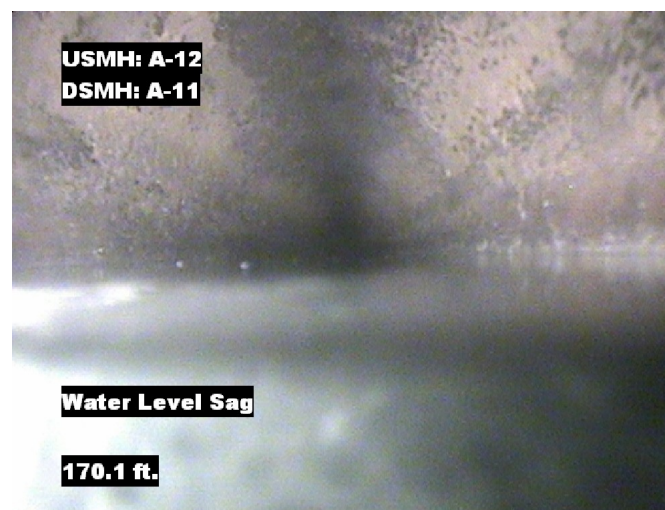
Distance: 169.9 ft. Grade: 2
Condition: Water Level Sag
Remarks: N/A

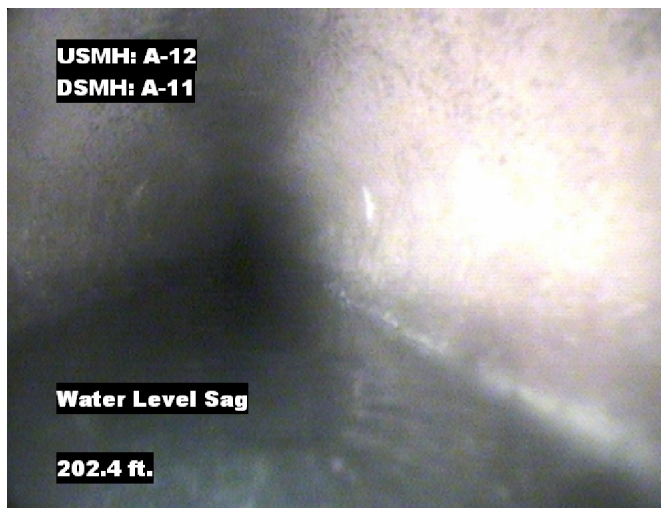
Distance: 202.4 ft. Grade: 2
Condition: Water Level Sag
Remarks: N/A

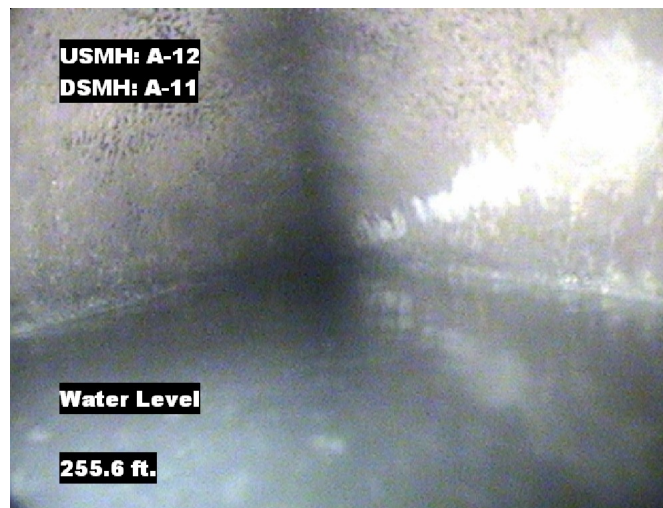
Distance: 255.4 ft. Grade: 0
Condition: Water Level
Remarks: N/A

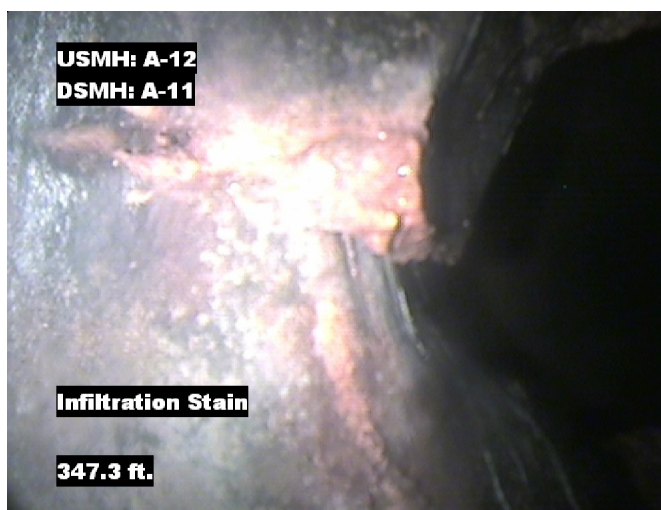
Distance: 347.3 ft. Grade: 0
Condition: Infiltration Stain
Remarks: N/A

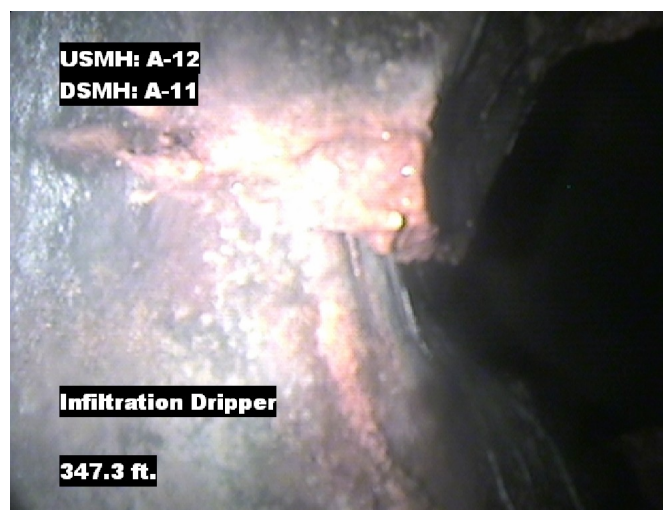
Distance: 347.3 ft. Grade: 3
Condition: Infiltration Dripper
Remarks: N/A

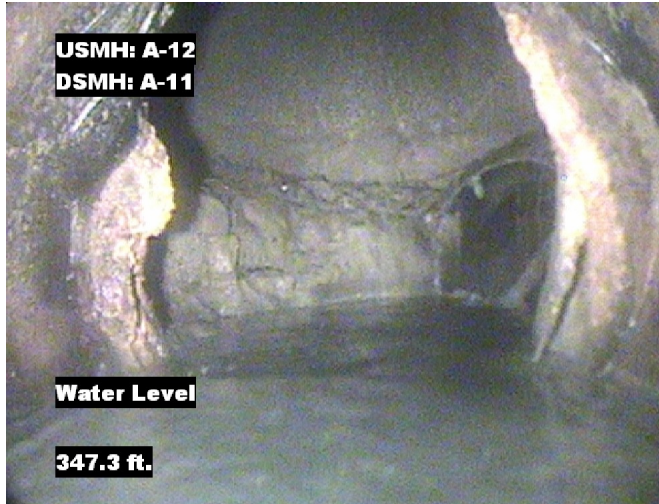
Distance: 347.3 ft. Grade: 0
Condition: Water Level
Remarks: N/A

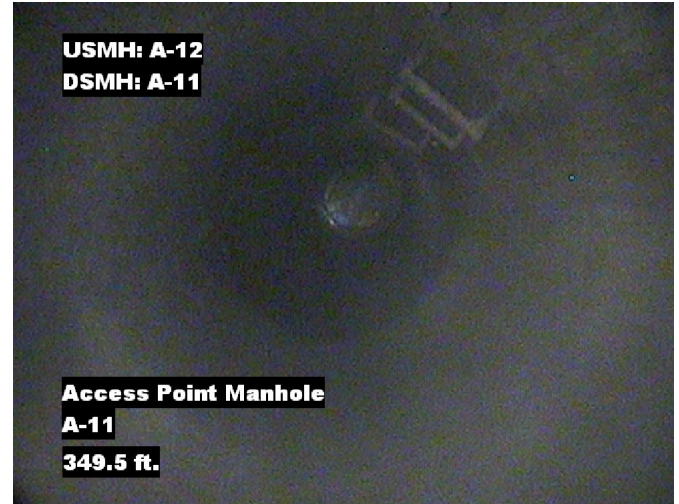
Distance: 349.5 ft. Grade: 0
Condition: Access Point Manhole
Remarks: A-12
