Defect Listing

Pipe Segment Refere		City		Street	Mat	Material		Sewer Use	
A-14	_A-13	Oliver	Springs	Old harriman HIGHWA	Fibreglass	Reinforc	nforc Easement/R		
Upstre	am MH	Total I	_ength	Year Laid	Shape		Location Details		
A-	-14	3:	25		Circ	ular	r		
DS M	anhole	Length s	surveyed	Year Renewed	Height	Width	Width Pipe Joint		
A-	·13	32	25		15	15	N/A		
SPR	N/A	MPR	25	PO Number			Customer		
				4397-03			GRW		
SPRI	N/A	MPRI	3.1	Work Order	Work Order		Purpose		
QSR	N/A	QMR	4137	4397-02		Pre-	Pre-Rehabilitation Survey		
Ol	PR	Surve	yed By	Direction	Date		Media	label	
2	25	Charlie_	_Gordon	Downstream	2015	1012			
OF	PRI	Certificate Number		Pre-Cleaning	Time		Weather		
3.1		U-615-07000491		No Pre-Cleaning	08:47		Damp		
		Date C	leaned	End		End Time Addit		al Info	
					09	:08

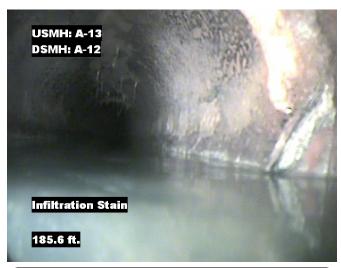
Distance: 185.6 ft. Grade: 0

Condition: Infiltration Stain

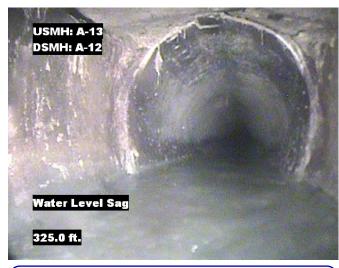
Distance: 325.0 ft. Grade: 3

Condition: Water Level Sag

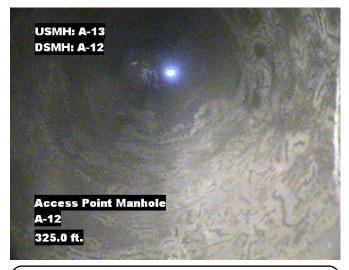
Distance: 325.0 ft. Grade: 0

Condition: Access Point Manhole

Remarks: A-13
