Defect Listing

Pipe Segment Refere... A-15_A-14	City Oliver Springs	Street Old harriman highwa...	Material Fibreglass Reinforc...	Location C... Easement/R...	Sewer Use Sanitary
Upstream MH A-15	Total Length 210.8	Year Laid	Shape Circular	Location Details	
DS Manhole A-14	Length surveyed 210.8	Year Renewed	Height 15	Width 15	Pipe Joint... N/A

SPR N/A	MPR 2	PO Number 4397-03		Customer GRW	
SPRI N/A	MPRI 2	Work Order 4397-02		Purpose Pre-Rehabilitation Survey	
QSR N/A	QMR 2100				
OPR 2	Surveyed By Charlie Gordon	Direction Upstream	Date 20151012	Media label	
OPRI 2	Certificate Number U-615-07000491	Pre-Cleaning No Pre-Cleaning	Time 12:17	Weather Damp	
Date Cleaned			End Time 12:32	Additional Info

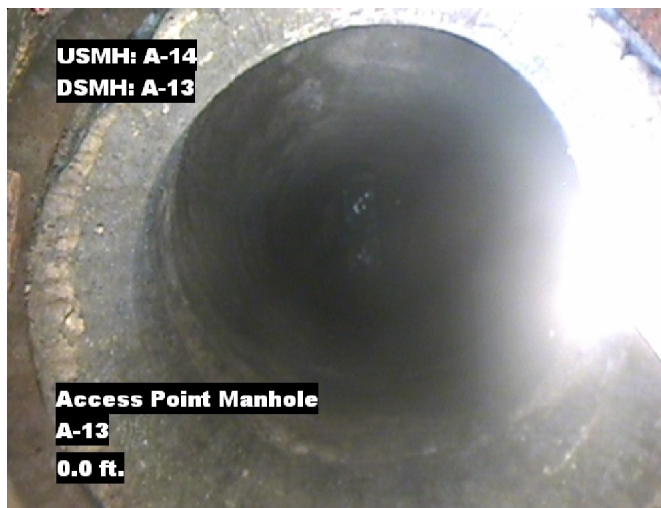
Distance: 0.0 ft. Grade: 0
Condition: Access Point Manhole
Remarks: A-14

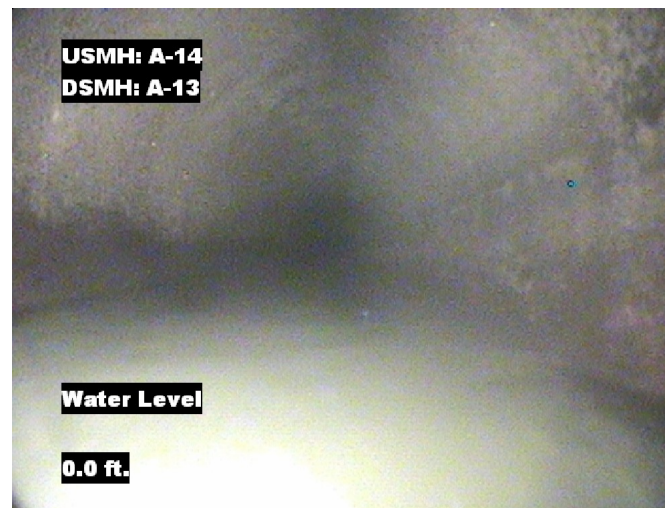
Distance: 0.0 ft. Grade: 0
Condition: Water Level
Remarks: N/A

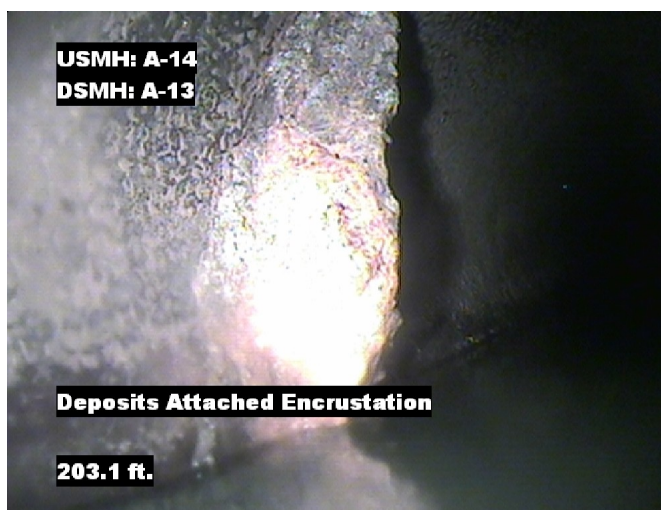
Distance: 203.1 ft. Grade: 2
Condition: Deposits Attached Encrustation
Remarks: N/A

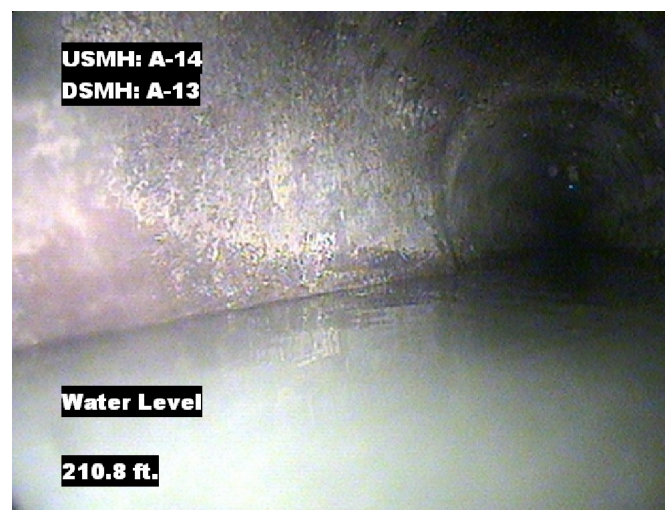
Distance: 210.8 ft. Grade: 0
Condition: Water Level
Remarks: N/A

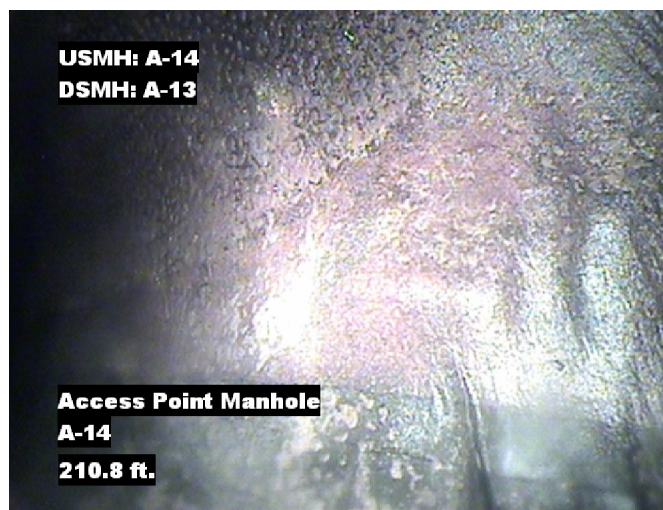
Distance: 210.8 ft. Grade: 0
Condition: Access Point Manhole
Remarks: A-15
