Defect Listing

Pipe Segment Refere... A-16_A-15	City Oliver Springs	Street Old harriman Highwa...	Material Fibreglass Reinforc...	Location C... Easement/R...	Sewer Use Sanitary
Upstream MH A-16	Total Length 229.2	Year Laid	Shape Circular	Location Details	
DS Manhole A-15	Length surveyed 229.2	Year Renewed	Height 15	Width 15	Pipe Joint... N/A

SPR N/A	MPR 12	PO Number 4397-03	Customer GRW
SPRI N/A	MPRI 4	Work Order 4397-02	Purpose Pre-Rehabilitation Survey
QSR N/A	QMR 4300		
OPR 12	Surveyed By Charlie Gordon	Direction Upstream	Date 20151012
OPRI 4	Certificate Number U-615-07000491	Pre-Cleaning No Pre-Cleaning	Time 12:39
	Date Cleaned	End Time 12:49	Weather Damp
			Additional Info

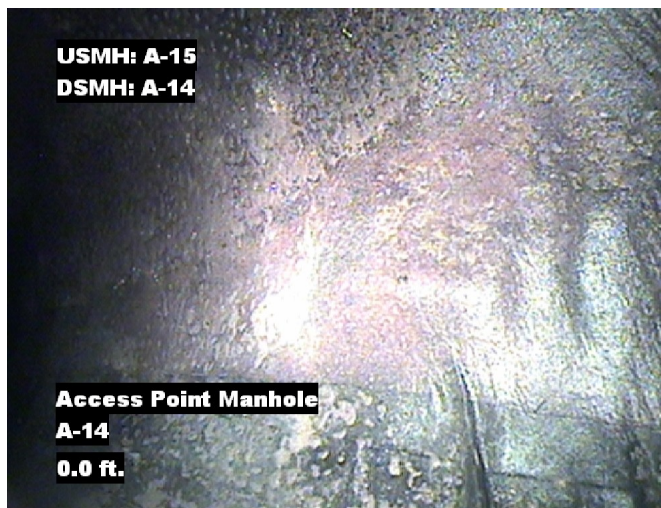
Distance: 0.0 ft. Grade: 0
Condition: Access Point Manhole
Remarks: A-15

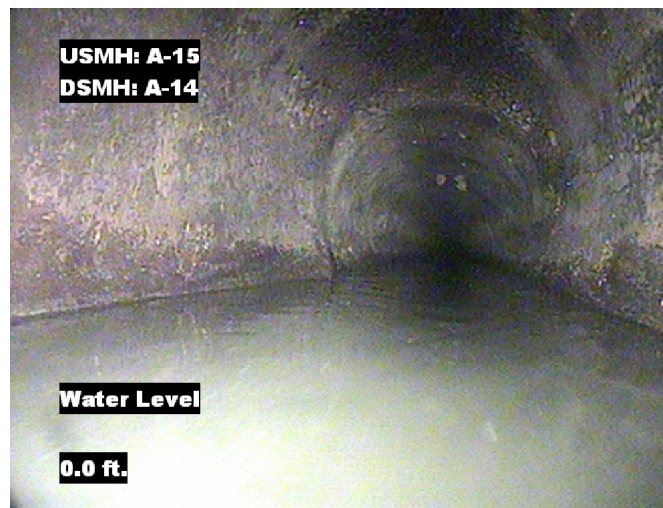
Distance: 0.0 ft. Grade: 0
Condition: Water Level
Remarks: N/A

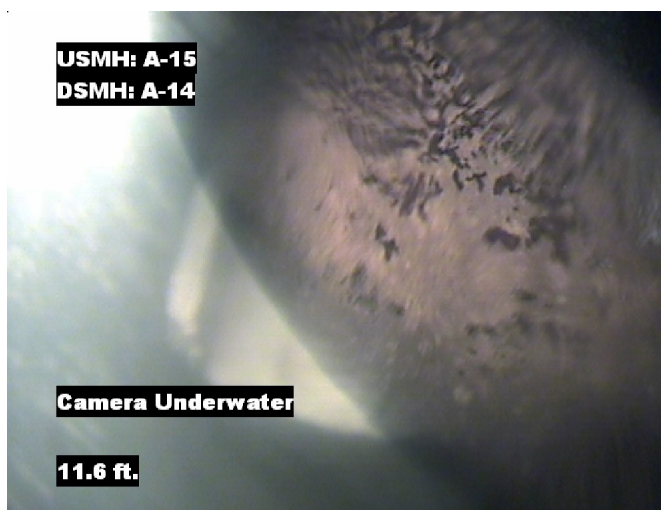
Distance: 11.6 ft. Grade: 4
Condition: Camera Underwater
Remarks: N/A

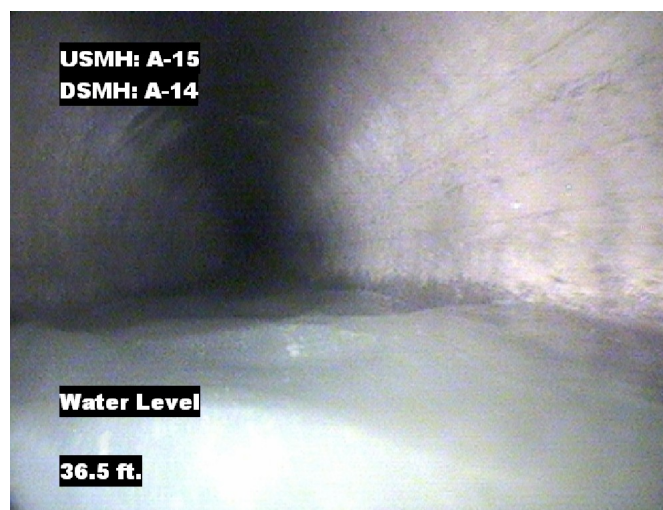
Distance: 36.4 ft. Grade: 0
Condition: Water Level
Remarks: N/A

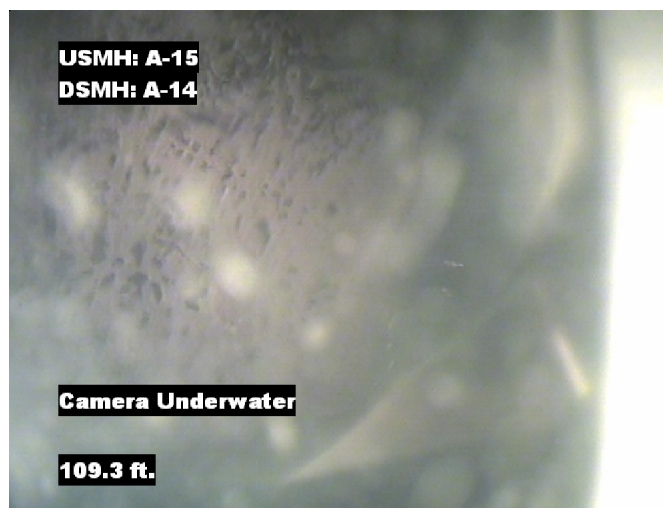
Distance: 109.3 ft. Grade: 4
Condition: Camera Underwater
Remarks: N/A

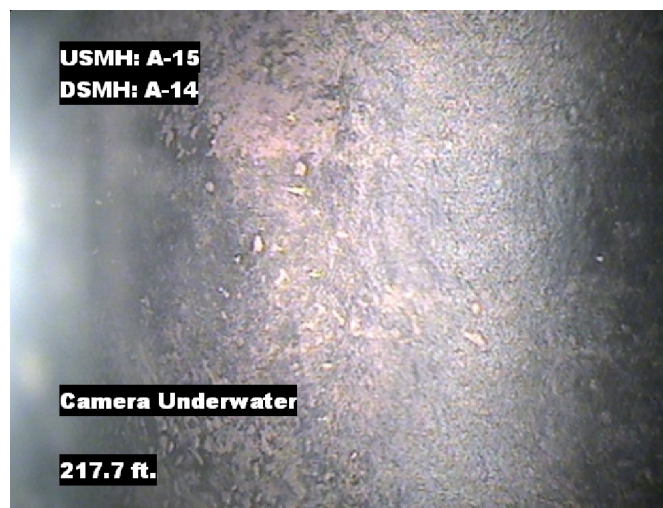
Distance: 217.7 ft. Grade: 4
Condition: Camera Underwater
Remarks: N/A

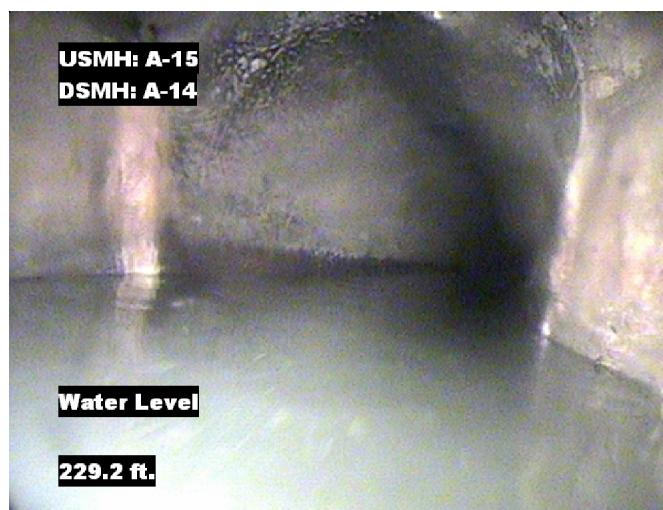
Distance: 229.2 ft. Grade: 0
Condition: Water Level
Remarks: N/A
