Defect Listing

Pipe Segme	ent Refere	City		Street	Mat	Material		Sewer Use		
A-17_	_A-16	Oliver	Springs	Old Harriman Highwa	Fibreglass	Reinforc Easement/r Sai				
Upstrea	am MH	Total I	_ength	Year Laid	Sh	ape	Location Details			
A-	17	16	8.2		Circ	Circular				
DS Ma	nhole	Length s	surveyed	Year Renewed	Height	Width	Pipe Joint			
Α-	16	16	8.2		15 15 N/A					
SPR	N/A	MPR	2	PO Number			Customer			
ODDI	NI/A	MDDI		4397-03	4397-03			GRW		
SPRI	N/A	MPRI	2	Work Order			Purpose			
QSR	N/A	QMR	2100	4397-02		Pre	e-rehabilitation Survey			
OF	PR	Surve	ed By	Direction	Da	ate	Media	label		
2	2	Charlie-Gordon		Downstream	20151013					
OP	rRI	Certificate Number		Pre-Cleaning	Time		Weather			
2	2 U-615-07000491		No Pre-cleaning	12:02		Damp				
Date Cleaned				End	Time	Addition	nal Info			
					12	:11

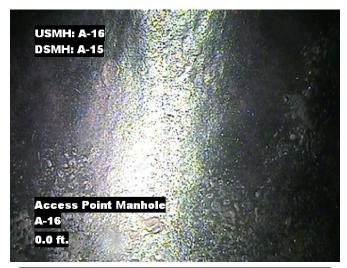
Distance: 0.0 ft. Grade:

Condition: Access Point Manhole

Remarks: A-17

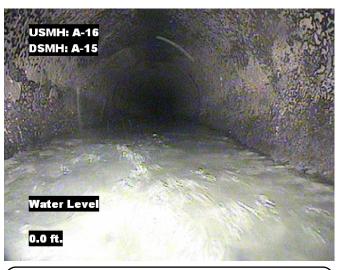
Distance: 0.0 ft. Grade:

Condition: Water Level

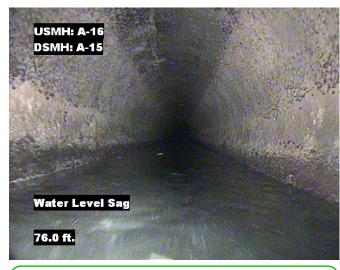
Distance: 75.8 ft. Grade:

Condition: Water Level Sag

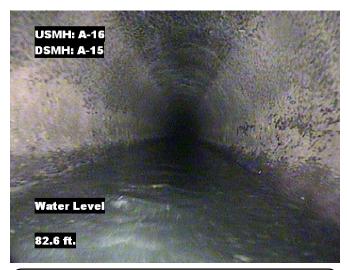
Distance: 82.6 ft. Grade:

Condition: Water Level Remarks: N/A

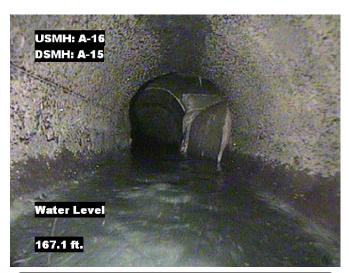
Distance: 167.0 ft. Grade: 0

Condition: Water Level
