Defect Listing

Pipe Segment Refere... A-18_A-17	City Oliver Springs	Street Old Harriman Highwa...	Material Fibreglass Reinforc...	Location C... Easement/r...	Sewer Use Sanitary
Upstream MH A-18	Total Length 314.5	Year Laid	Shape Circular	Location Details	
DS Manhole A-17	Length surveyed 314.5	Year Renewed	Height 15	Width 15	Pipe Joint... N/A

SPR N/A	MPR 31	PO Number 4397-03	Customer GRW
SPRI N/A	MPRI 2.1	Work Order 4397-02	Purpose Pre-rehabilitation Survey
QSR N/A	QMR 312A		
OPR 31	Surveyed By Charlie-Gordon	Direction Downstream	Date 20151013
OPRI 2.1	Certificate Number U-615-07000491	Pre-Cleaning No Pre-cleaning	Time 11:41
	Date Cleaned	End Time 11:59	Weather Damp
		Additional Info

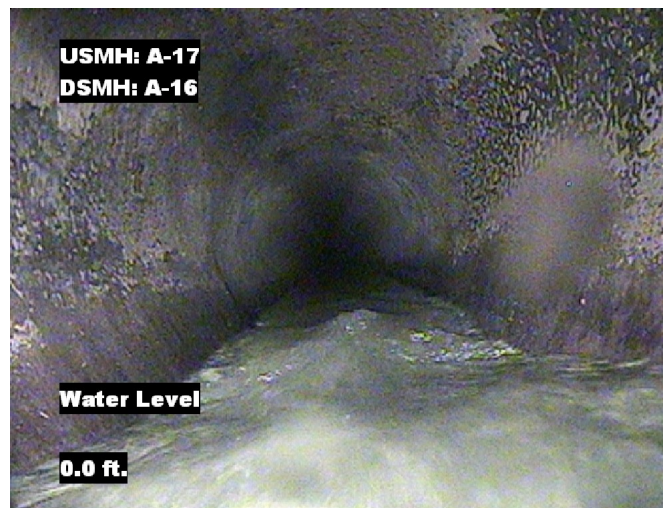
Distance: 0.0 ft. Grade: 0
Condition: Water Level
Remarks: N/A

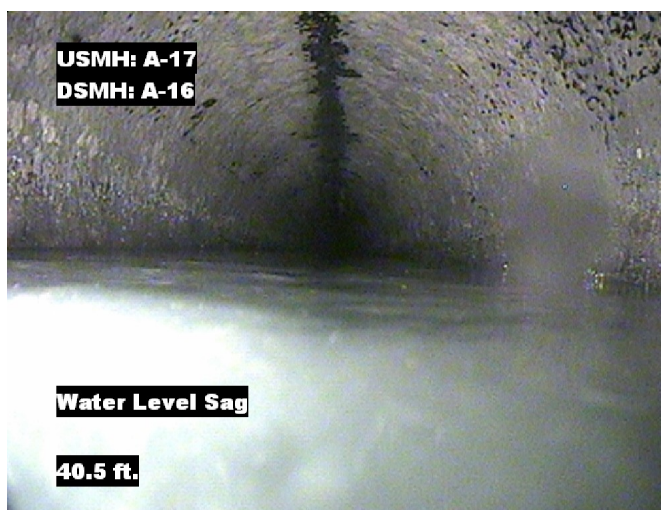
Distance: 40.5 ft. Grade: 2
Condition: Water Level Sag
Remarks: N/A

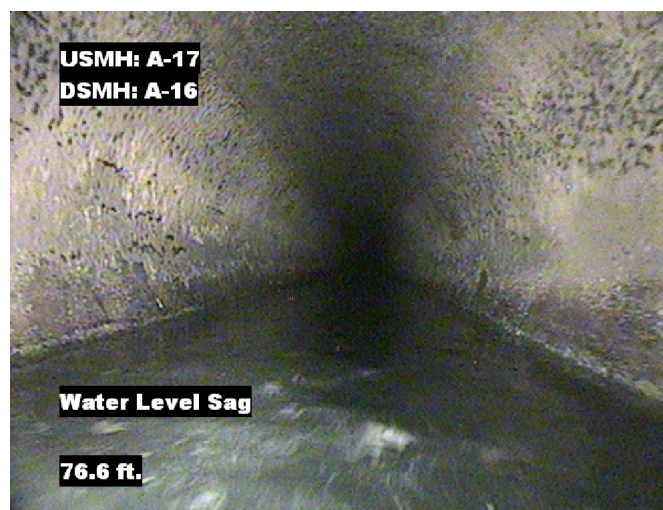
Distance: 76.3 ft. Grade: 2
Condition: Water Level Sag
Remarks: N/A

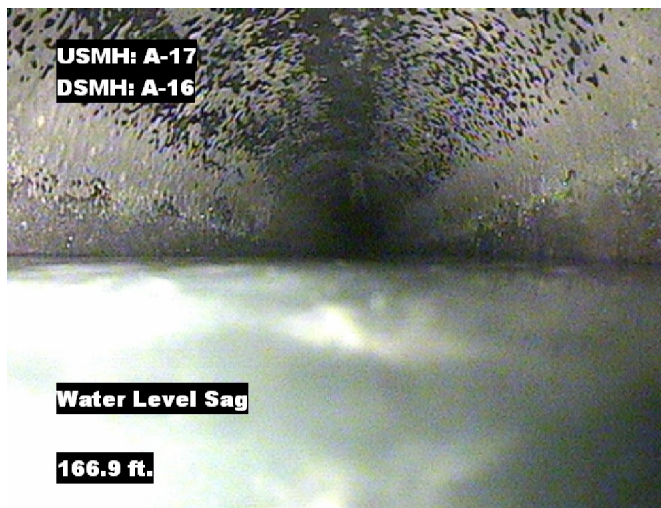
Distance: 166.9 ft. Grade: 2
Condition: Water Level Sag
Remarks: N/A

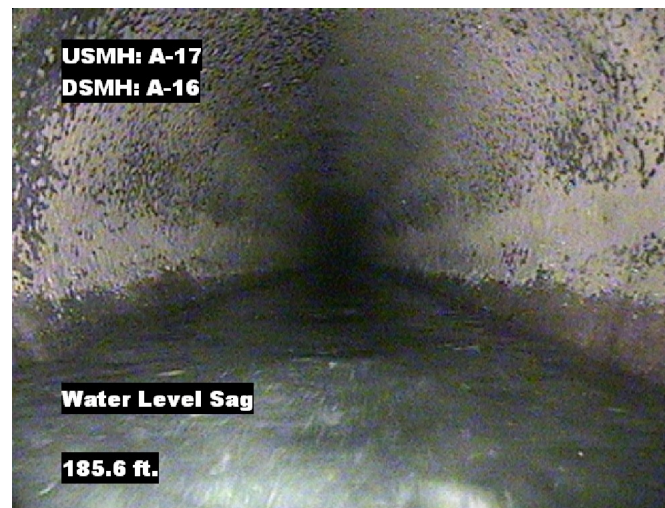
Distance: 185.4 ft. Grade: 2
Condition: Water Level Sag
Remarks: N/A

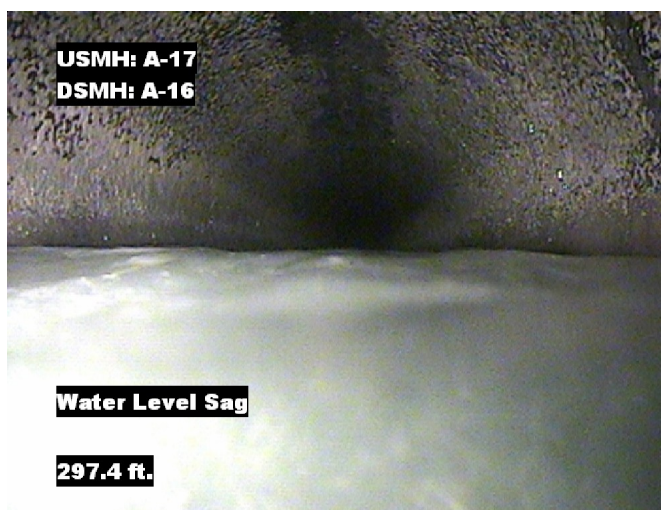
Distance: 297.4 ft. Grade: 2
Condition: Water Level Sag
Remarks: N/A

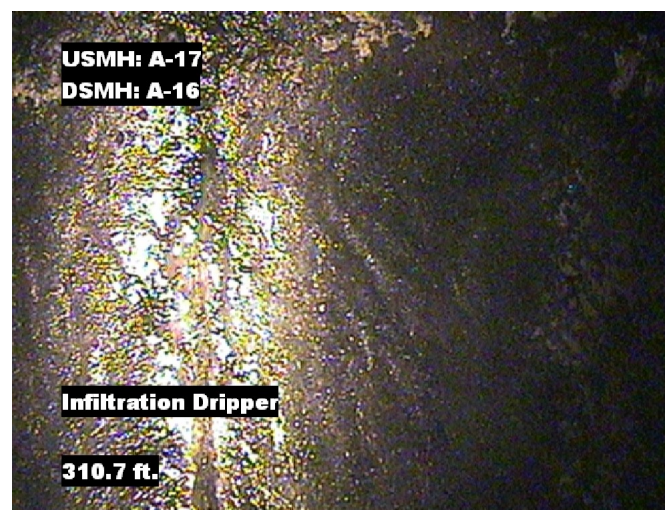
Distance: 310.7 ft. Grade: 3
Condition: Infiltration Dripper
Remarks: N/A

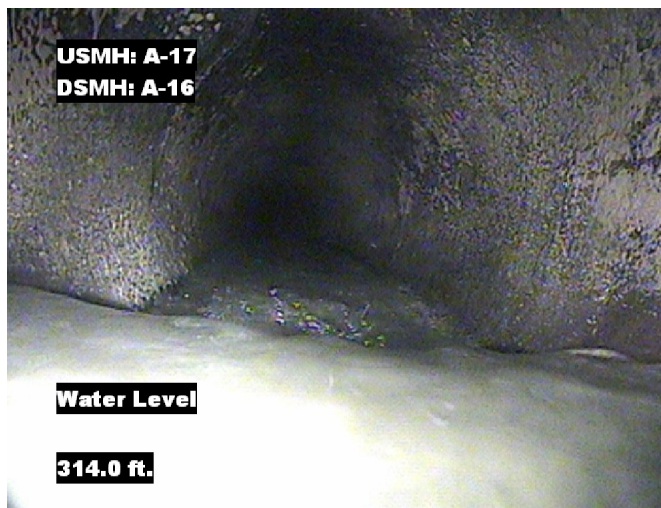
Distance: 314.0 ft. Grade: 0
Condition: Water Level
Remarks: N/A

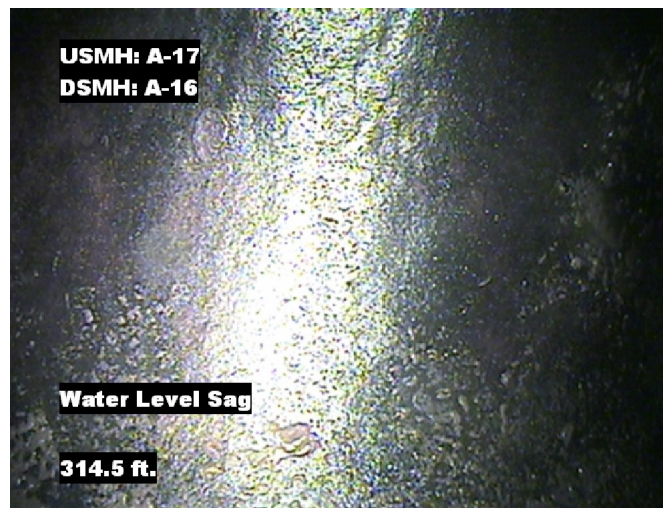
Distance: 314.4 ft. Grade: 2
Condition: Water Level Sag
Remarks: N/A
