## **Defect Listing**

Pipe Segment Refere		City		Street	Mat	Material		Sewer Use	
A-19_A-18 Upstream MH A-19		Oliver Springs  Total Length  162.4		Old Harriman Highwa	Fibreglass	Fibreglass Reinforc		Sanitary	
				Year Laid	Shape Circular		Location Details		
DS Ma	anhole	Length surveyed 162.4		Year Renewed	Height	Width 15	Pipe Joint N/A		
Α-	18				15				
SPR	N/A	MPR	N/A	PO Number			Customer		
0001	N1/A			4397-03			<b>GRW</b> Purpose		
SPRI	N/A	MPRI	N/A	Work Order					
QSR	N/A	QMR	N/A	4397-02		Pre	Pre-rehabilitation Survey		
OF	PR	Survey	red By	Direction	Date		Media label		
N/	<b>'</b> A	Charlie-Gordon		Downstream	20151013				
OP	PRI	Certificate Number		Pre-Cleaning	Time		Weather		
N/A U-615		U-615-0	7000491	No Pre-cleaning		11:22			
Date Cleaned						End Time 11:39		Additional Info

## **Image Report 4/Page**

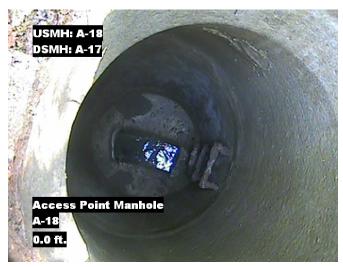
Distance: 0.0 ft. Grade: 0

Condition: Access Point Manhole

Remarks: A-19

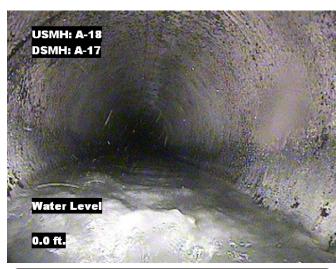
Distance: 0.0 ft. Grade: 0

Condition: Water Level

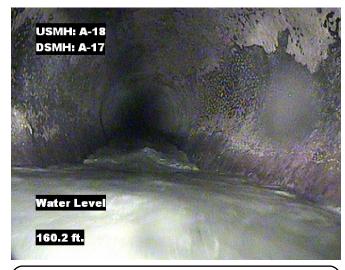
Distance: 160.2 ft. Grade: 0

Condition: Water Level
