## **Defect Listing**

Pipe Segment Refere		City		Street	Mat	Material		Sewer Use	
A-2_A-1		Oliver Springs		pump Station 1	Fibreglass	Fibreglass Reinforc		Sanitary	
Upstream MH		Total Length		Year Laid	Sha	ape	Location Details		
A-2		299.3			Circ	ular			
DS Manhole		Length surveyed		Year Renewed	Height	Width	Pipe Joint		
A-1		299.3			21	21	N/A		
SPR	N/A	MPR	N/A	PO Number			Customer		
0001	-			4397-03		GRW			
SPRI	N/A	MPRI	N/A	Work Order				Purpose	
QSR	N/A	QMR	N/A	4397-02		Pre-Rehabilitation Survey			
Ol	PR	Surveyed By		Direction	Date		Media label		
N	/A	Charlie_Gordon		Downstream	20151007				
OF	PRI	Certificate Number		Pre-Cleaning	Time		Weather		
N/A		U-615-07000491		No Pre-Cleaning	12:27		Damp		
		Date C	leaned	End Time		Additional Info			
					12:38

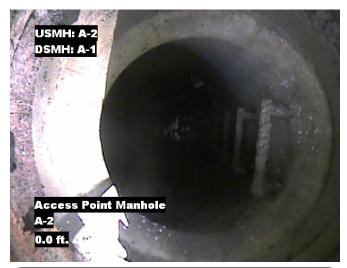
Distance: 0.0 ft. Grade: 0

Condition: Access Point Manhole

Remarks: A-2

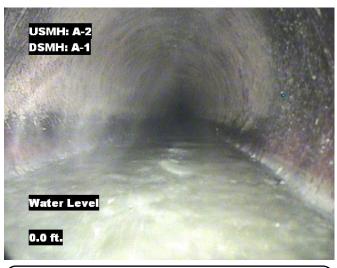
Distance: 0.0 ft. Grade: 0

Condition: Water Level

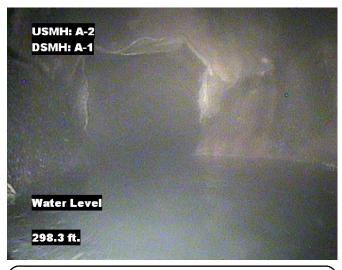
Distance: 298.3 ft. Grade: 0

Condition: Water Level
