Defect Listing

Pipe Segment Refere... A-20_A-19	City Oliver Springs	Street Old Harriman Highwa...	Material Fibreglass Reinf...	Location C... Easement/r...	Sewer Use Sanitary
Upstream MH A-20	Total Length 168.9	Year Laid	Shape Circular	Location Details	
DS Manhole A-19	Length surveyed 168.9	Year Renewed	Height 15	Width 15	Pipe Joint... N/A

SPR N/A	MPR 32	PO Number 4397-03		Customer GRW	
SPRI N/A	MPRI 2	Work Order 4397-02		Purpose Pre-rehabilitation Survey	
QSR N/A	QMR 2B00				
OPR 32	Surveyed By Charlie-Gordon	Direction Downstream	Date 20151013	Media label	
OPRI 2	Certificate Number U-615-07000491	Pre-Cleaning No Pre-cleaning	Time 12:59	Weather Damp	
Date Cleaned			End Time 13:08	Additional Info

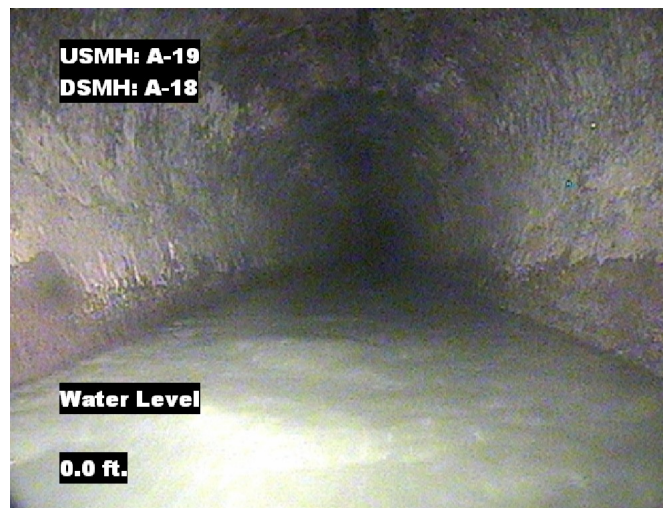
Distance: 0.0 ft. Grade: 0
Condition: Water Level
Remarks: N/A

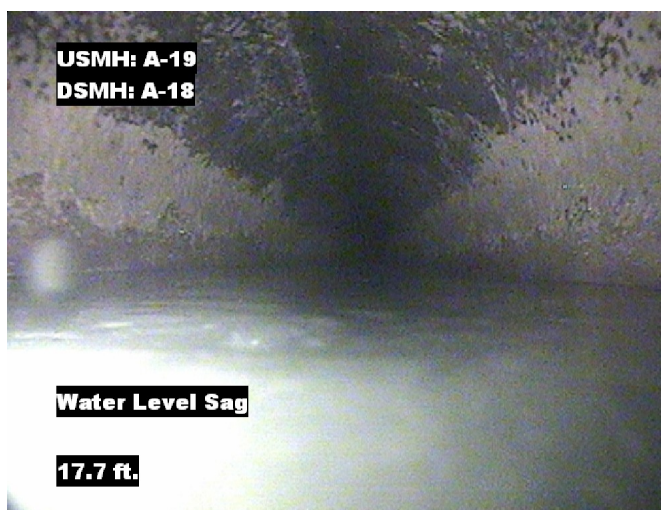
Distance: 17.6 ft. Grade: 2
Condition: Water Level Sag
Remarks: N/A

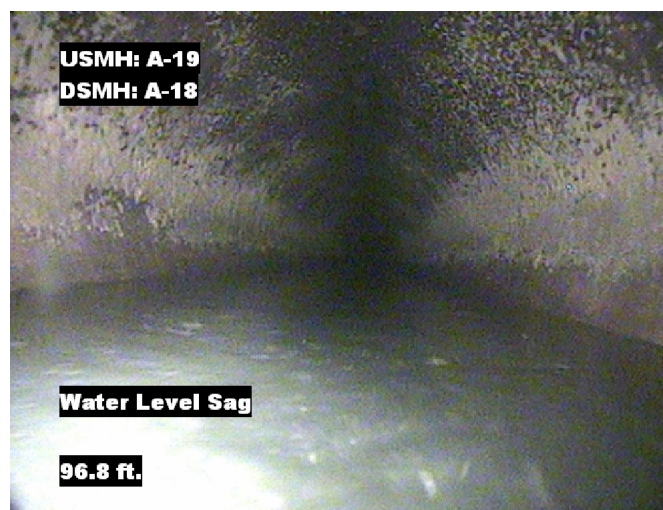
Distance: 96.7 ft. Grade: 2
Condition: Water Level Sag
Remarks: N/A

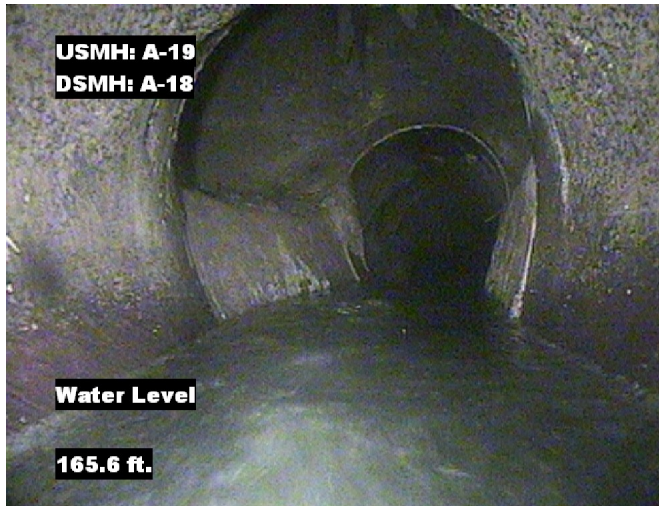
Distance: 165.6 ft. Grade: 0
Condition: Water Level
Remarks: N/A

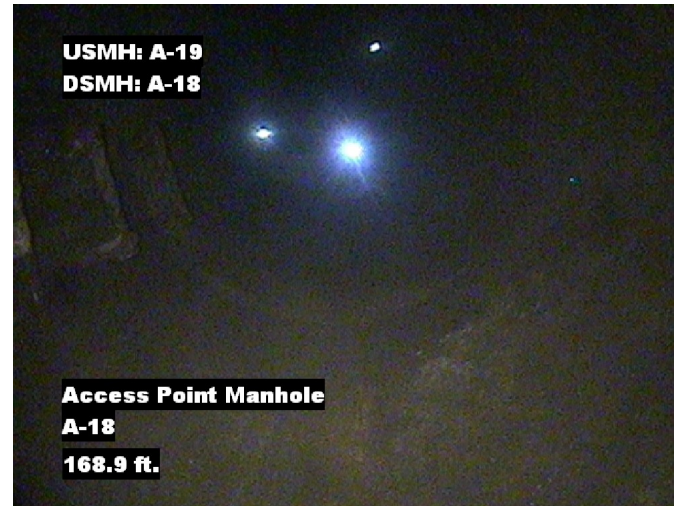
Distance: 168.9 ft. Grade: 0
Condition: Access Point Manhole
Remarks: A-19
