Defect Listing

Pipe Segment Refere... A-21_A-20	City Oliver Springs	Street Old Harriman Highwa...	Material Fibreglass Reinforc...	Location C... Easement/r...	Sewer Use Sanitary
Upstream MH A-21	Total Length 349.8	Year Laid	Shape Circular	Location Details	
DS Manhole A-20	Length surveyed 349.8	Year Renewed	Height 15	Width 15	Pipe Joint... N/A

SPR N/A	MPR 26	PO Number 4397-03		Customer GRW	
SPRI N/A	MPRI 2.6	Work Order 4397-02		Purpose Pre-rehabilitation Survey	
QSR N/A	QMR 3624				
OPR 26	Surveyed By Charlie-Gordon	Direction Downstream	Date 20151013	Media label	
OPRI 2.6	Certificate Number U-615-07000491	Pre-Cleaning No Pre-cleaning	Time 12:53	Weather Damp	
Date Cleaned			End Time 12:54	Additional Info

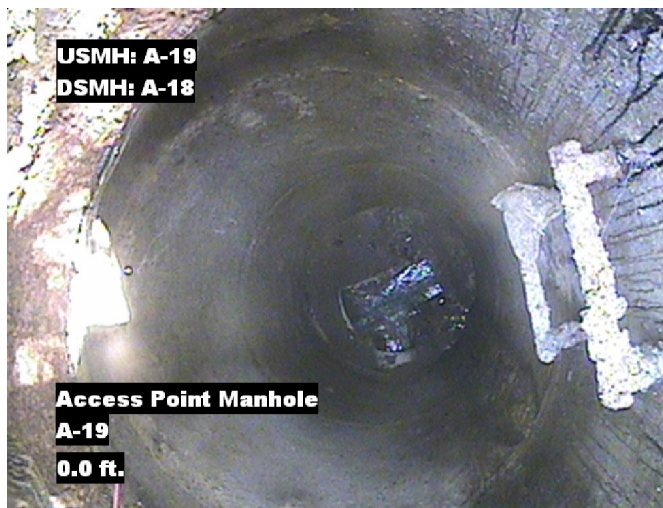
Distance: 0.0 ft. Grade: 0
Condition: Access Point Manhole
Remarks: A-21

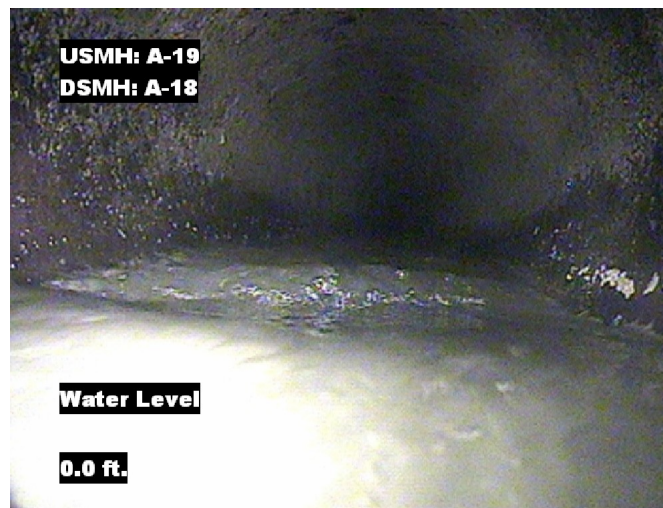
Distance: 0.0 ft. Grade: 0
Condition: Water Level
Remarks: N/A

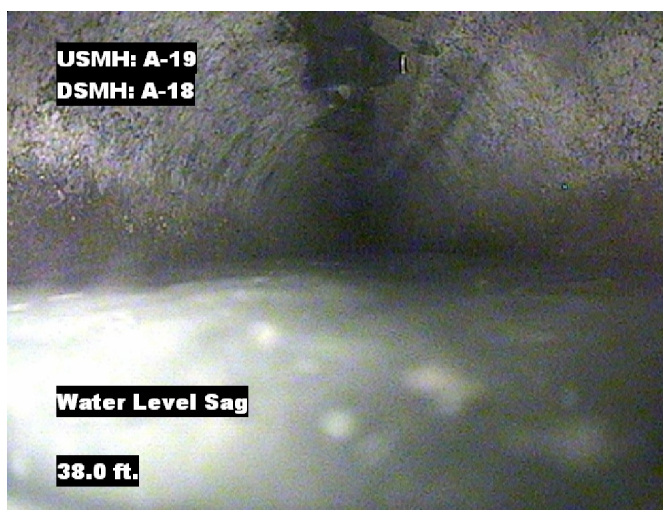
Distance: 38.0 ft. Grade: 2
Condition: Water Level Sag
Remarks: N/A

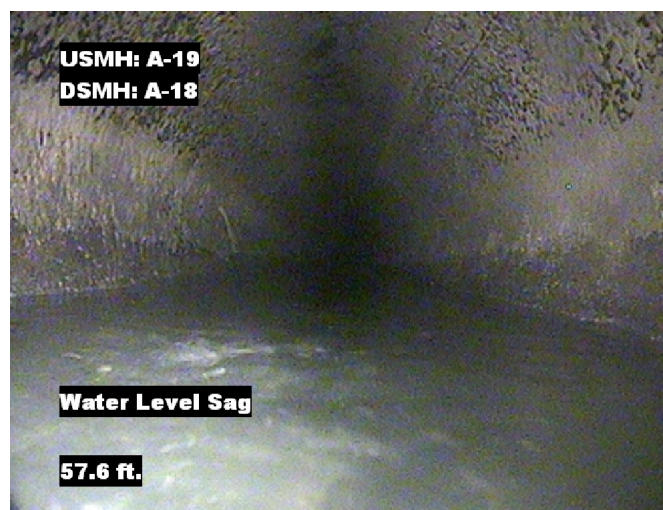
Distance: 57.6 ft. Grade: 2
Condition: Water Level Sag
Remarks: N/A

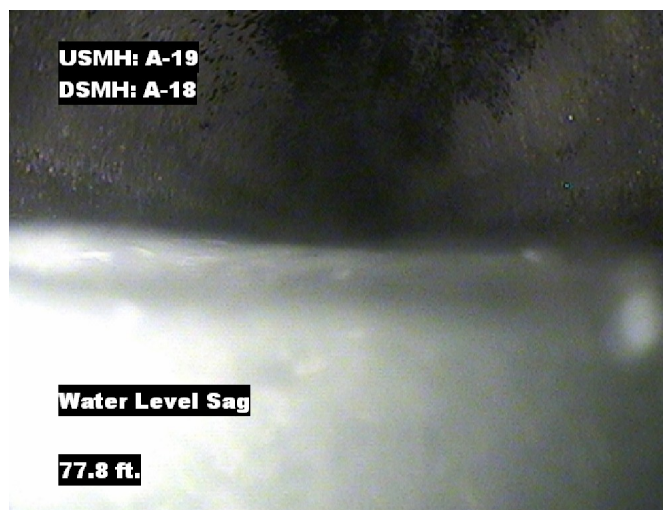
Distance: 77.8 ft. Grade: 3
Condition: Water Level Sag
Remarks: N/A

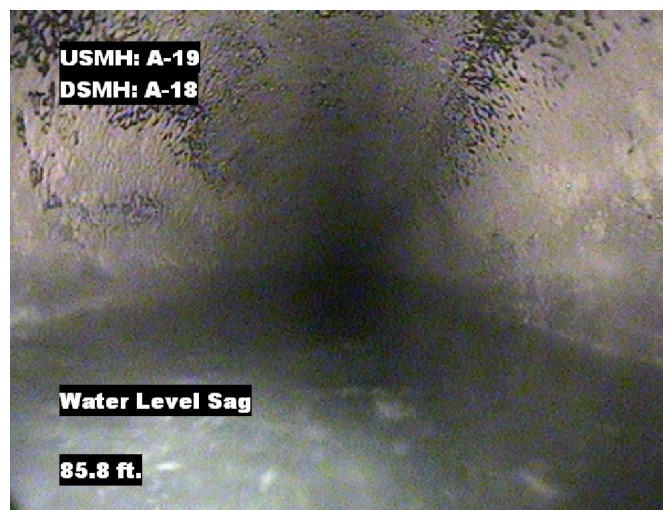
Distance: 85.7 ft. Grade: 3
Condition: Water Level Sag
Remarks: N/A

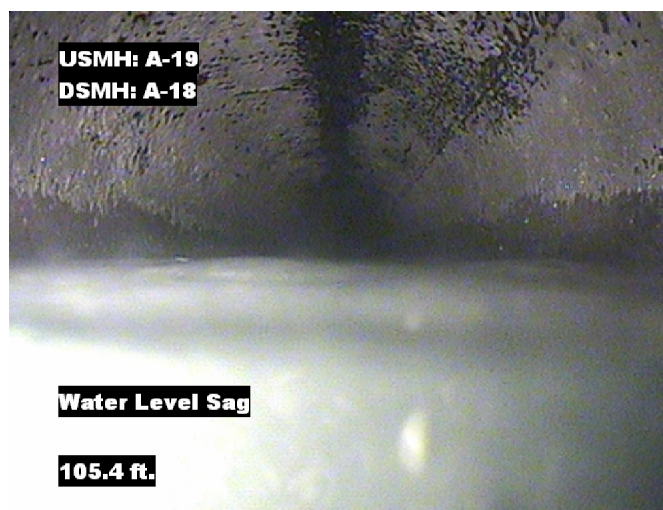
Distance: 105.4 ft. Grade: 3
Condition: Water Level Sag
Remarks: N/A

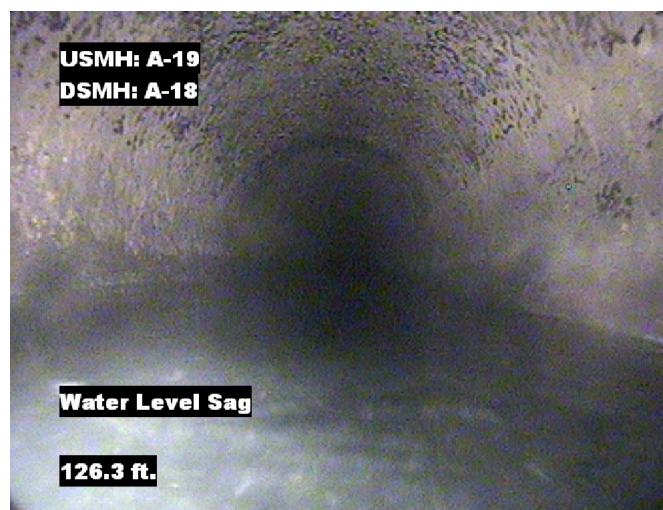
Distance: 126.1 ft. Grade: 3
Condition: Water Level Sag
Remarks: N/A

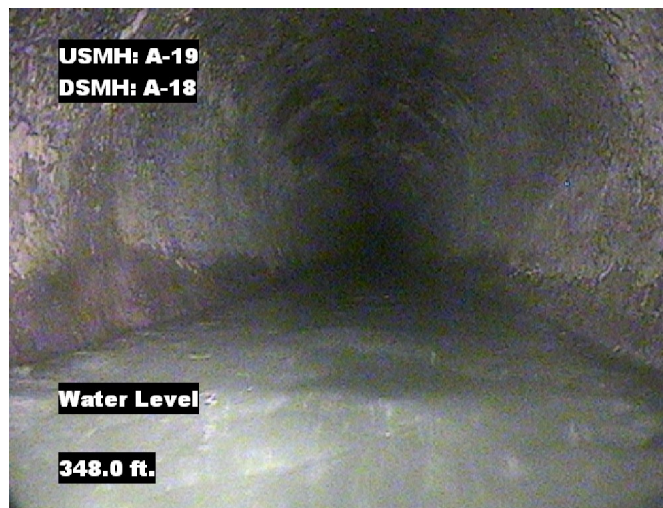
Distance: 348.0 ft. Grade: 0
Condition: Water Level
Remarks: N/A

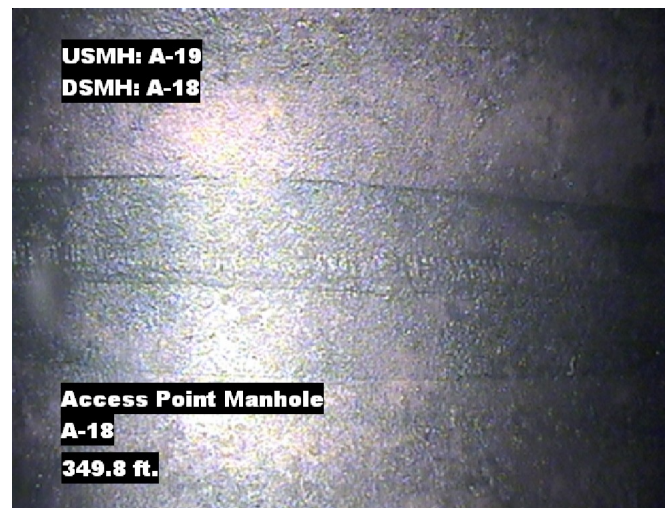
Distance: 349.8 ft. Grade: 0
Condition: Access Point Manhole
Remarks: A-20
