Defect Listing

Pipe Segment Refere... A-22_A-21	City Oliver Springs	Street Old Harriman Highwa...	Material Fibreglass Reinforc...	Location C... Easement/r...	Sewer Use Sanitary
Upstream MH A-22	Total Length 344	Year Laid	Shape Circular	Location Details	
DS Manhole A-21	Length surveyed 344	Year Renewed	Height 15	Width 15	Pipe Joint... N/A

SPR 3	MPR 42	PO Number 4397-03	Customer GRW
SPRI 1.5	MPRI 2.1	Work Order 4397-02	Purpose Pre-rehabilitation Survey
QSR 2111	QMR 412B		
OPR 45	Surveyed By Charlie-Gordon	Direction Upstream	Date 20151013
OPRI 2	Certificate Number U-615-07000491	Pre-Cleaning No Pre-cleaning	Time 13:45
	Date Cleaned	End Time 14:14	Weather Damp
			Media label
			Additional Info

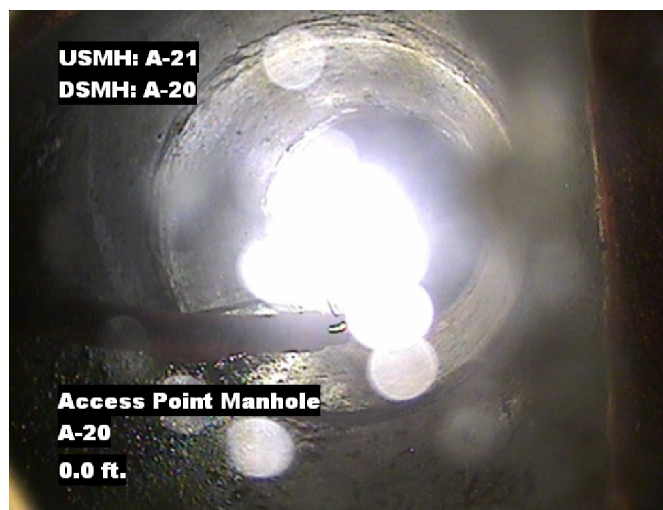
Distance: 0.0 ft. Grade: 0
Condition: Access Point Manhole
Remarks: A-21

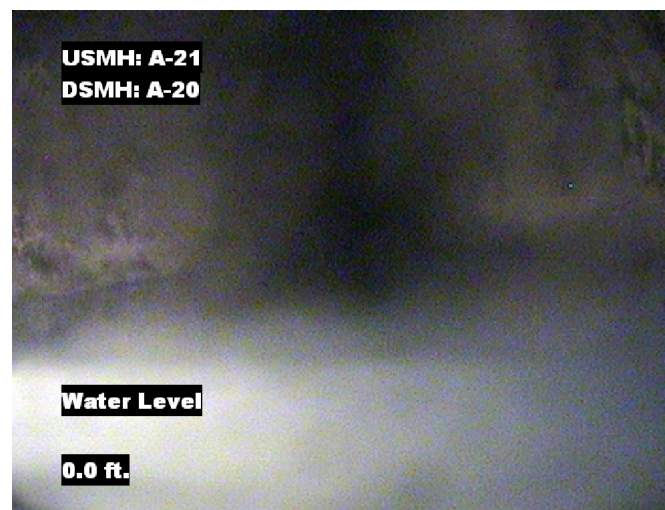
Distance: 0.0 ft. Grade: 0
Condition: Water Level
Remarks: N/A

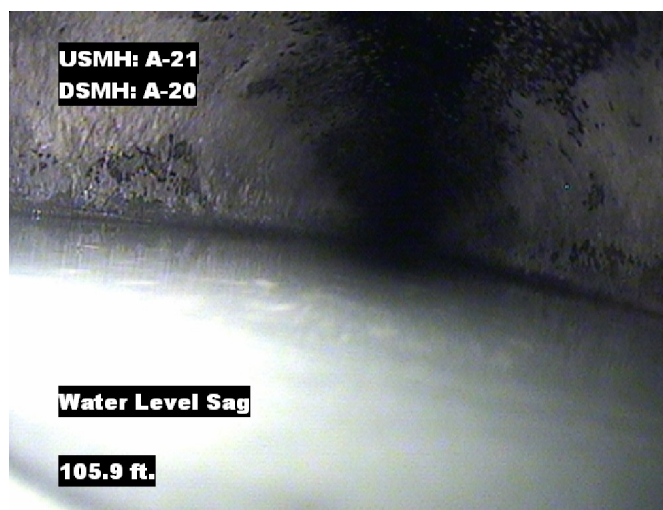
Distance: 105.9 ft. Grade: 2
Condition: Water Level Sag
Remarks: N/A

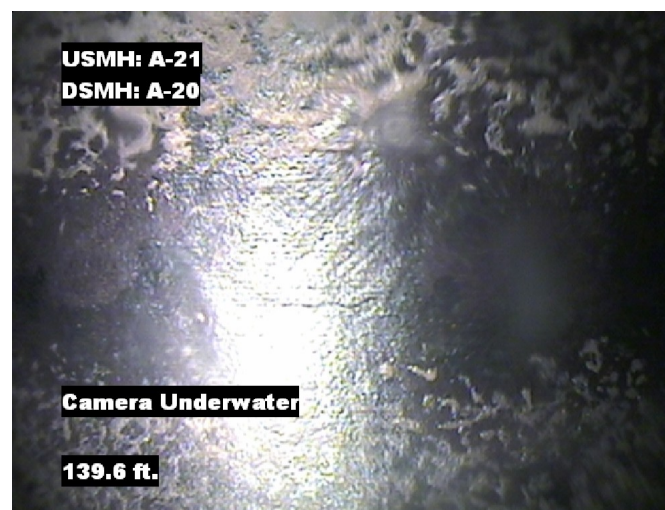
Distance: 139.6 ft. Grade: 4
Condition: Camera Underwater
Remarks: N/A

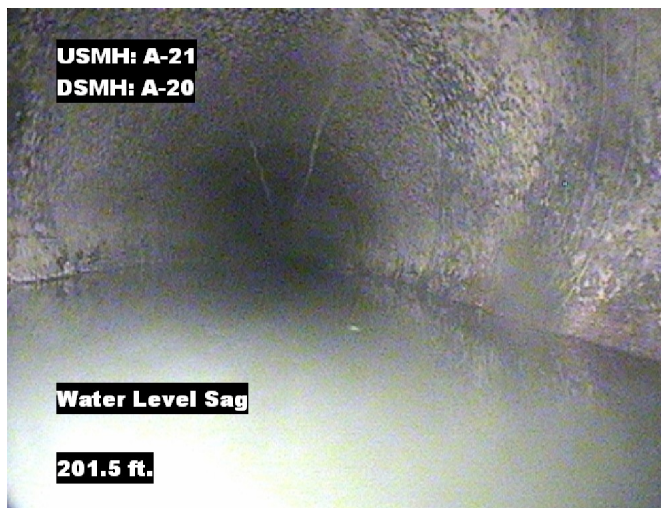
Distance: 201.3 ft. Grade: 2
Condition: Water Level Sag
Remarks: N/A

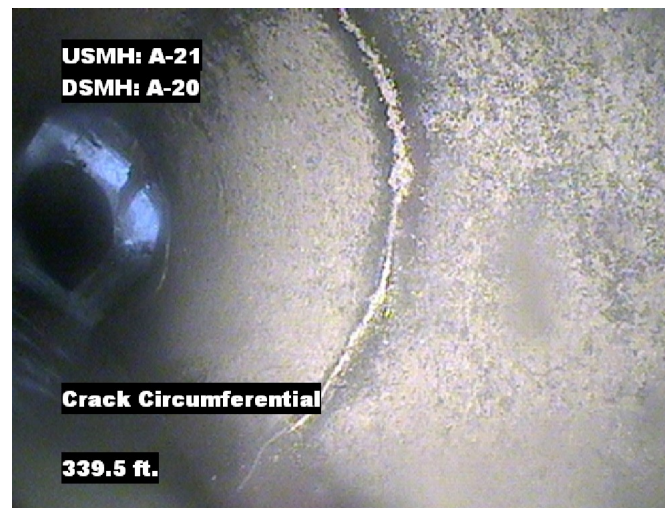
Distance: 339.5 ft. Grade: 1
Condition: Crack Circumferential
Remarks: N/A

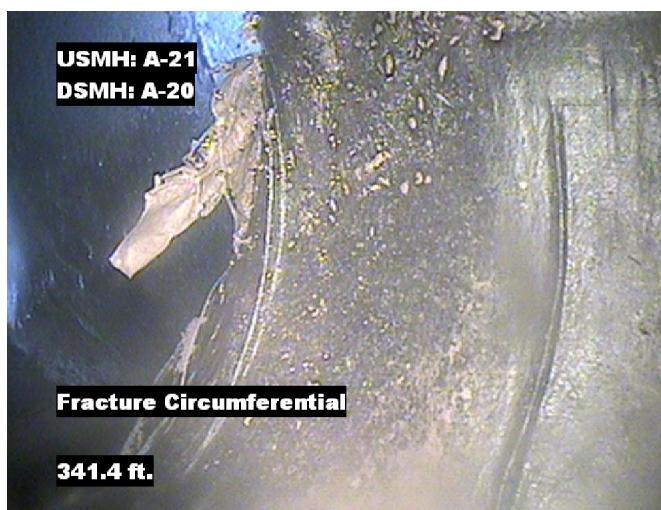
Distance: 341.4 ft. Grade: 2
Condition: Fracture Circumferential
Remarks: N/A

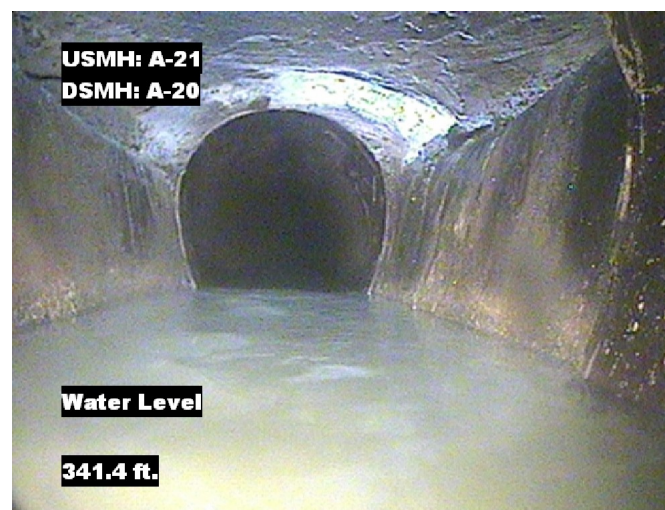
Distance: 341.4 ft. Grade: 0
Condition: Water Level
Remarks: N/A

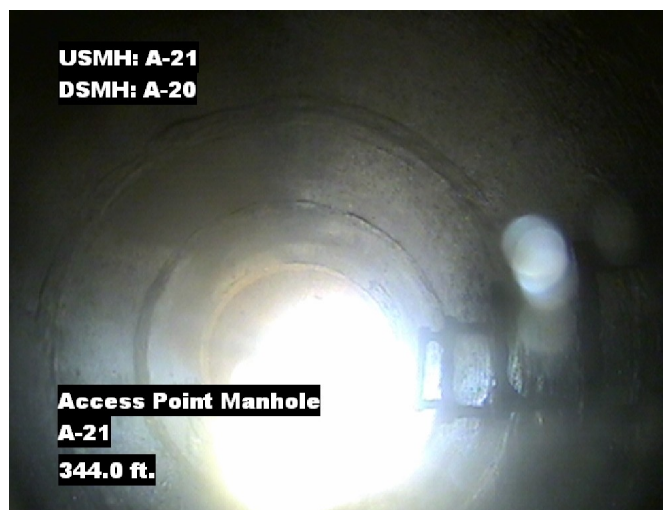
Distance: 344.0 ft. Grade: 0
Condition: Access Point Manhole
Remarks: A-22
