Defect Listing

SPR	3	MPR	20	PO Number	Customer
SPRI	3	MPRI	2.2	4397-03	GRW
QSR	3100	QMR	4128	Work Order	Purpose
			4397-02	Pre-rehabilitation Survey	
OPR		Surveyed By	Direction	Date	Media label
23		Charlie-Gordon	Downstream	20151013	
OPRI		Certificate Number	Pre-Cleaning	Time	Weather
2.3		U-615-07000491	No Pre-cleaning	15:15	Damp
Date Cleaned				End Time	Additional Info
				15:33

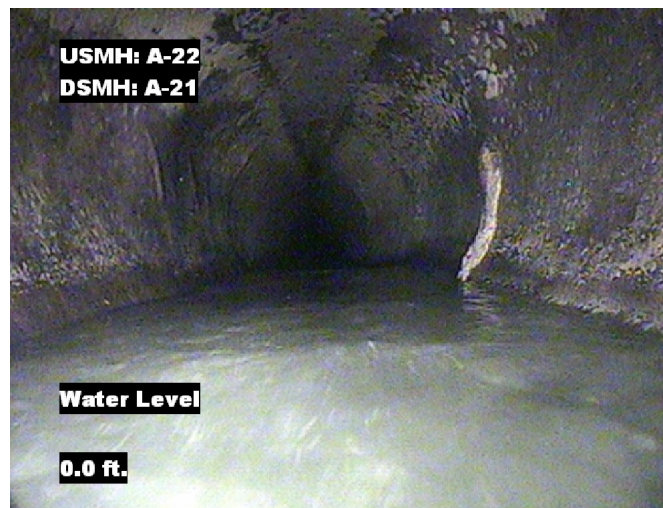
Distance: 0.0 ft. Grade: 0
Condition: Water Level
Remarks: N/A

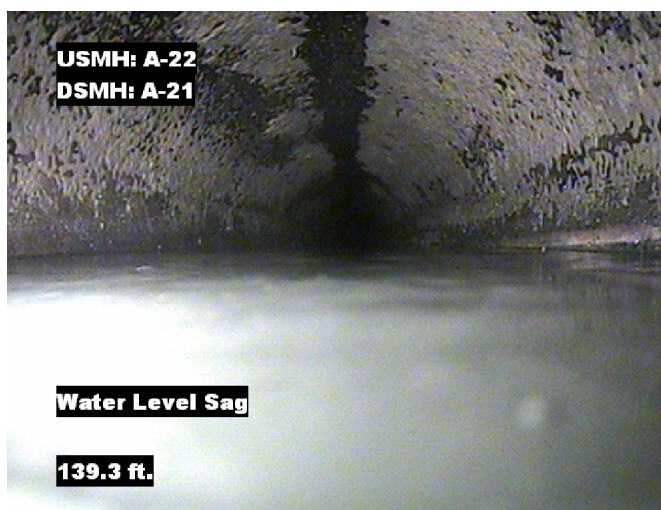
Distance: 139.3 ft. Grade: 2
Condition: Water Level Sag
Remarks: N/A

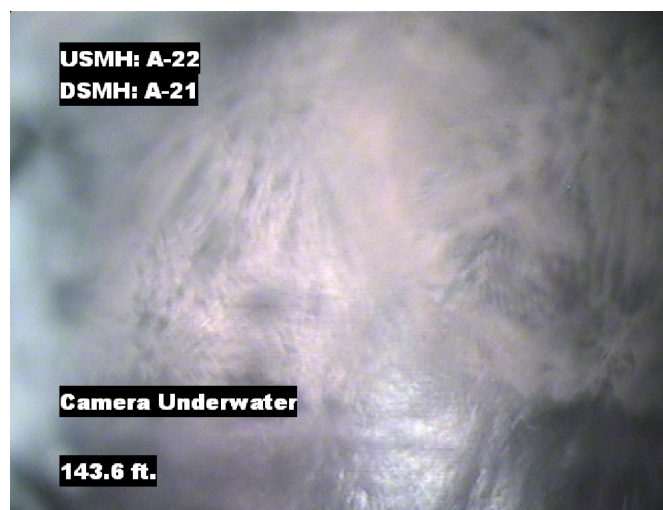
Distance: 143.6 ft. Grade: 4
Condition: Camera Underwater
Remarks: N/A

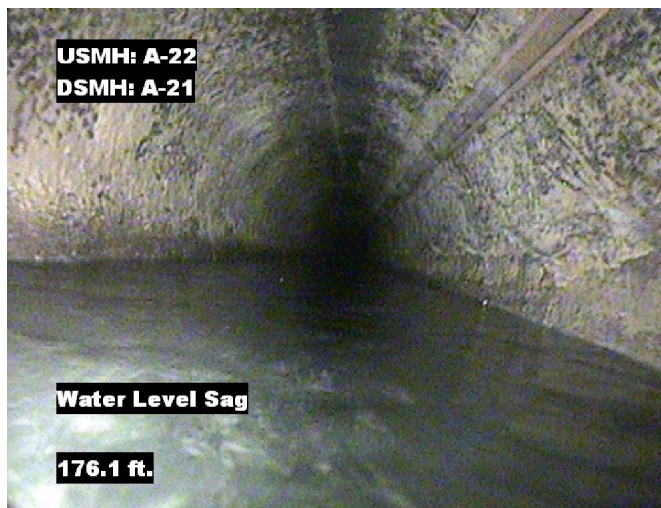
Distance: 176.0 ft. Grade: 2
Condition: Water Level Sag
Remarks: N/A

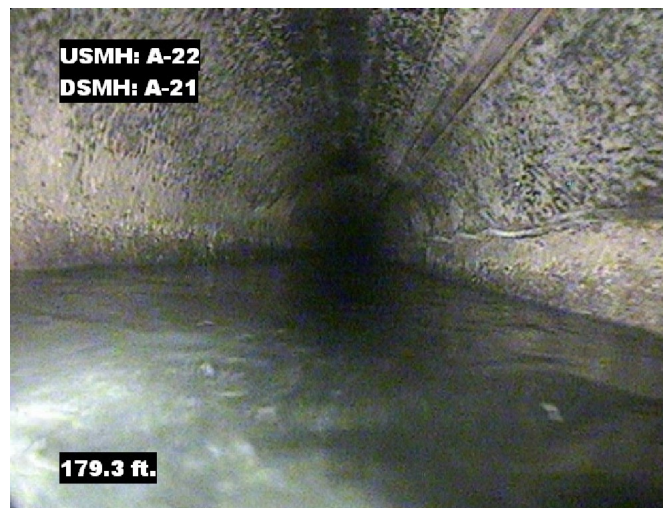
Distance: 179.2 ft. Grade: 3
Condition: Lining Failure Wrinkled
Remarks: N/A

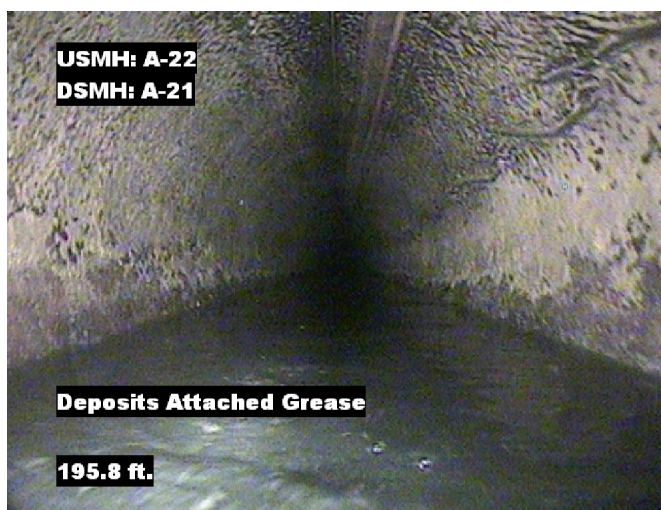
Distance: 195.8 ft. Grade: 2
Condition: Deposits Attached Grease
Remarks: N/A

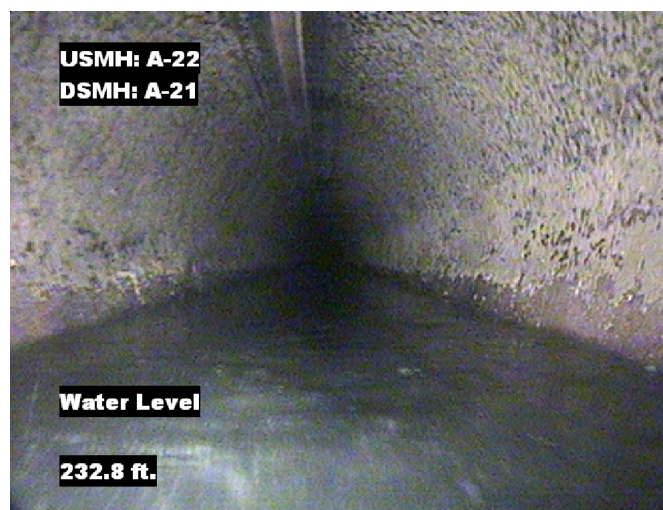
Distance: 232.7 ft. Grade: 0
Condition: Water Level
Remarks: N/A

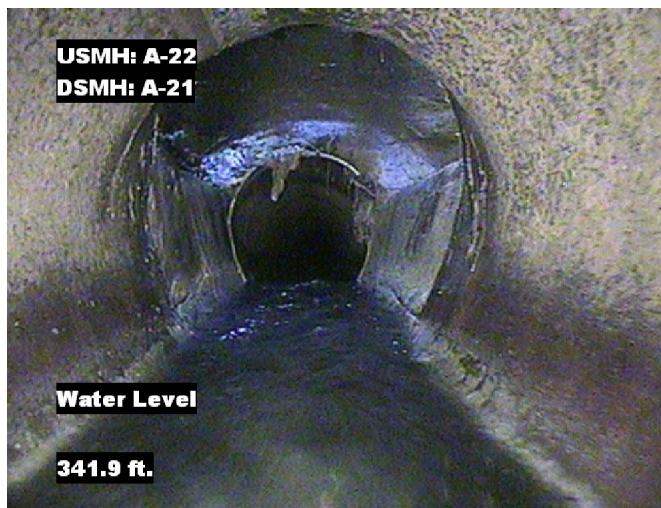
Distance: 341.8 ft. Grade: 0
Condition: Water Level
Remarks: N/A
