Defect Listing

Pipe Segment Refere... A-24_A-23	City Oliver Springs	Street Old Harriman Highwa...	Material Fibreglass Reinf...	Location C... Easement/r...	Sewer Use Sanitary
Upstream MH A-24	Total Length 222.4	Year Laid	Shape Circular	Location Details	
DS Manhole A-23	Length surveyed 222.4	Year Renewed	Height 15	Width 15	Pipe Joint... N/A

SPR N/A	MPR 56	PO Number 4397-03		Customer GRW	
SPRI N/A	MPRI 2	Work Order 4397-02		Purpose Pre-rehabilitation Survey	
QSR N/A	QMR 2D00				
OPR 56	Surveyed By Charlie-Gordon	Direction Downstream	Date 20151013	Media label	
OPRI 2	Certificate Number U-615-07000491	Pre-Cleaning No Pre-cleaning	Time 15:05	Weather Damp	
Date Cleaned			End Time 15:14	Additional Info

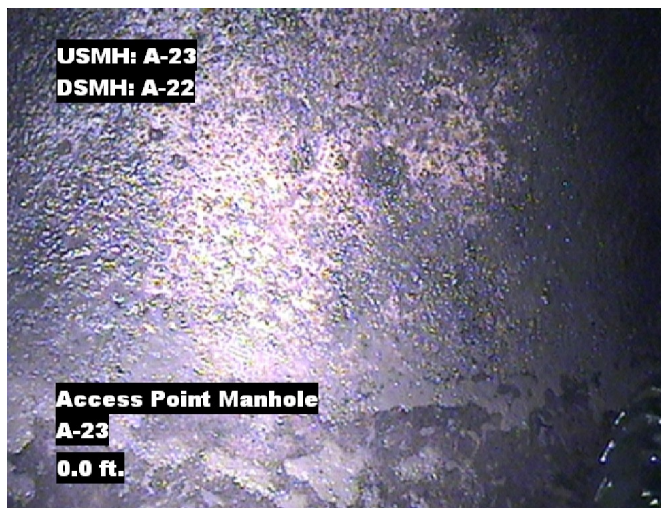
Distance: 0.0 ft. Grade: 0
Condition: Access Point Manhole
Remarks: A-24

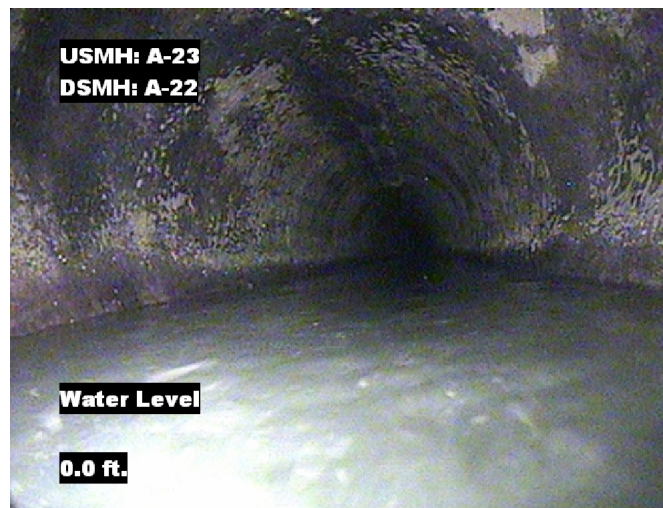
Distance: 0.0 ft. Grade: 0
Condition: Water Level
Remarks: N/A

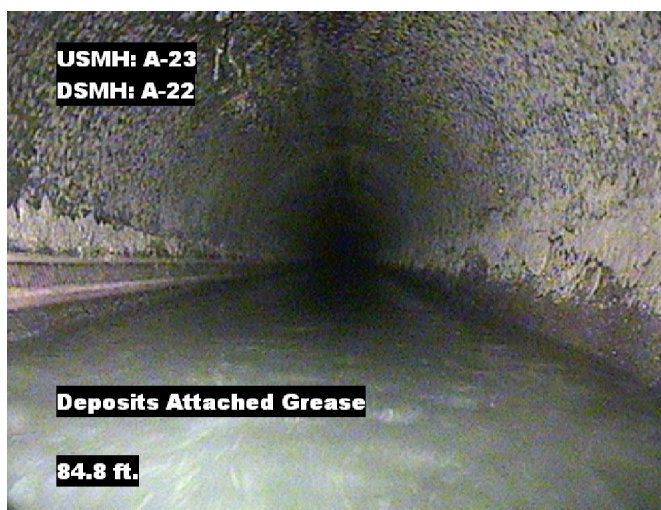
Distance: 84.8 ft. Grade: 2
Condition: Deposits Attached Grease
Remarks: N/A

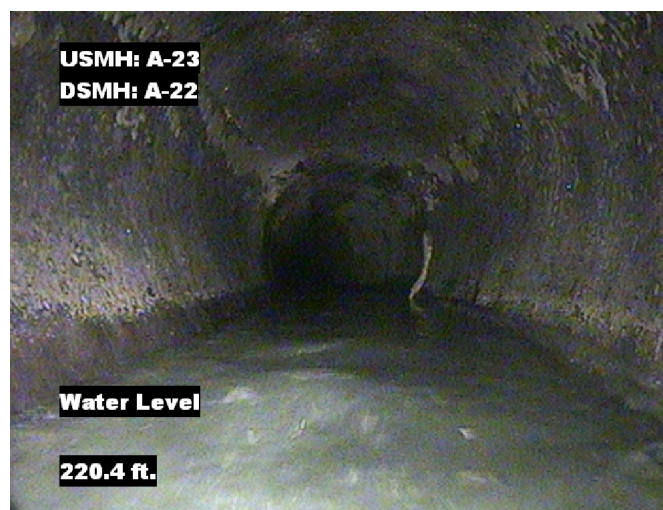
Distance: 220.4 ft. Grade: 0
Condition: Water Level
Remarks: N/A

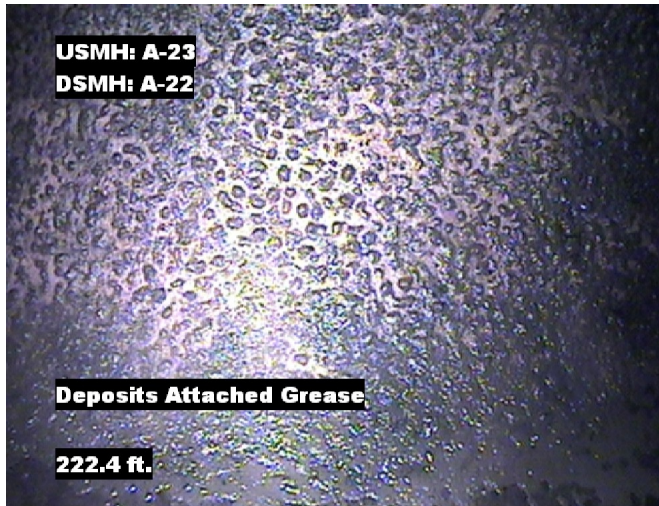
Distance: 222.4 ft. Grade: 2
Condition: Deposits Attached Grease
Remarks: N/A

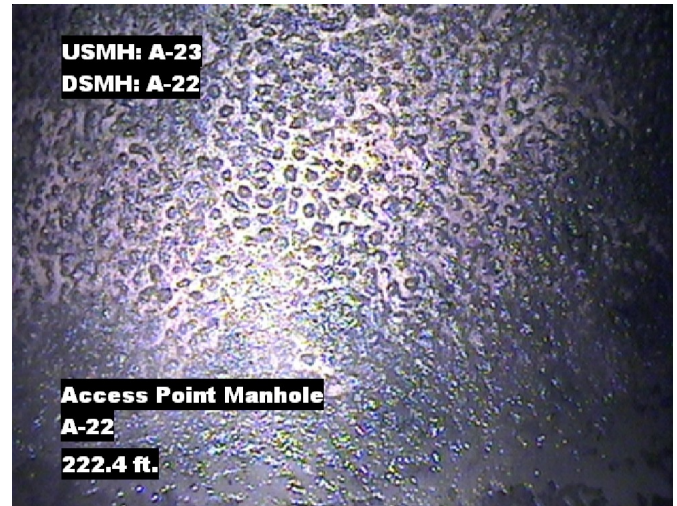
Distance: 222.4 ft. Grade: 0
Condition: Access Point Manhole
Remarks: A-23
