## Defect Listing

Pipe Segment Refere... <b>A-26_A-25</b>	City <b>Oliver Springs</b>	Street <b>Old harriman highwa...</b>	Material <b>Fibreglass Reinforc...</b>	Location C... <b>Easement/R...</b>	Sewer Use <b>Sanitary</b>
Upstream MH <b>A-26</b>	Total Length <b>345.5</b>	Year Laid	Shape <b>Circular</b>	Location Details	
DS Manhole <b>A-25</b>	Length surveyed <b>345.5</b>	Year Renewed	Height <b>15</b>	Width <b>15</b>	Pipe Joint... <b>N/A</b>

SPR <b>N/A</b>	MPR <b>24</b>	PO Number <b>4397-03</b>	Customer <b>GRW</b>
SPRI <b>N/A</b>	MPRI <b>2.2</b>	Work Order <b>4397-02</b>	Purpose <b>Pre-Rehabilitation Survey</b>
QSR <b>N/A</b>	QMR <b>412A</b>		
OPR <b>24</b>	Surveyed By <b>Charlie Gordon</b>	Direction <b>Downstream</b>	Date <b>20151014</b>
OPRI <b>2.2</b>	Certificate Number <b>U-615-07000491</b>	Pre-Cleaning <b>No Pre-Cleaning</b>	Time <b>10:31</b>
	Date Cleaned	End Time <b>10:50</b>	Weather <b>Damp</b>
		Additional Info

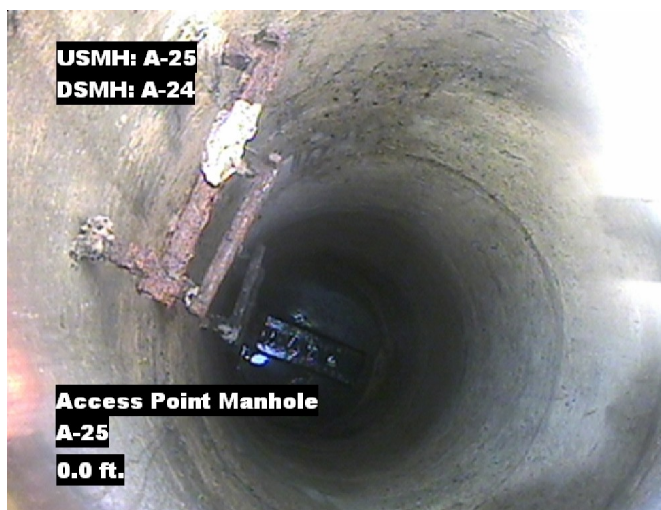
Distance: 0.0 ft. Grade: 0  
Condition: Access Point Manhole  
Remarks: A-26

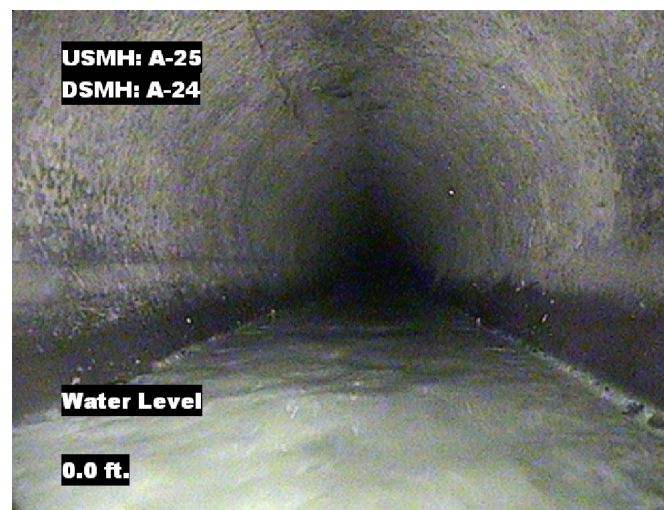
Distance: 0.0 ft. Grade: 0  
Condition: Water Level  
Remarks: N/A

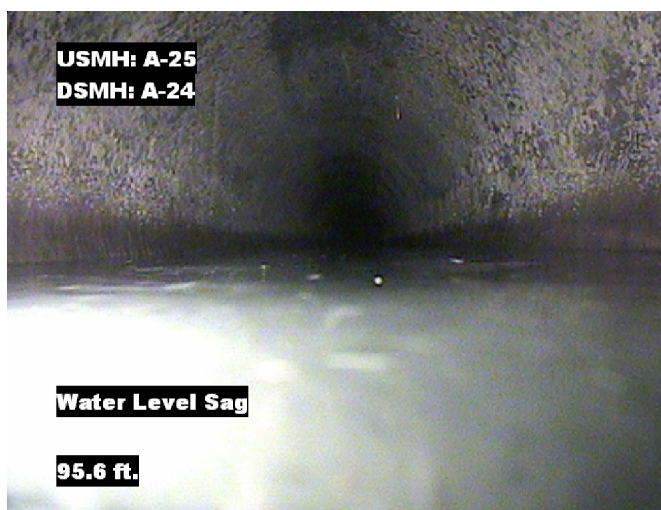
Distance: 95.6 ft. Grade: 2  
Condition: Water Level Sag  
Remarks: N/A

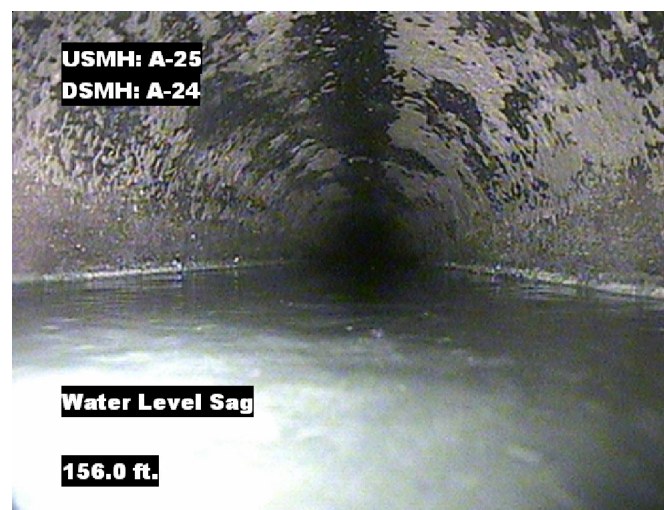
Distance: 156.0 ft. Grade: 2  
Condition: Water Level Sag  
Remarks: N/A

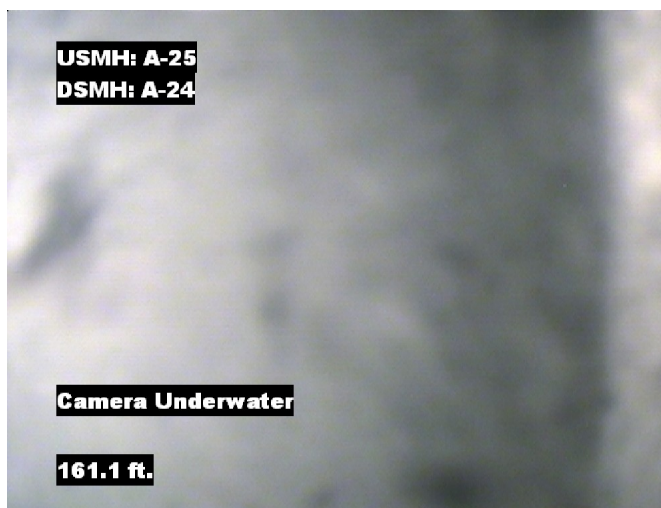
Distance: 161.1 ft. Grade: 4  
Condition: Camera Underwater  
Remarks: N/A

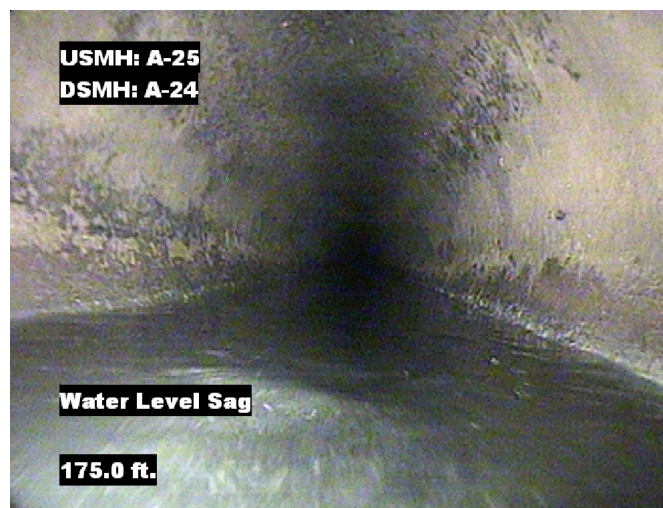
Distance: 174.7 ft. Grade: 2  
Condition: Water Level Sag  
Remarks: N/A

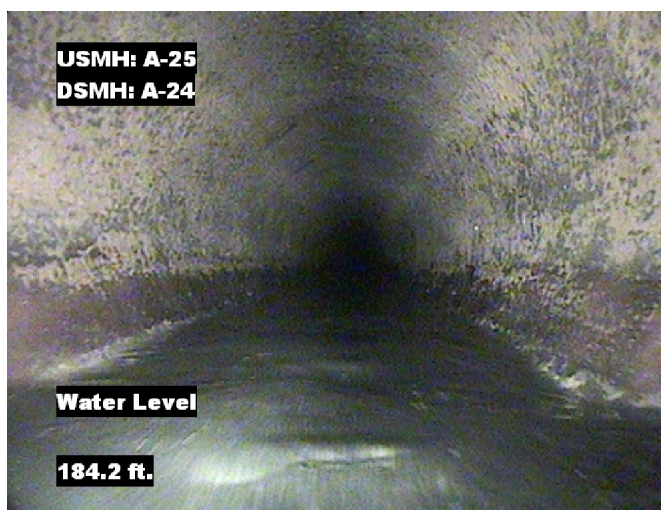
Distance: 184.1 ft. Grade: 0  
Condition: Water Level  
Remarks: N/A

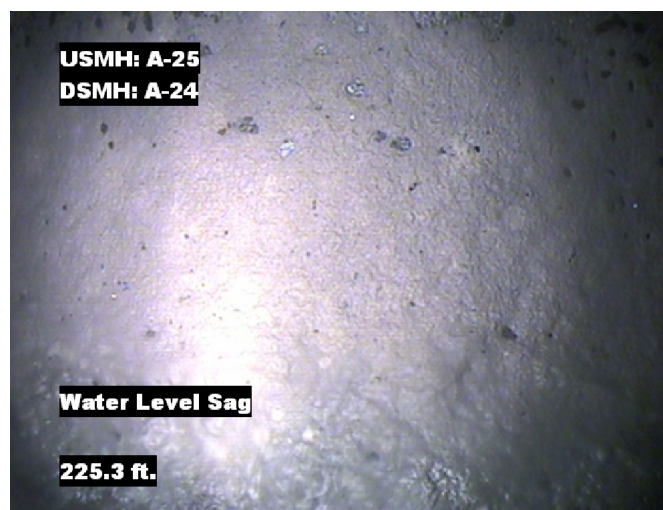
Distance: 225.3 ft. Grade: 2  
Condition: Water Level Sag  
Remarks: N/A

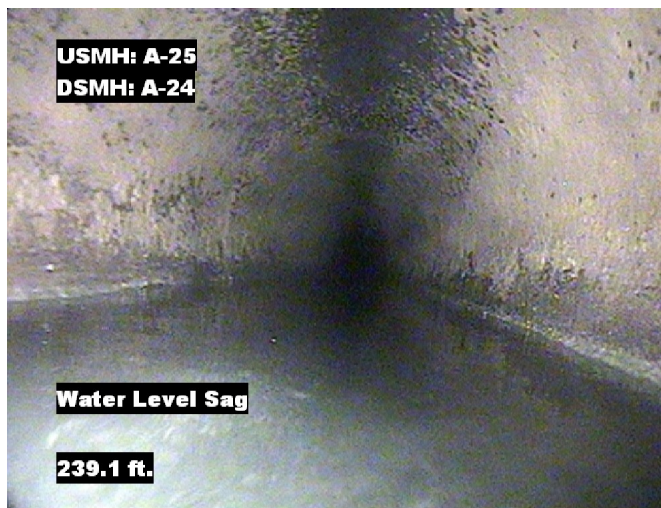
Distance: 238.8 ft. Grade: 2  
Condition: Water Level Sag  
Remarks: N/A

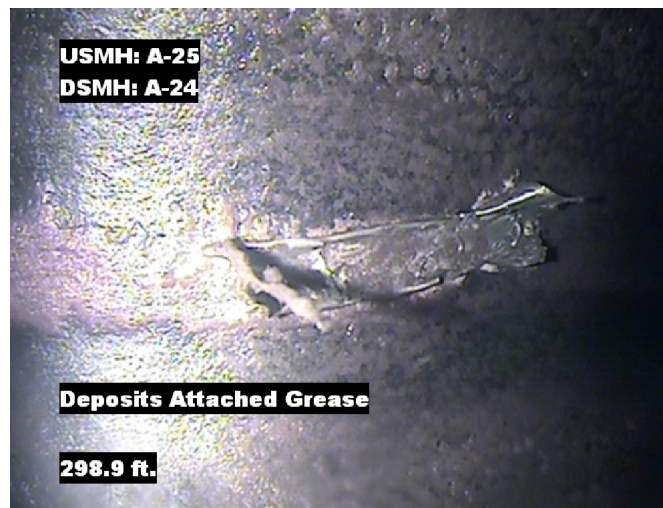
Distance: 298.9 ft. Grade: 2  
Condition: Deposits Attached Grease  
Remarks: N/A

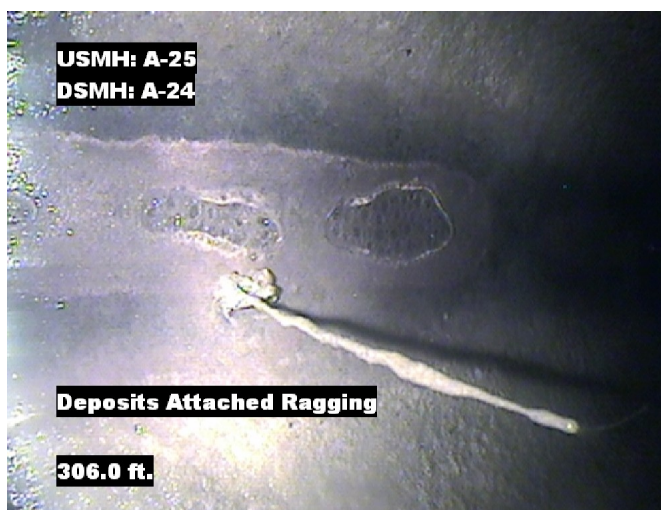
Distance: 306.0 ft. Grade: 2  
Condition: Deposits Attached Ragging  
Remarks: N/A

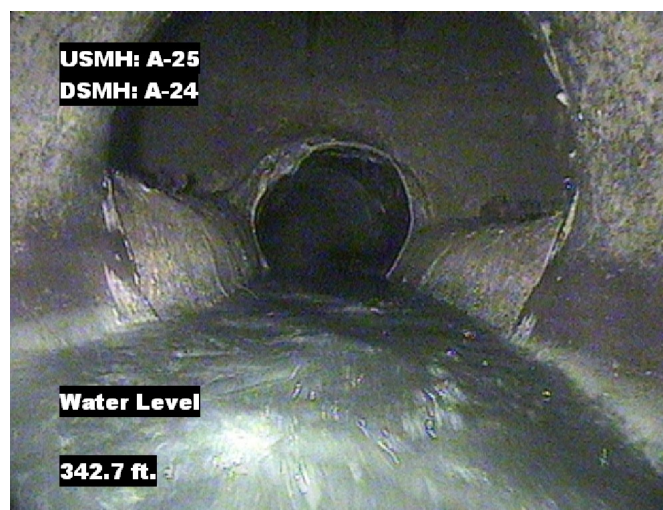
Distance: 342.7 ft. Grade: 0  
Condition: Water Level  
Remarks: N/A

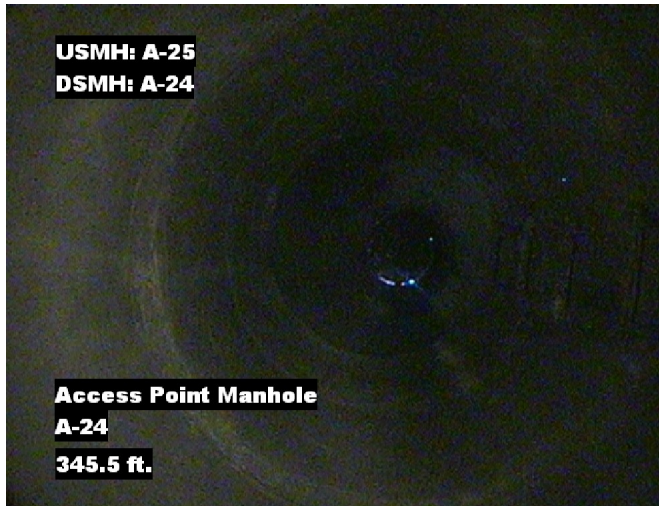
Distance: 345.5 ft.      Grade: 0  
Condition: Access Point Manhole  
Remarks: A-25
