Defect Listing

Pipe Segment Refere... A-27_A-26	City Oliver Springs	Street Old harriman highwa...	Material Fibreglass Reinf...	Location C... Easement/R...	Sewer Use Sanitary
Upstream MH A-27	Total Length 310.4	Year Laid	Shape Circular	Location Details	
DS Manhole A-26	Length surveyed 310.4	Year Renewed	Height 15	Width 15	Pipe Joint... N/A

Image Report 4/Page

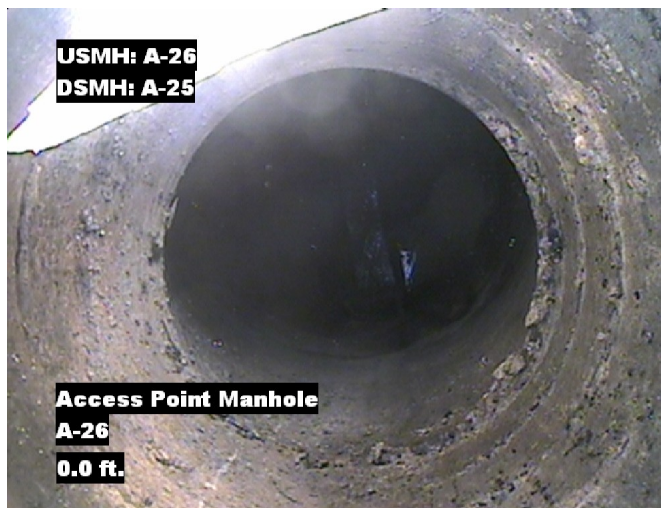
Distance: 0.0 ft. Grade: 0
Condition: Access Point Manhole
Remarks: A-27

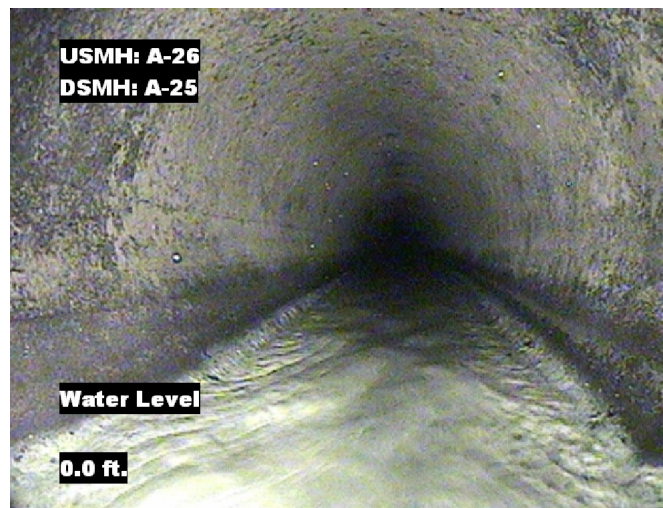
Distance: 0.0 ft. Grade: 0
Condition: Water Level
Remarks: N/A

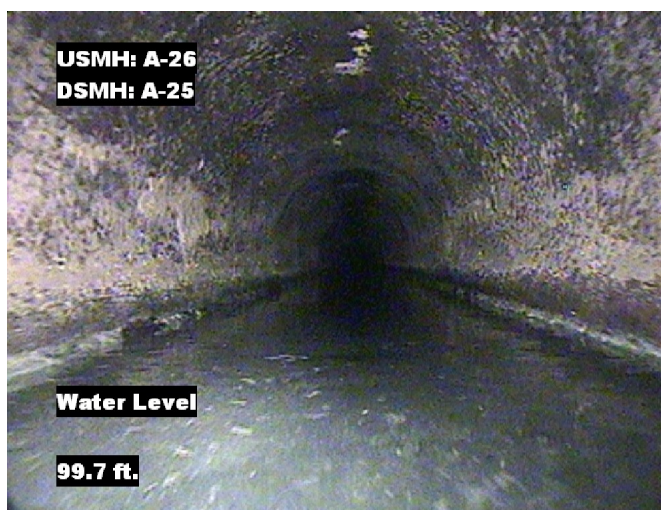
Distance: 99.5 ft. Grade: 0
Condition: Water Level
Remarks: N/A

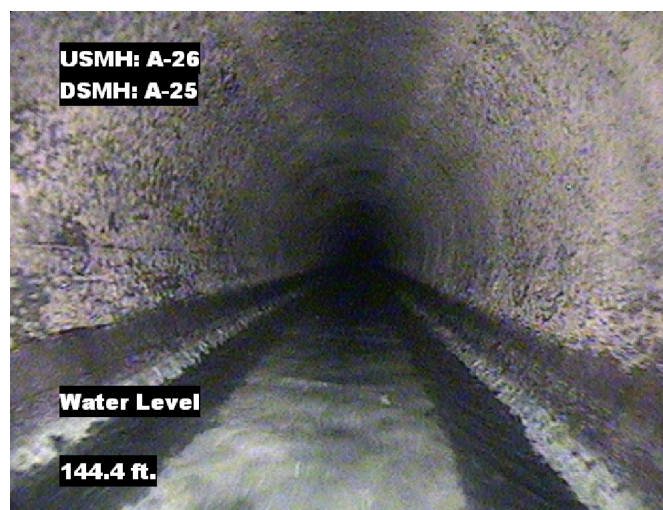
Distance: 144.3 ft. Grade: 0
Condition: Water Level
Remarks: N/A

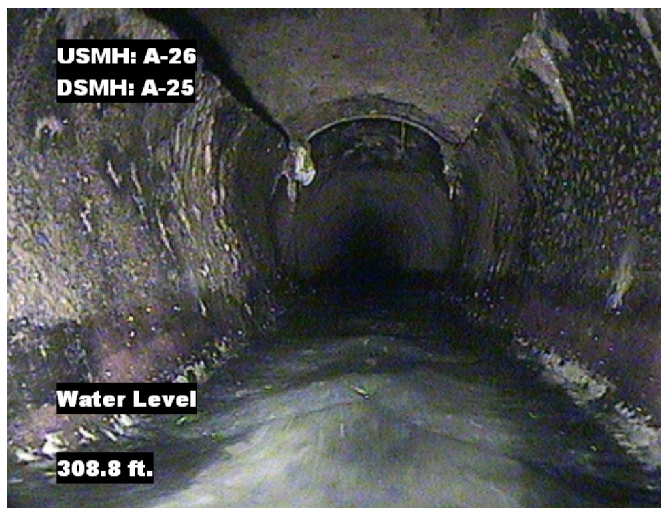
Distance: 308.7 ft. Grade: 0
Condition: Water Level
Remarks: N/A

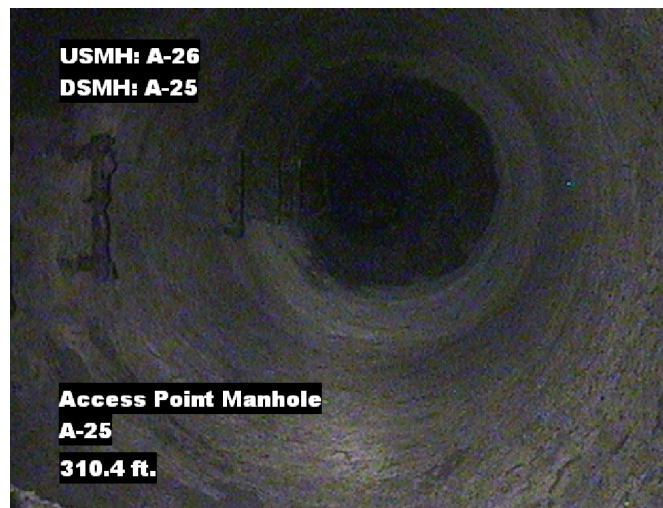
Distance: 310.4 ft. Grade: 0
Condition: Access Point Manhole
Remarks: A-26
