Defect Listing

Pipe Segment Refere... A-28_A-27	City Oliver Springs	Street Old harriman Highwa...	Material Fibreglass Reinforc...	Location C... Easement/R...	Sewer Use Sanitary
Upstream MH A-28	Total Length 311.9	Year Laid	Shape Circular	Location Details	
DS Manhole A-27	Length surveyed 311.9	Year Renewed	Height 15	Width 15	Pipe Joint... N/A

SPR	N/A	MPR	10	PO Number 4397-03	Customer GRW
SPRI	N/A	MPRI	2	Work Order 4397-02	Purpose Pre-Rehabilitation Survey
QSR	N/A	QMR	2500		
OPR 10	Surveyed By Charlie_Gordon	Direction Downstream	Date 20151014	Media label	
OPRI 2	Certificate Number U-615-07000491	Pre-Cleaning No Pre-Cleaning	Time 11:52	Weather Damp	
	Date Cleaned		End Time 12:05	Additional Info

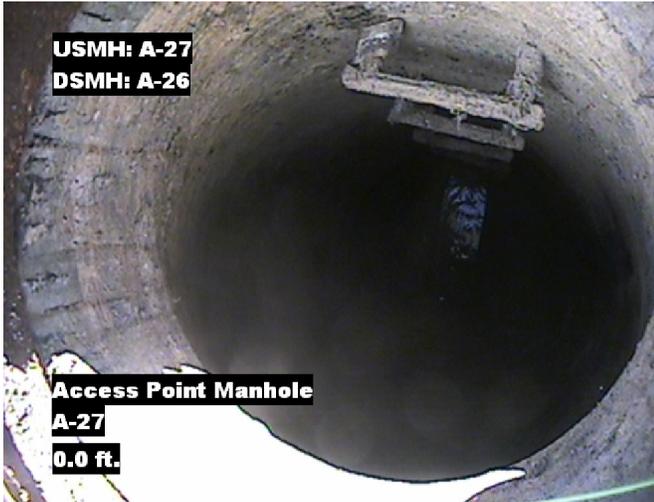
Distance: 0.0 ft. Grade: 0
 Condition: Access Point Manhole
 Remarks: A-28

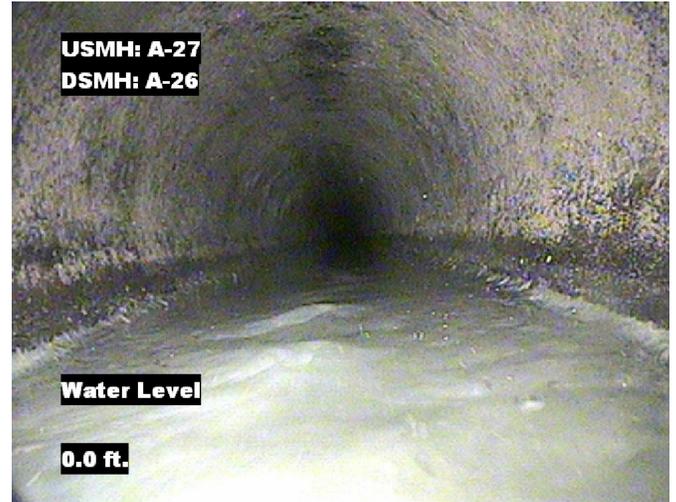
Distance: 0.0 ft. Grade: 0
 Condition: Water Level
 Remarks: N/A

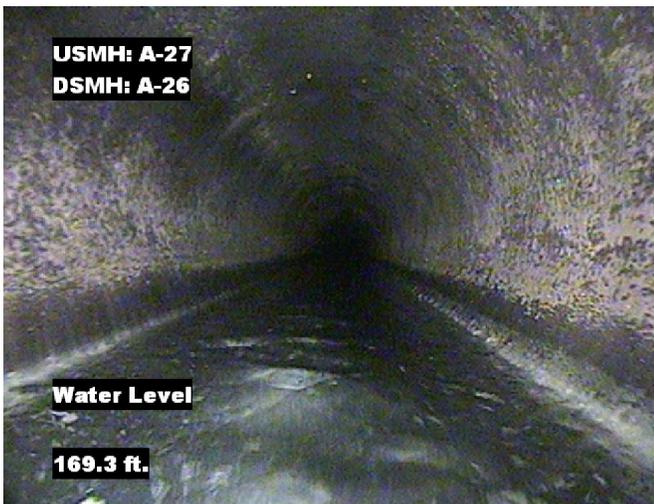
Distance: 169.3 ft. Grade: 0
 Condition: Water Level
 Remarks: N/A

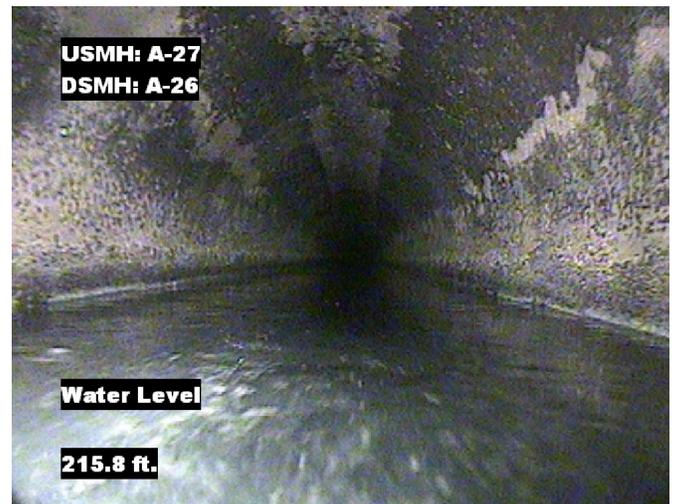
Distance: 215.7 ft. Grade: 0
 Condition: Water Level
 Remarks: N/A

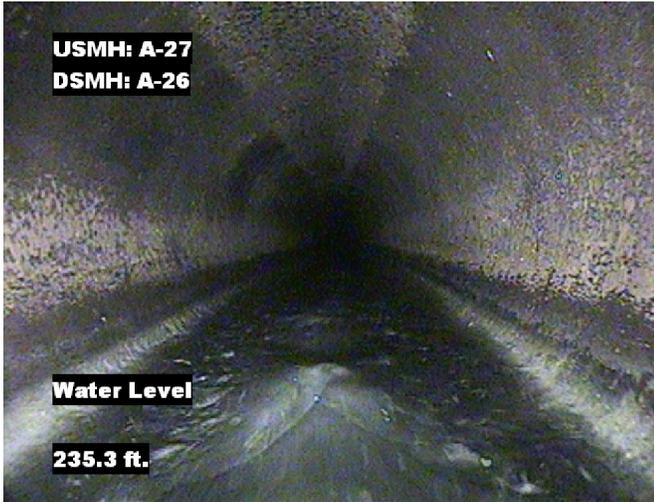
Distance: 235.2 ft. Grade: 0
 Condition: Water Level
 Remarks: N/A

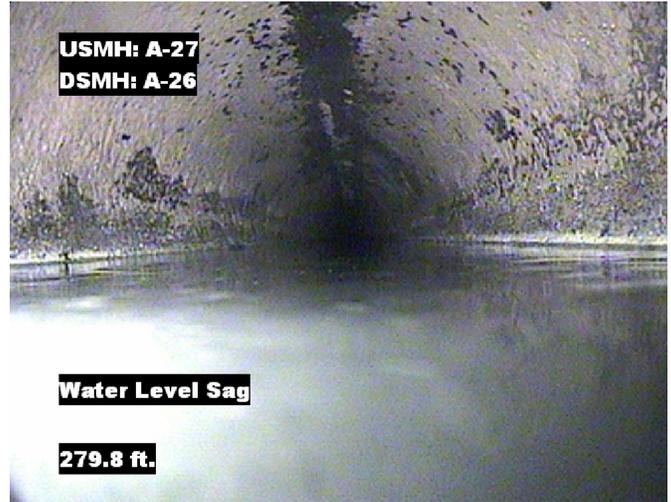
Distance: 279.8 ft. Grade: 2
 Condition: Water Level Sag
 Remarks: N/A

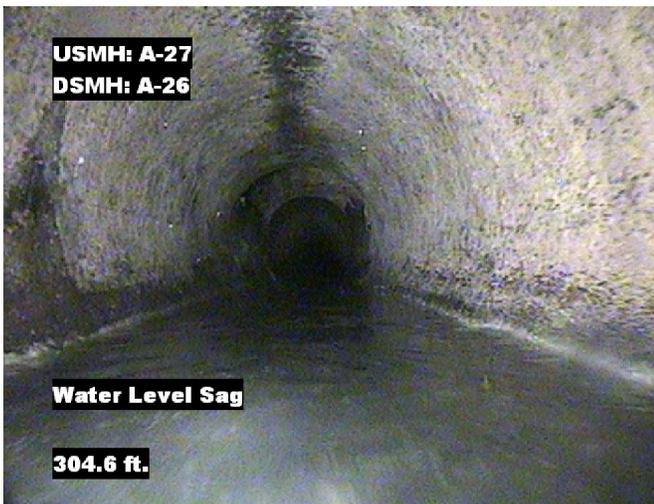
Distance: 304.5 ft. Grade: 2
 Condition: Water Level Sag
 Remarks: N/A

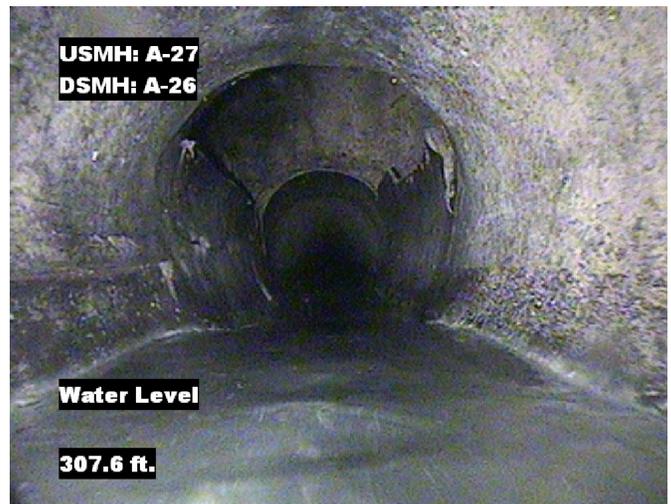
Distance: 307.6 ft. Grade: 0
 Condition: Water Level
 Remarks: N/A

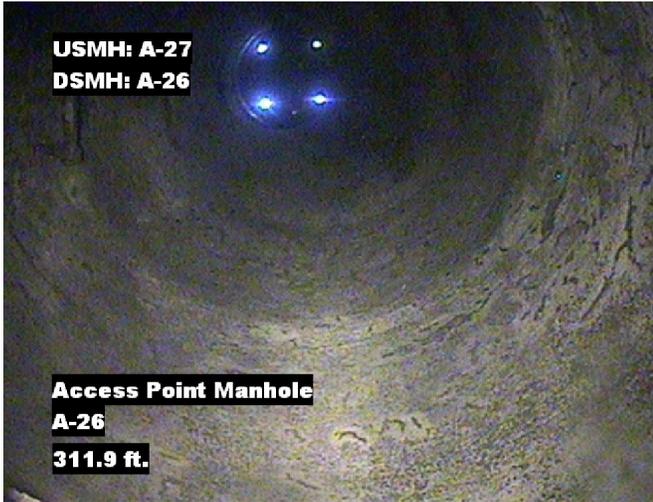
Distance:	311.9 ft.	Grade:	0
Condition:	Access Point Manhole		
Remarks:	A-27
