## Defect Listing

| Pipe Segment Refere...<br><b>A-29_A-28</b> | City<br><b>OLiver Springs</b> | Street<br><b>Old harriman</b> | Material<br><b>Fibreglass Reinforc...</b> | Location C...<br><b>Easement/R...</b> | Sewer Use<br><b>Sanitary</b> |

| SPRI<br><b>N/A</b> | MPRI<br><b>2</b> | Work Order<br><b>4397-02</b> | Purpose<br><b>Pre-Rehabilitation Survey</b> |

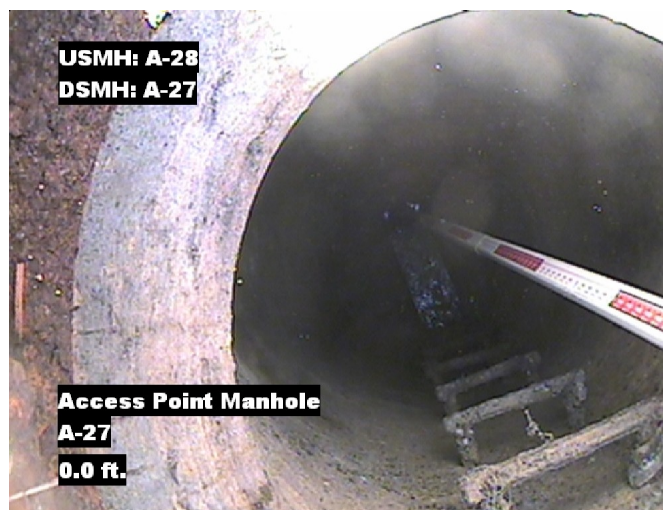
Distance: 0.0 ft. Grade: 0  
Condition: Access Point Manhole  
Remarks: A-28

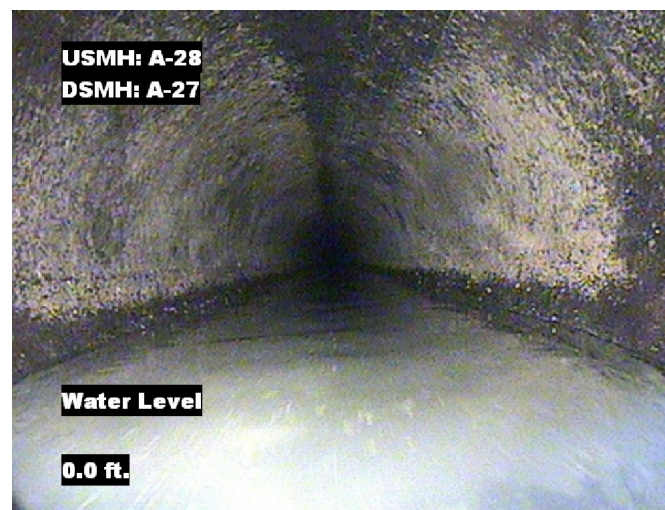
Distance: 0.0 ft. Grade: 0  
Condition: Water Level  
Remarks: N/A

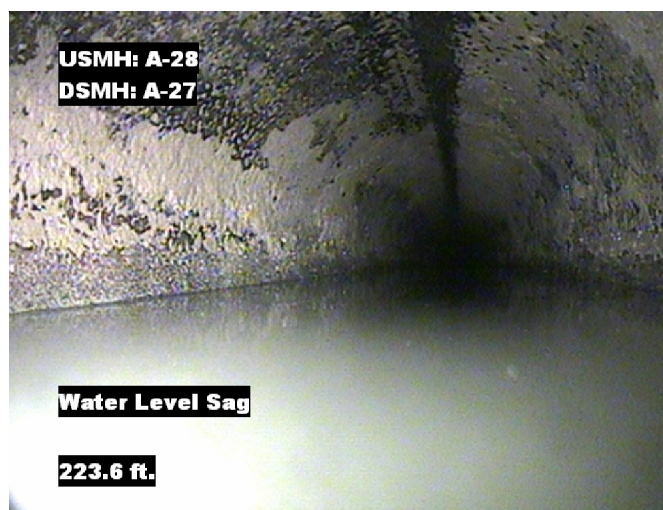
| Distance | Condition | Cont. Dfct. | Values | | | Joint | Clock Position | | Grade |
|---|---|---|---|---|---|---|---|---|---|
| 223.6 ft. | Water Level Sag | S01 | | | 20 | <input type="checkbox"/> | | | 2 |

Distance: 223.6 ft. Grade: 2  
Condition: Water Level Sag  
Remarks: N/A

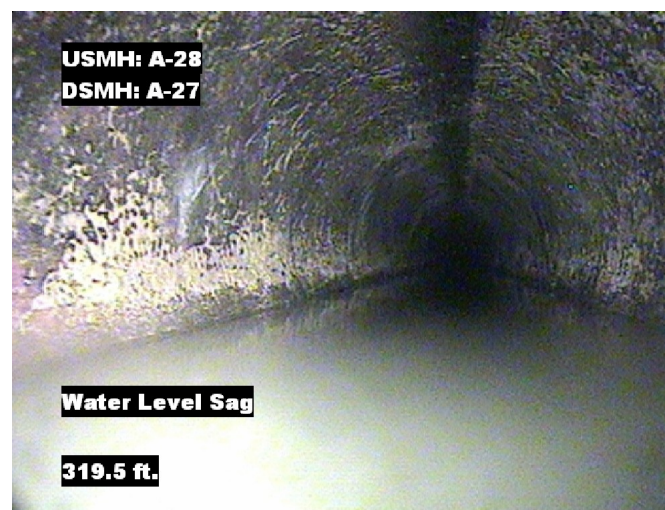
| Distance | Condition | Cont. Dfct. | Values | | | Joint | Clock Position | | Grade |
|---|---|---|---|---|---|---|---|---|---|
| 319.3 ft. | Water Level Sag | F01 | | | 20 | <input type="checkbox"/> | | | 2 |

Distance: 319.3 ft. Grade: 2  
Condition: Water Level Sag  
Remarks: N/A

| Normal Defects | | | Structural Ratings | | | O & M Ratings | | | Combined Ratings | | |
|---|---|---|---|---|---|---|---|---|---|---|---|
| MWLS | F01 | 95.7 | | | | | | | | | |

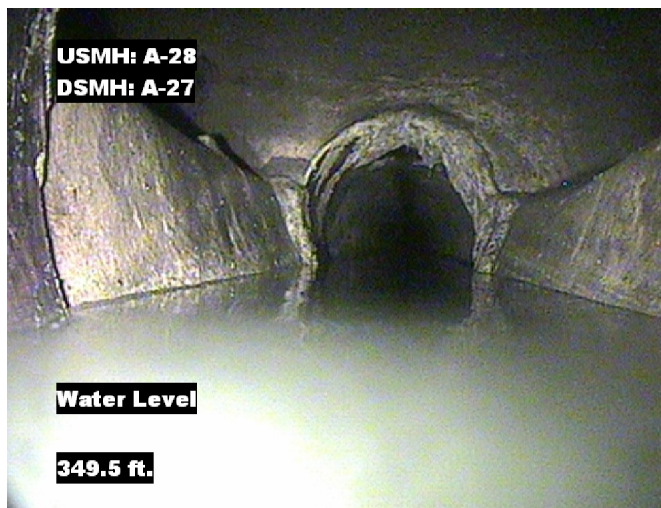
Distance: 349.5 ft.      Grade: 0  
Condition: Water Level  
Remarks: N/A

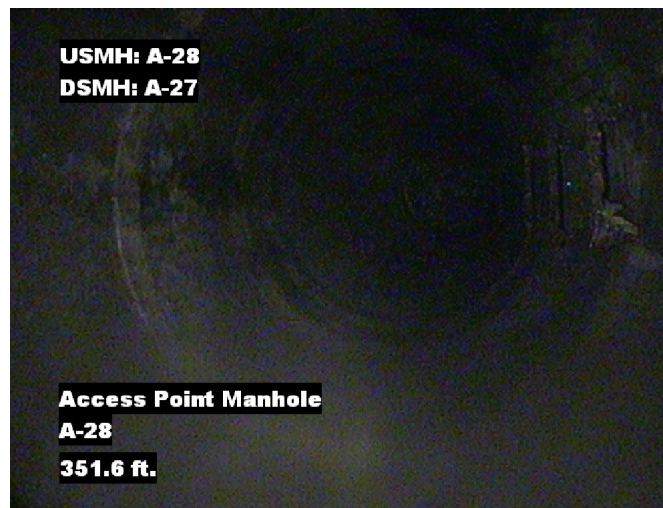
Distance: 351.6 ft.      Grade: 0  
Condition: Access Point Manhole  
Remarks: A-29
