Defect Listing

Pipe Segment Refere...	City	Street	Material	Location C...	Sewer Use
A-3_A-2	OLiver Springs	Pump Station	Fibreglass Reinforc...	Easement/R...	Sanitary
Upstream MH	Total Length	Year Laid	Shape	Location Details	
A-3	348.9		Circular		
DS Manhole	Length surveyed	Year Renewed	Height	Width	Pipe Joint...
A-2	348.9		21	21	N/A

SPR	3	MPR	54	PO Number	4397-03	Customer	GRW
SPRI	3	MPRI	2	Work Order	4397-02	Purpose	Pre-Rehabilitation Survey
QSR	3100	QMR	2D00				
OPR	57	Surveyed By	Charlie Gordon	Direction	Upstream	Date	20151007
OPRI	2	Certificate Number	U-615-07000491	Pre-Cleaning	No Pre-Cleaning	Time	13:04
Date Cleaned				End Time	13:21	Weather	Damp
				Additional Info

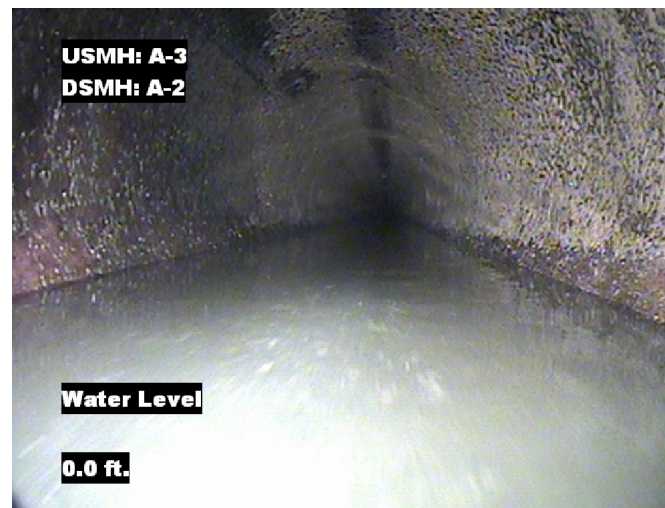
Distance: 0.0 ft. Grade: 0
Condition: Water Level
Remarks: N/A

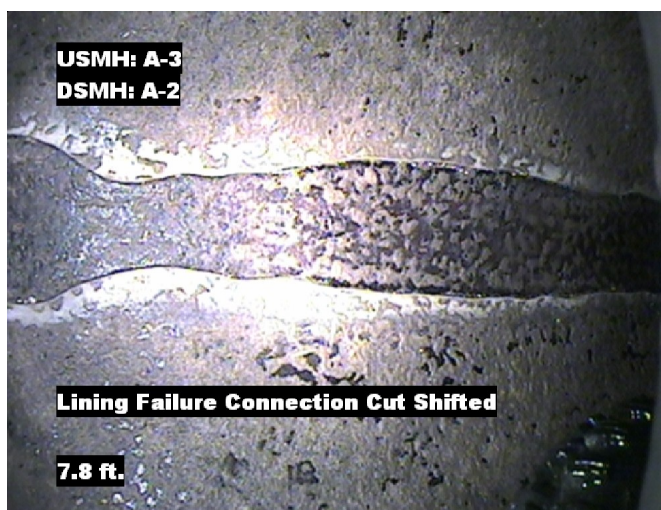
Distance: 7.8 ft. Grade: 3
Condition: Lining Failure Connection Cut Shifted
Remarks: N/A

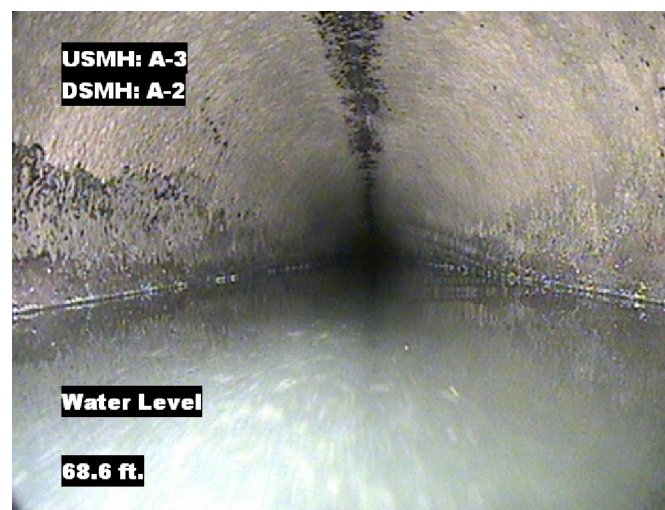
Distance: 68.6 ft. Grade: 0
Condition: Water Level
Remarks: N/A

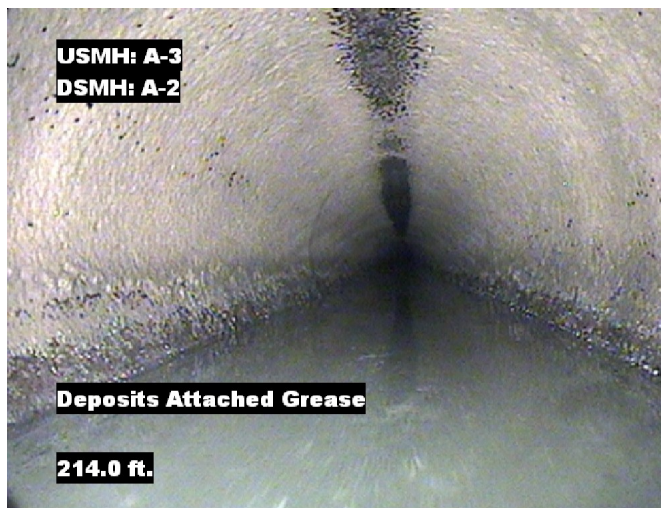
Distance: 214.0 ft. Grade: 2
Condition: Deposits Attached Grease
Remarks: N/A

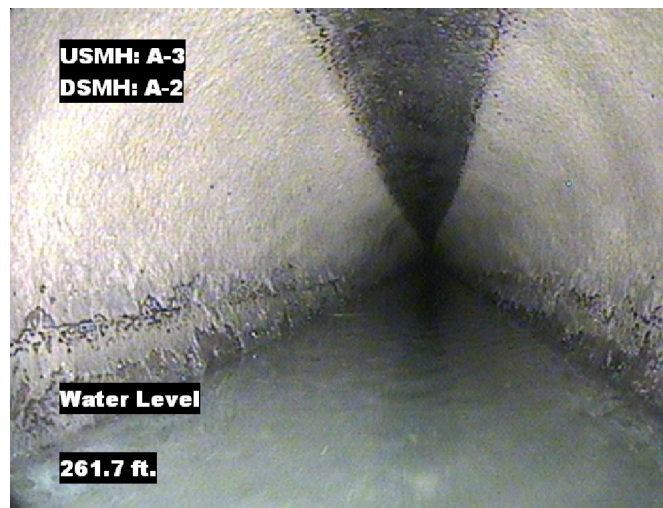
Distance: 261.7 ft. Grade: 0
Condition: Water Level
Remarks: N/A

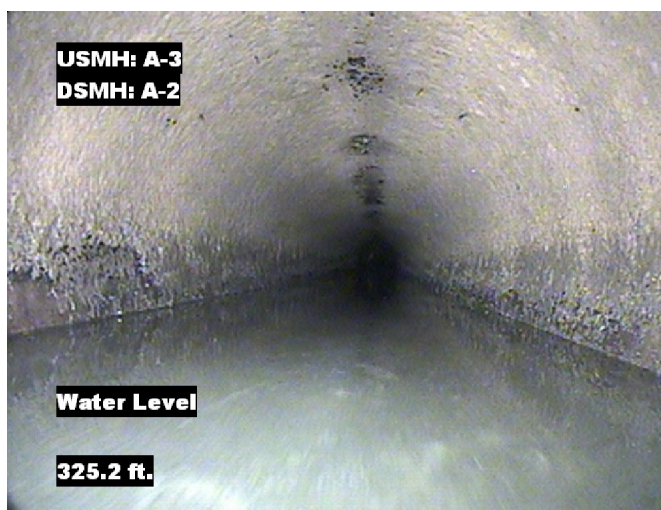
Distance: 325.1 ft. Grade: 0
Condition: Water Level
Remarks: N/A

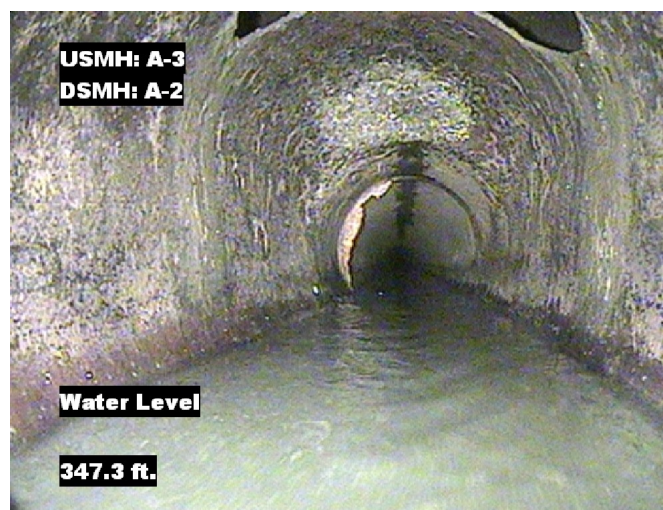
Distance: 347.3 ft. Grade: 0
Condition: Water Level
Remarks: N/A

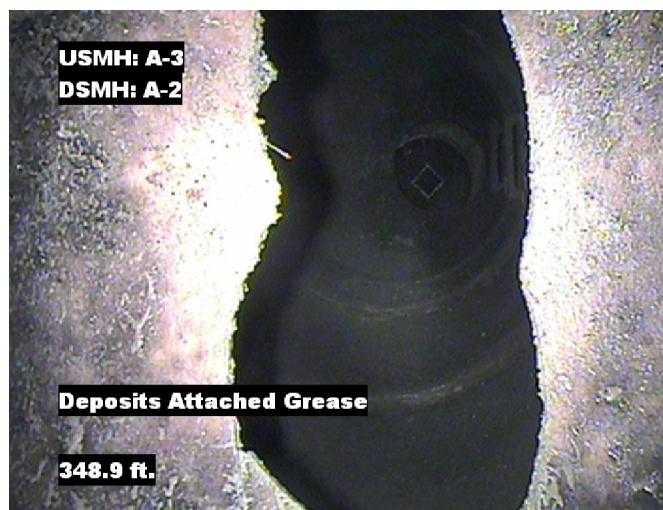
Distance: 348.9 ft. Grade: 2
Condition: Deposits Attached Grease
Remarks: N/A
