# **Defect Listing**

The Town of Oliver Springs Clean and CCTV

#### **Image Report 4/Page**

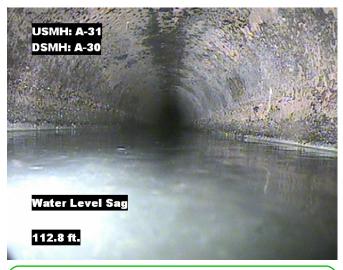
Distance: 112.8 ft. Grade: 2

Condition: Water Level Sag

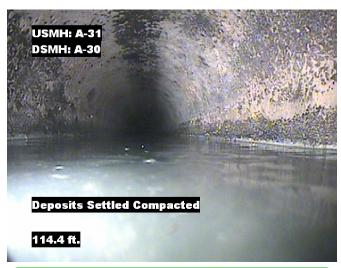
Distance: 114.4 ft. Grade: Condition: **Deposits Settled Compacted**

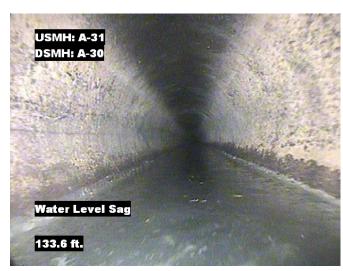
Distance: 133.3 ft. Grade: 2

Condition: Water Level Sag

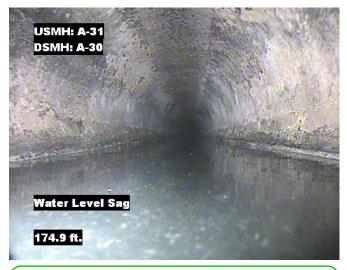
Distance: 174.8 ft. Grade:

Condition: Water Level Sag

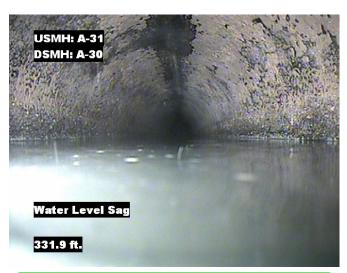
Distance: 331,9 ft. Grade: 2

Condition: Water Level Sag

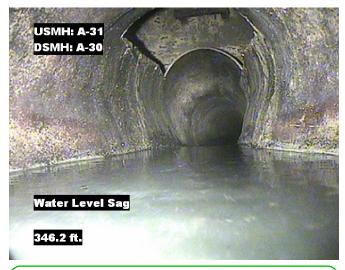
Distance: 346.2 ft. Grade: 2

Condition: Water Level Sag
