Defect Listing

Pipe Segment Refere... A-33_A-32	City Oliver Springs	Street Arrowhead Ln	Material Fibreglass Reinforc...	Location C... Easement/R...	Sewer Use Sanitary
Upstream MH A-33	Total Length 221.5	Year Laid	Shape Circular	Location Details	
DS Manhole A-32	Length surveyed 221.5	Year Renewed	Height 15	Width 15	Pipe Joint... N/A

Image Report 4/Page

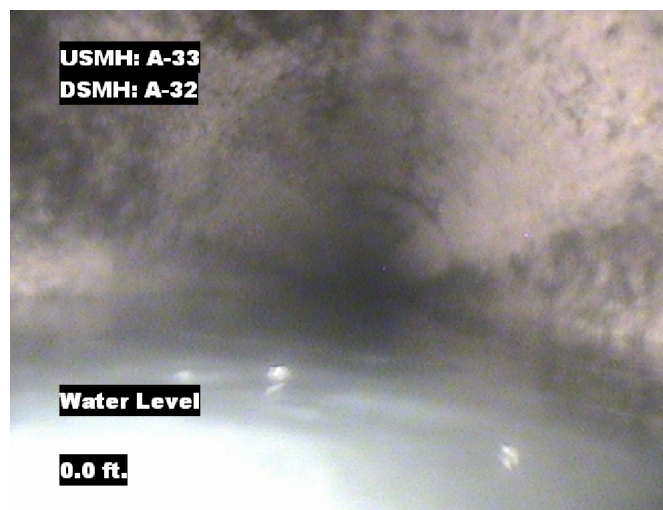
Distance: 0.0 ft. Grade: 0
Condition: Water Level
Remarks: N/A

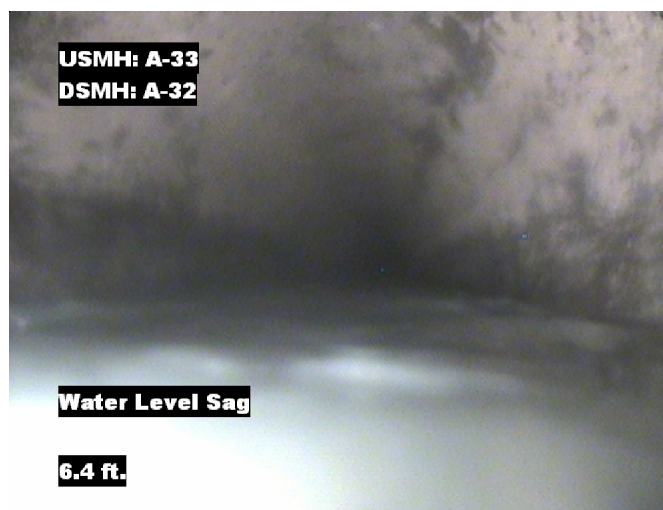
Distance: 6.4 ft. Grade: 2
Condition: Water Level Sag
Remarks: N/A

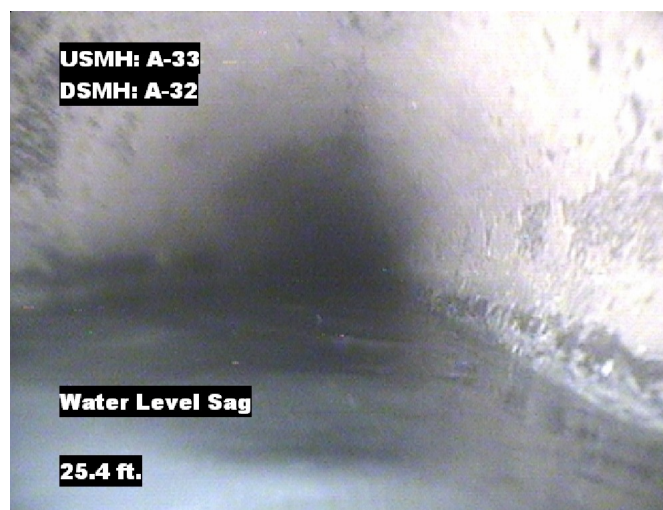
Distance: 25.1 ft. Grade: 2
Condition: Water Level Sag
Remarks: N/A

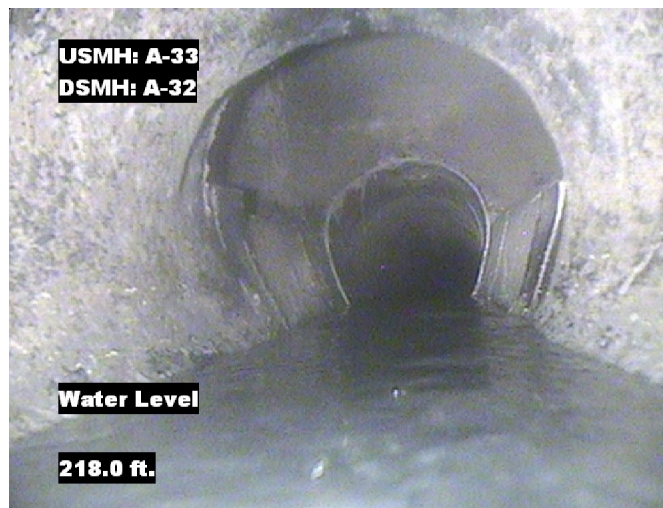
Distance: 218.0 ft. Grade: 0
Condition: Water Level
Remarks: N/A
