Defect Listing

Pipe Segment Refere...	City	Street	Material	Location C...	Sewer Use
A-34_A-33	Oliver Springs	Arrowhead Ln	Fibreglass Reinforc...	Yard	Sanitary
Upstream MH	Total Length	Year Laid	Shape	Location Details	
A-34	231.7		Circular		
DS Manhole	Length surveyed	Year Renewed	Height	Width	Pipe Joint...
A-33	231.7		15	15	N/A

SPR	N/A	MPR	22	PO Number	Customer
SPRI	N/A	MPRI	2.2	4397-03	GRW
QSR	N/A	QMR	4129	Work Order	Purpose
				4397-02	Pre-Rehabilitation Survey
OPR	Surveyed By	Direction	Date	Media label	
22	Charlie Gordon	Downstream	20150902		
OPRI	Certificate Number	Pre-Cleaning	Time	Weather	
2.2	U-615-07000491	Jetting	07:12	Dry	
Date Cleaned			End Time	Additional Info	
20150902			07:25

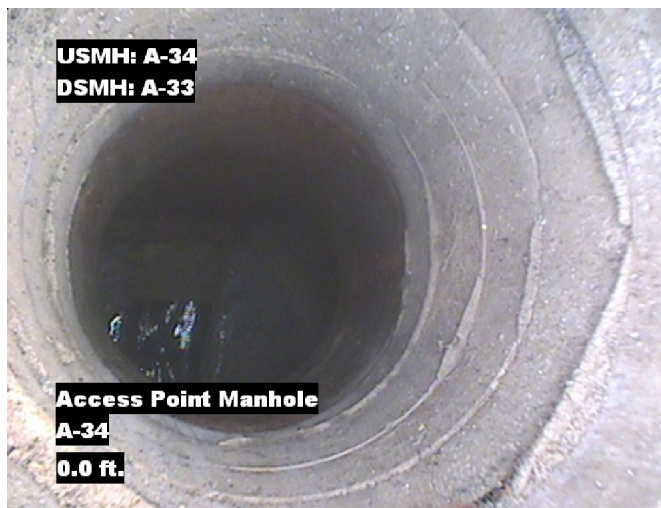
Distance: 0.0 ft. Grade: 0
Condition: Access Point Manhole
Remarks: A-34

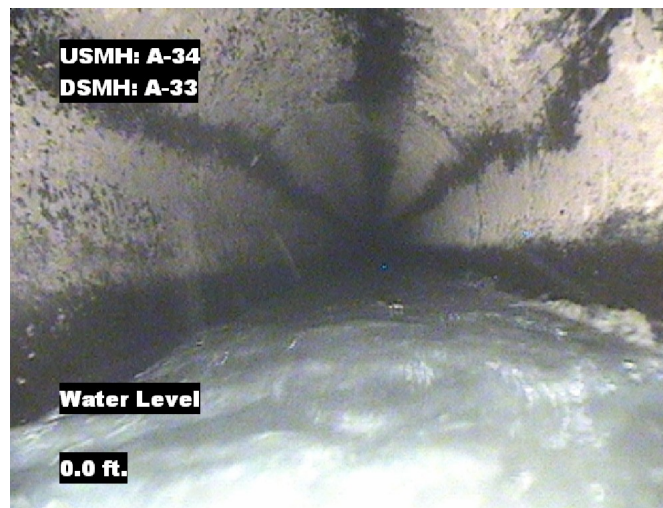
Distance: 0.0 ft. Grade: 0
Condition: Water Level
Remarks: N/A

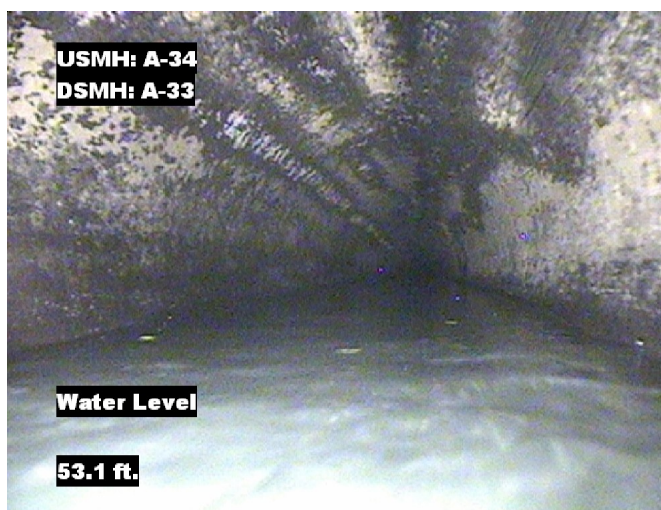
Distance: 53.1 ft. Grade: 0
Condition: Water Level
Remarks: N/A

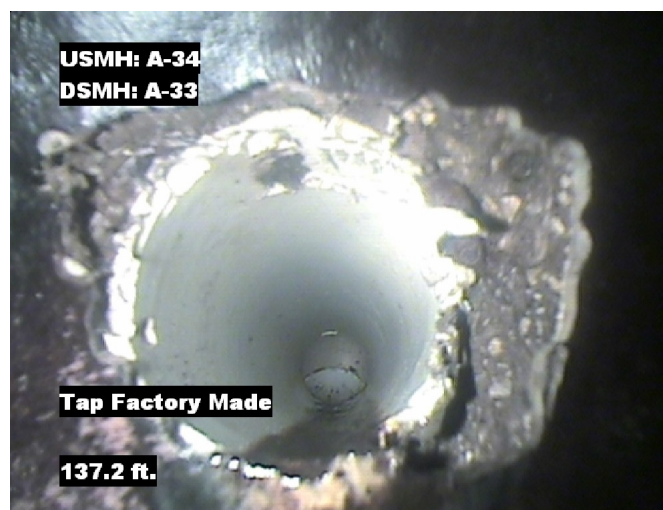
Distance: 137.2 ft. Grade: 0
Condition: Tap Factory Made
Remarks: N/A

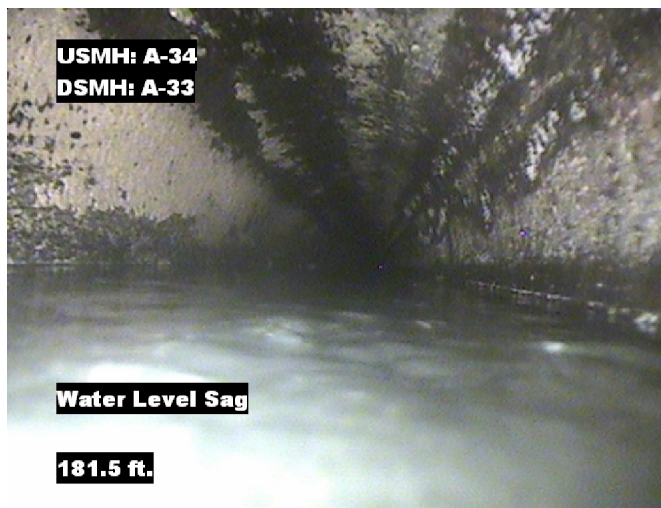
Distance: 181.5 ft. Grade: 2
Condition: Water Level Sag
Remarks: N/A

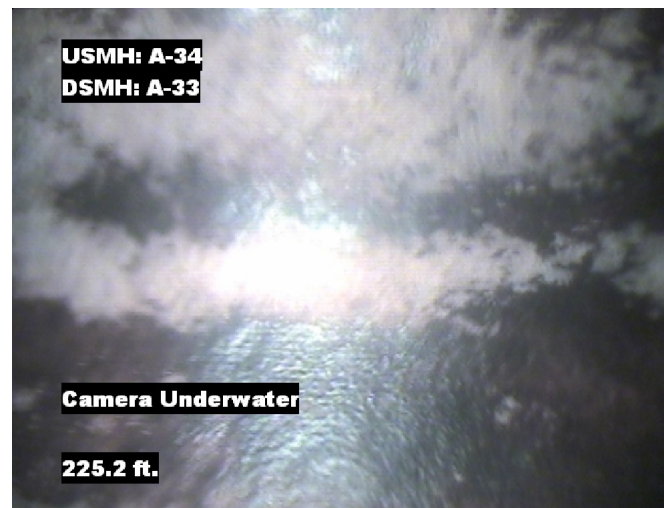
Distance: 225.2 ft. Grade: 4
Condition: Camera Underwater
Remarks: N/A

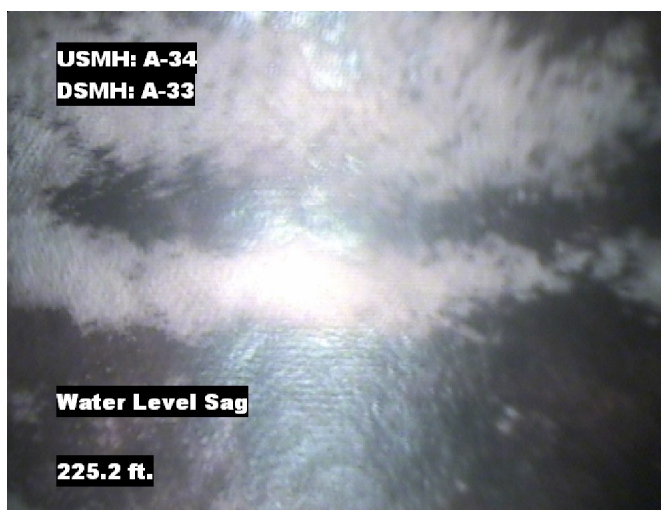
Distance: 225.2 ft. Grade: 2
Condition: Water Level Sag
Remarks: N/A

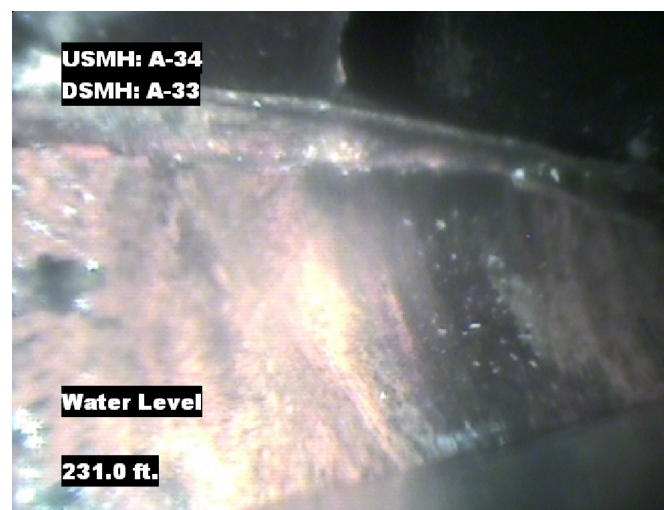
Distance: 231.0 ft. Grade: 0
Condition: Water Level
Remarks: N/A

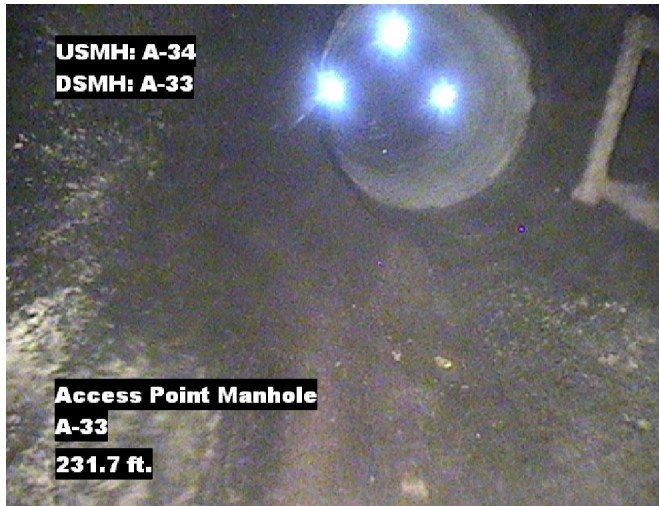
Distance: 231.7 ft. Grade: 0
Condition: Access Point Manhole
Remarks: A-33
