## Defect Listing

| <b>A-35_A-34</b> | <b>Oliver Springs</b> | <b>Arrowhead Ln.</b> | <b>Fibreglass Reinforc...</b> | <b>Yard</b> | <b>Sanitary</b> |

| | | | | <b>4397-02</b> | <b>Pre-Rehabilitation Survey</b> |

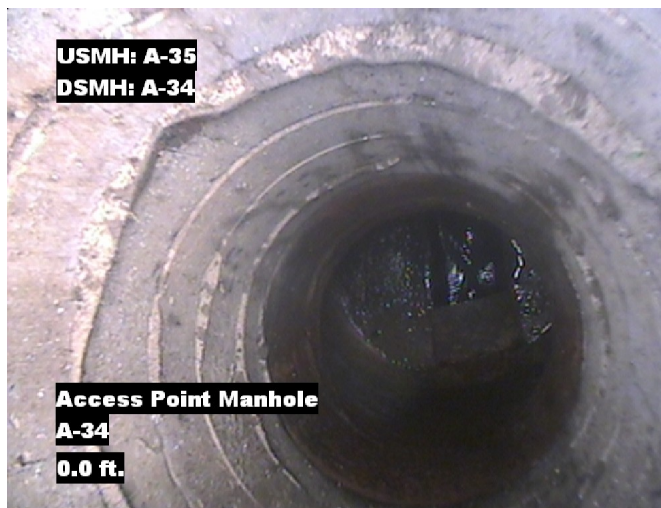
Distance: 0.0 ft. Grade: 0  
Condition: Access Point Manhole  
Remarks: A-34

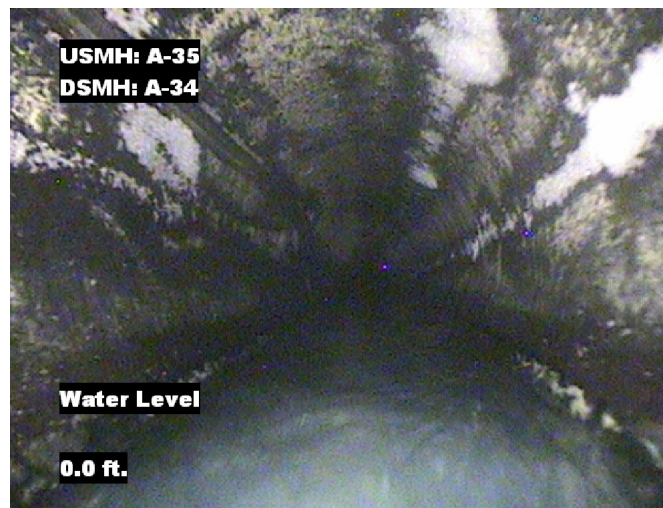
Distance: 0.0 ft. Grade: 0  
Condition: Water Level  
Remarks: N/A

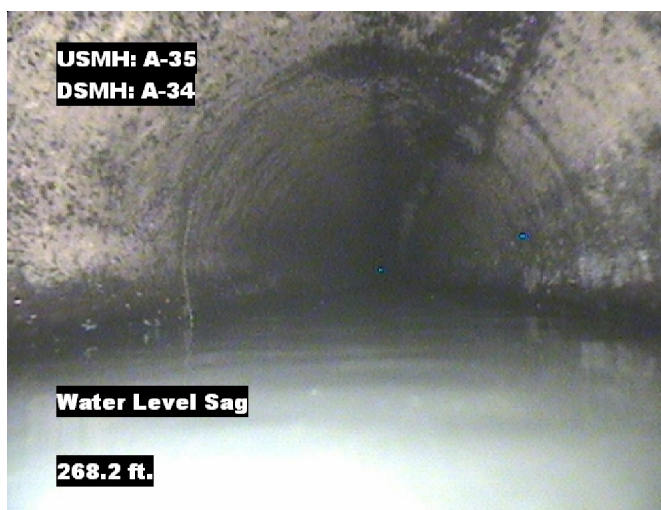
| Distance | Condition | Cont. Dfct. | Values | | | Joint | Clock Position | | Grade |
|---|---|---|---|---|---|---|---|---|---|
| 268.2 ft. | Water Level Sag | | | | 15 | <input type="checkbox"/> | | | 2 |

Distance: 268.2 ft. Grade: 2  
Condition: Water Level Sag  
Remarks: N/A

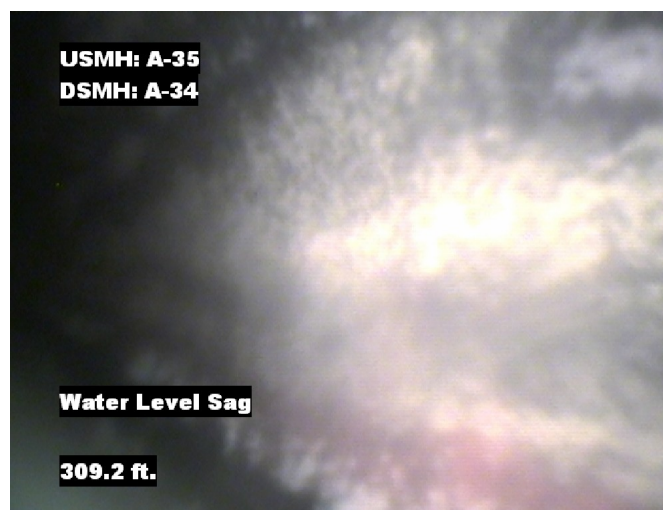
| Distance | Condition | Cont. Dfct. | Values | | | Joint | Clock Position | | Grade |
|---|---|---|---|---|---|---|---|---|---|
| 309.2 ft. | Water Level Sag | | | | 25 | <input type="checkbox"/> | | | 2 |

Distance: 309.2 ft. Grade: 2  
Condition: Water Level Sag  
Remarks: N/A

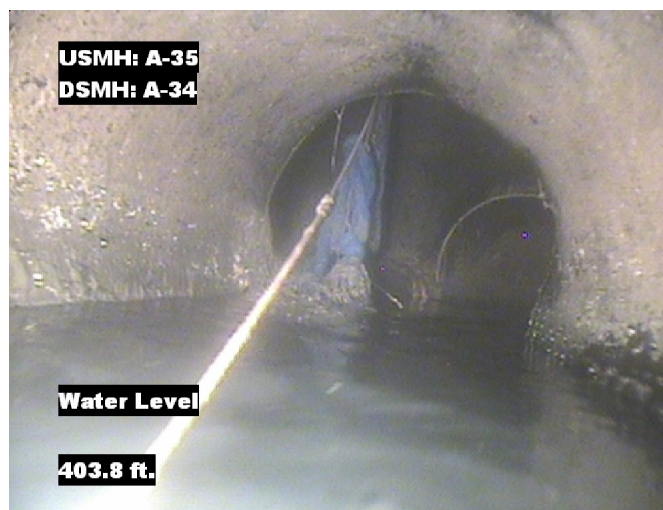
Distance: 403.8 ft.      Grade: 0  
Condition: Water Level  
Remarks: N/A

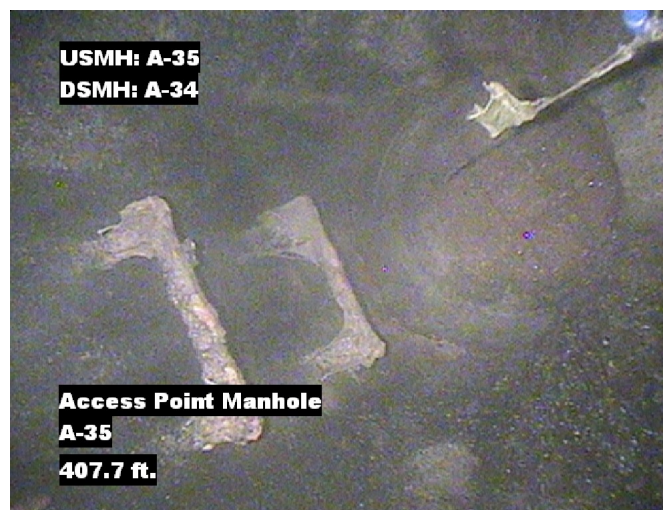
Distance: 407.7 ft.      Grade: 0  
Condition: Access Point Manhole  
Remarks: A-35
