Defect Listing

Pipe Segment Refere... A-38_A-37	City Oliver Springs	Street Arrowhead Ln	Material Fibreglass Reinforc...	Location C... Easement/R...	Sewer Use Sanitary
Upstream MH A-38	Total Length 250.3	Year Laid	Shape Circular	Location Details	
DS Manhole A-37	Length surveyed 250.3	Year Renewed	Height 15	Width 15	Pipe Joint... N/A

SPR N/A	MPR N/A	PO Number 4397-03		Customer GRW	
SPRI N/A	MPRI N/A	Work Order 4397-02		Purpose Pre-Rehabilitation Survey	
QSR N/A	QMR N/A				
OPR N/A	Surveyed By Charlie Gordon	Direction Upstream	Date 20150903	Media label	
OPRI N/A	Certificate Number U-615-07000491	Pre-Cleaning No Pre-Cleaning	Time 08:55	Weather Dry	
Date Cleaned			End Time 09:04	Additional Info

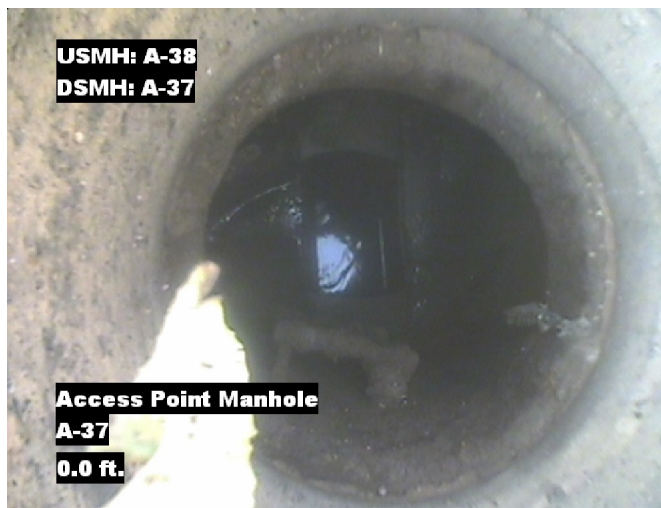
Distance: 0.0 ft. Grade: 0
Condition: Access Point Manhole
Remarks: A-37

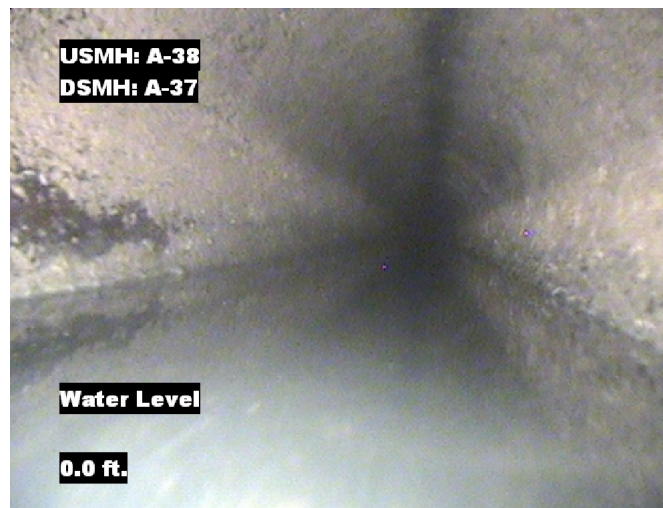
Distance: 0.0 ft. Grade: 0
Condition: Water Level
Remarks: N/A

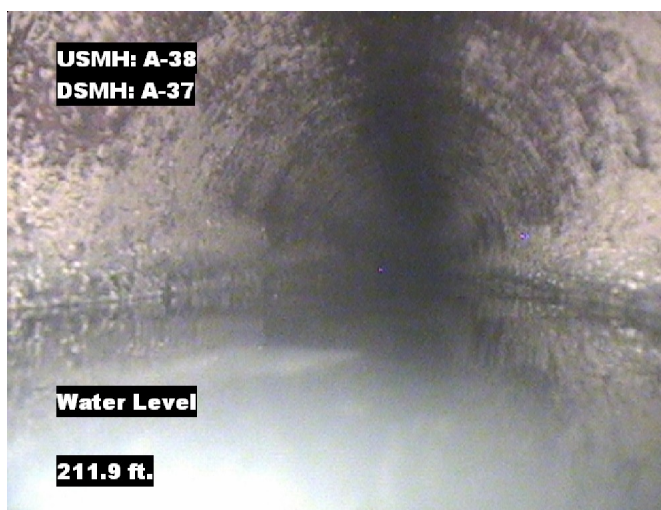
Distance: 211.9 ft. Grade: 0
Condition: Water Level
Remarks: N/A

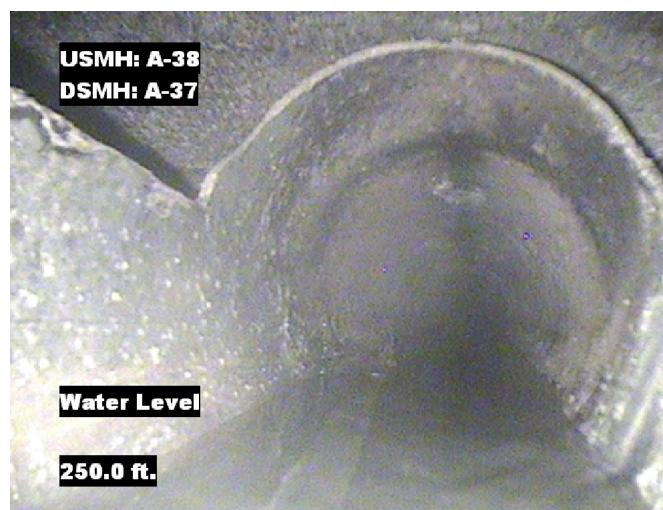
Distance: 250.0 ft. Grade: 0
Condition: Water Level
Remarks: N/A

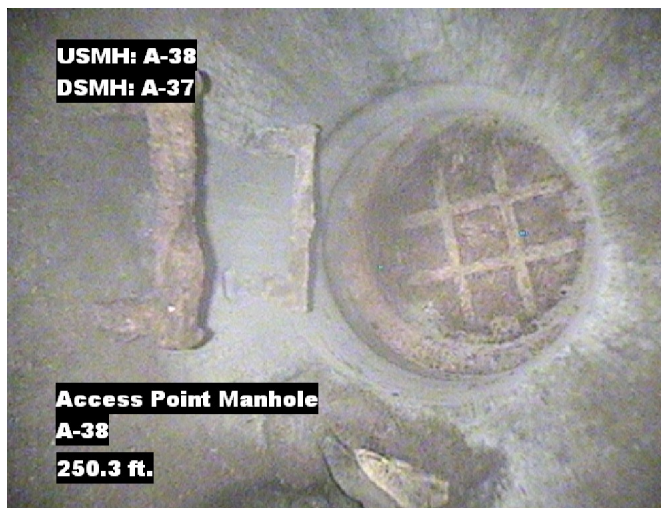
Distance: 250.3 ft. Grade: 0
Condition: Access Point Manhole
Remarks: A-38
