## Defect Listing

Pipe Segment Refere... <b>A-39_A-38</b>	City <b>Oliver Springs</b>	Street <b>Burney Dr</b>	Material <b>Fibreglass Reinforc...</b>	Location C... <b>Easement/R...</b>	Sewer Use <b>Sanitary</b>
Upstream MH <b>A-39</b>	Total Length <b>252.6</b>	Year Laid	Shape <b>Circular</b>	Location Details	
DS Manhole <b>A-38</b>	Length surveyed <b>252.6</b>	Year Renewed	Height <b>15</b>	Width <b>15</b>	Pipe Joint... <b>N/A</b>

SPR <b>N/A</b>	MPR <b>N/A</b>	PO Number <b>4397-03</b>		Customer <b>GRW</b>	
SPRI <b>N/A</b>	MPRI <b>N/A</b>	Work Order <b>4397-02</b>		Purpose <b>Pre-Rehabilitation Survey</b>	
QSR <b>N/A</b>	QMR <b>N/A</b>				
OPR <b>N/A</b>	Surveyed By <b>Charlie_Gordon</b>	Direction <b>Upstream</b>	Date <b>20150903</b>	Media label	
OPRI <b>N/A</b>	Certificate Number <b>U-615-07000491</b>	Pre-Cleaning <b>No Pre-Cleaning</b>	Time <b>09:09</b>	Weather <b>Dry</b>	
Date Cleaned			End Time <b>09:17</b>	Additional Info

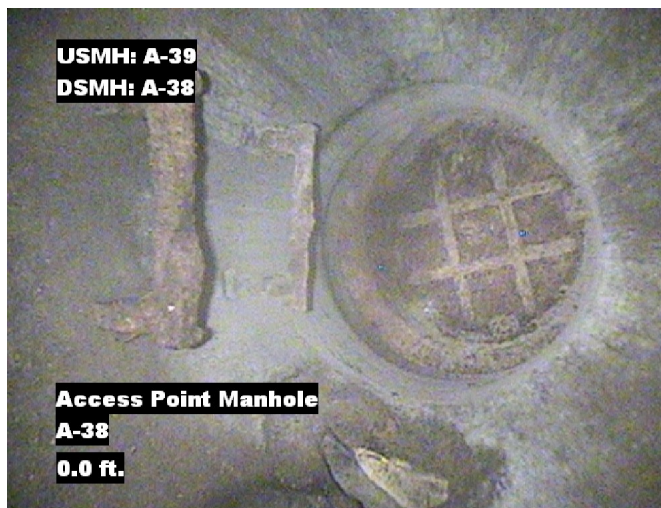
Distance: 0.0 ft. Grade: 0  
Condition: Access Point Manhole  
Remarks: A-38

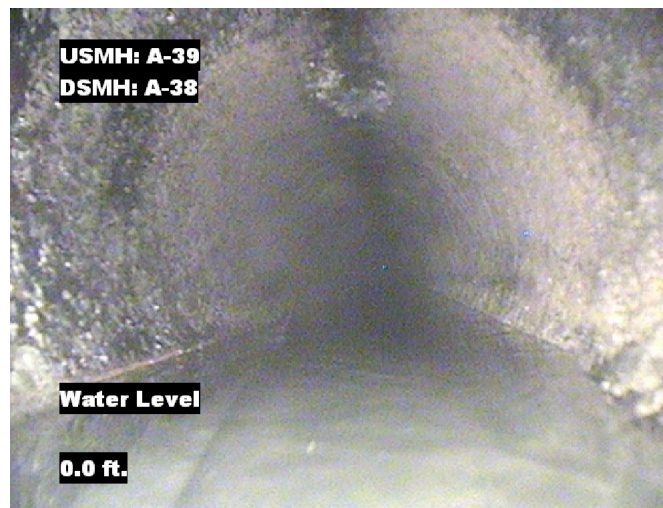
Distance: 0.0 ft. Grade: 0  
Condition: Water Level  
Remarks: N/A

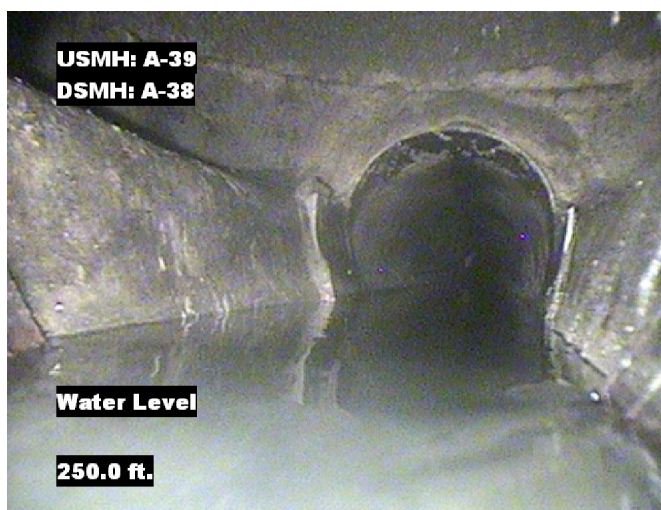
Distance: 250.0 ft. Grade: 0  
Condition: Water Level  
Remarks: N/A

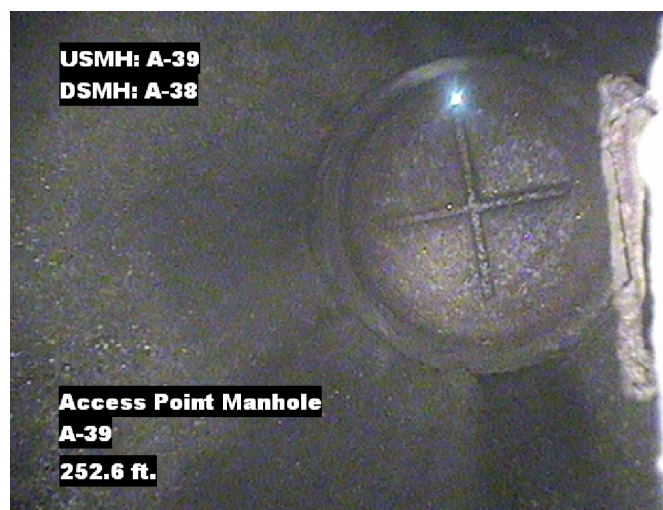
Distance: 252.6 ft. Grade: 0  
Condition: Access Point Manhole  
Remarks: A-39
