### Defect Listing

Pipe Segment Refere... <b>A-4_A-3</b>	<b>City</b> <b>Oliver Springs</b>	<b>Street</b> <b>Pump Station</b>	<b>Material</b> <b>Fibreglass Reinforc...</b>	<b>Location C...</b> <b>Easement/R...</b>	<b>Sewer Use</b> <b>Sanitary</b>
<b>Upstream MH</b> <b>A-4</b>	Total Length <b>251.5</b>	Year Laid	<b>Shape</b> <b>Circular</b>	Location Details	
<b>DS Manhole</b> <b>A-3</b>	<b>Length surveyed</b> <b>251.5</b>	Year Renewed	<b>Height</b> <b>21</b>	<b>Width</b> <b>21</b>	<b>Pipe Joint...</b> <b>N/A</b>

SPR <b>N/A</b>	MPR <b>103</b>	PO Number <b>4397-03</b>		<b>Customer</b> <b>GRW</b>	
SPRI <b>N/A</b>	MPRI <b>2</b>	Work Order <b>4397-02</b>		Purpose <b>Pre-Rehabilitation Survey</b>	
QSR <b>N/A</b>	QMR <b>312I</b>	<b>Direction</b> <b>Upstream</b>	<b>Date</b> <b>20151007</b>	<b>Media label</b>	
OPR <b>103</b>	<b>Surveyed By</b> <b>Charlie_Gordon</b>	<b>Pre-Cleaning</b> <b>No Pre-Cleaning</b>	<b>Time</b> <b>13:31</b>	<b>Weather</b> <b>Damp</b>	
OPRI <b>2</b>	<b>Certificate Number</b> <b>U-615-07000491</b>		<b>End Time</b> <b>13:41</b>	<b>Additional Info</b>	
	<b>Date Cleaned</b>

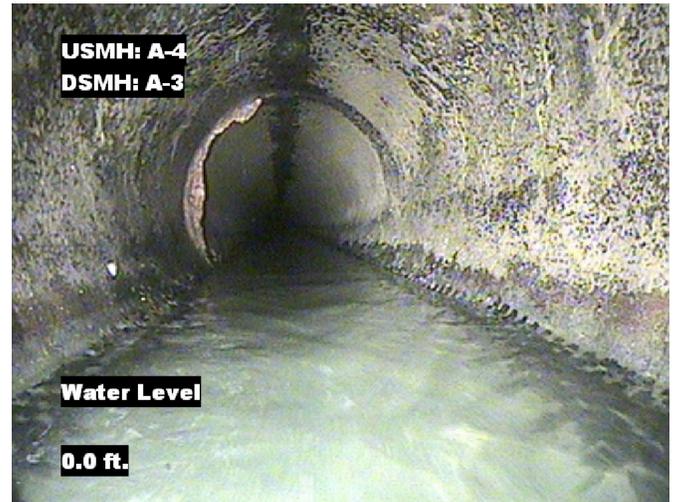
Distance: 0.0 ft.      Grade: 0  
 Condition: Water Level  
 Remarks: N/A

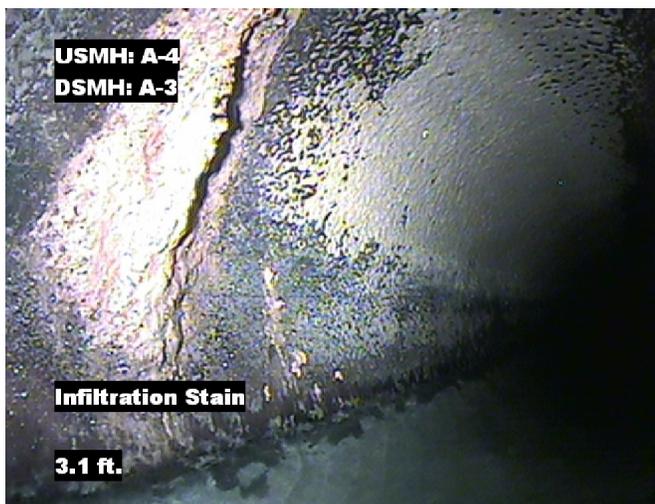
Distance: 3.1 ft.      Grade: 0  
 Condition: Infiltration Stain  
 Remarks: N/A

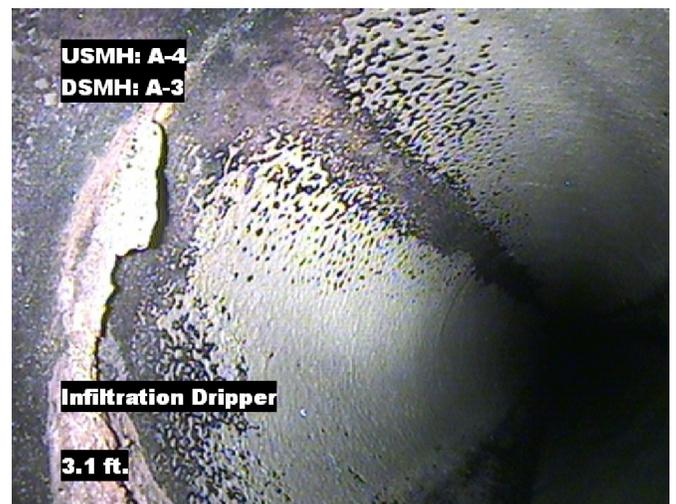
Distance: 3.1 ft.      Grade: 3  
 Condition: Infiltration Dripper  
 Remarks: N/A

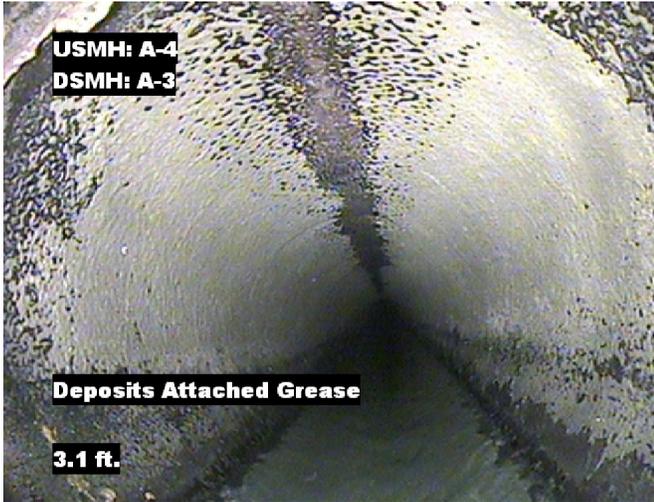
Distance: 3.1 ft.      Grade: 2  
 Condition: Deposits Attached Grease  
 Remarks: N/A

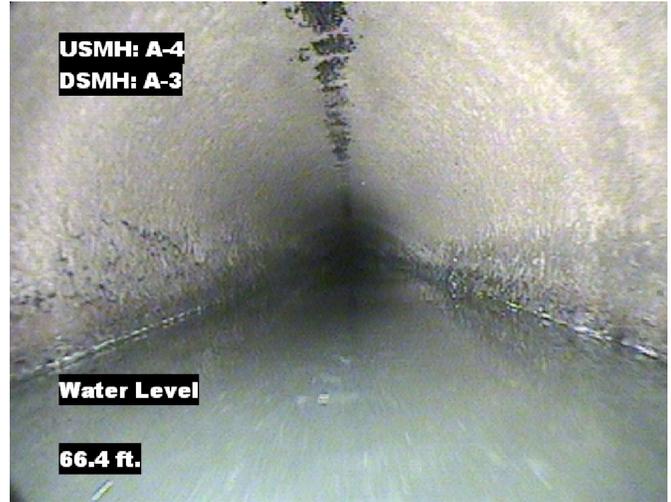
Distance: 66.2 ft.      Grade: 0  
 Condition: Water Level  
 Remarks: N/A

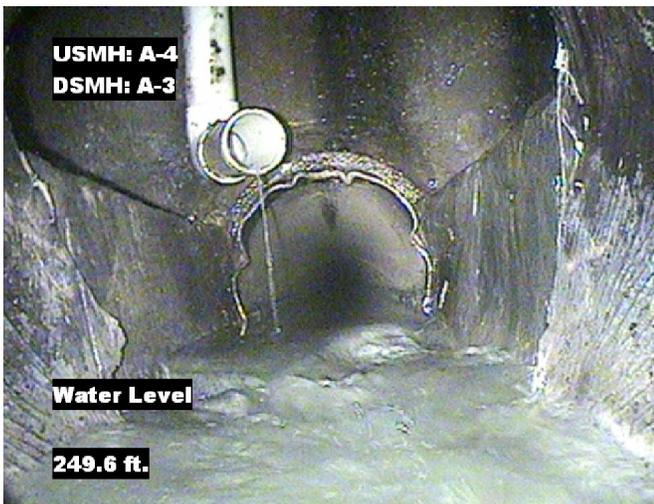
Distance: 249.6 ft.      Grade: 0  
 Condition: Water Level  
 Remarks: N/A

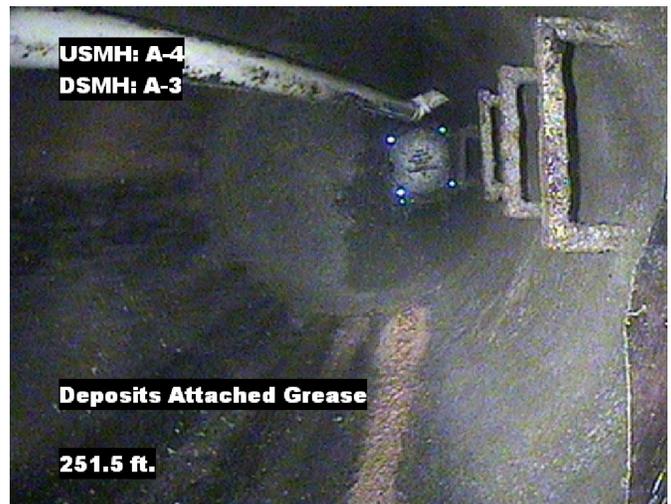
Distance: 251.5 ft.      Grade: 2  
 Condition: Deposits Attached Grease  
 Remarks: N/A
