## Defect Listing

Pipe Segment Refere... <b>A-50_A-49</b>	City <b>Oliver Springs</b>	Street <b>Windrock</b>	Material <b>PolyVinyl Chloride</b>	Location C... <b>Easement/R...</b>	Sewer Use <b>Sanitary</b>
Upstream MH <b>A-50</b>	Total Length <b>67.1</b>	Year Laid	Shape <b>Circular</b>	Location Details	
DS Manhole <b>A-49</b>	Length surveyed <b>67.1</b>	Year Renewed	Height <b>8</b>	Width <b>8</b>	Pipe Joint... <b>13</b>

SPR <b>N/A</b>	MPR <b>22</b>	PO Number <b>4397-03</b>		Customer <b>GRW</b>	
SPRI <b>N/A</b>	MPRI <b>2.2</b>	Work Order <b>4397-02</b>		Purpose <b>Pre-Rehabilitation Survey</b>	
QSR <b>N/A</b>	QMR <b>4129</b>				
OPR <b>22</b>	Surveyed By <b>Charlie Gordon</b>	Direction <b>Downstream</b>	Date <b>20150901</b>	Media label	
OPRI <b>2.2</b>	Certificate Number <b>U-615-07000491</b>	Pre-Cleaning <b>No Pre-Cleaning</b>	Time <b>13:19</b>	Weather <b>Dry</b>	
Date Cleaned			End Time <b>13:31</b>	Additional Info

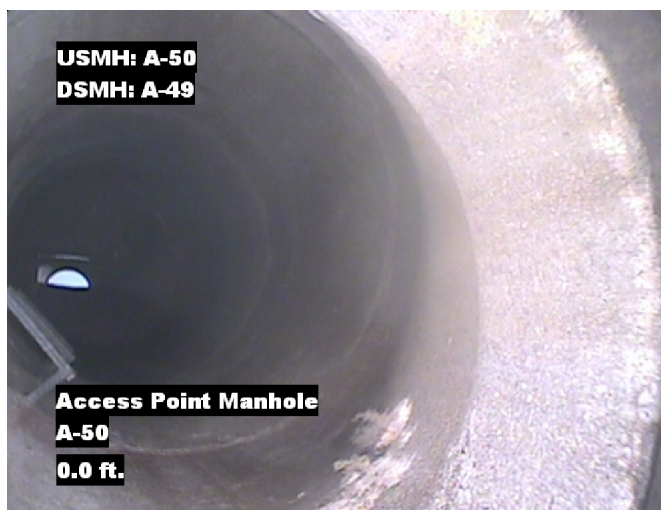
Distance: 0.0 ft. Grade: 0  
Condition: Access Point Manhole  
Remarks: A-50

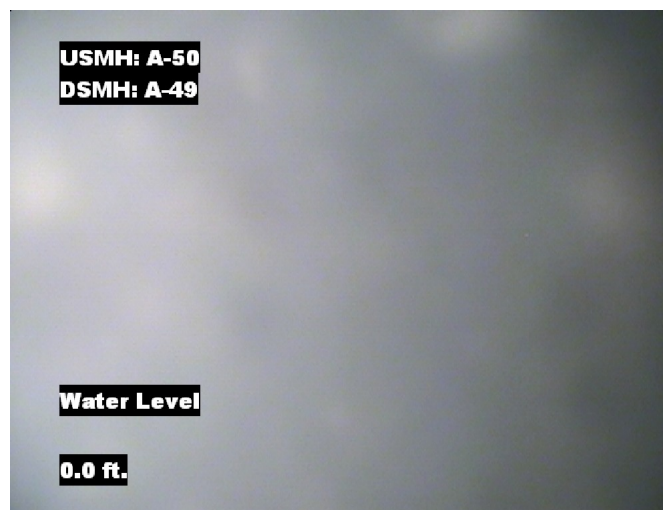
Distance: 0.0 ft. Grade: 0  
Condition: Water Level  
Remarks: N/A

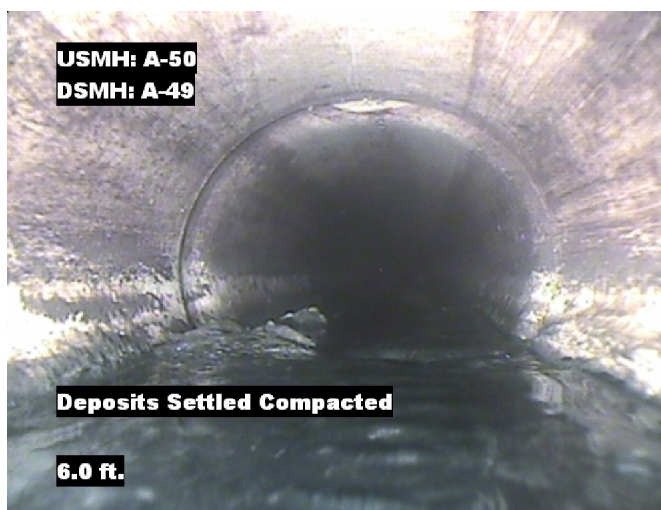
Distance: 6.0 ft. Grade: 2  
Condition: Deposits Settled Compacted  
Remarks: N/A

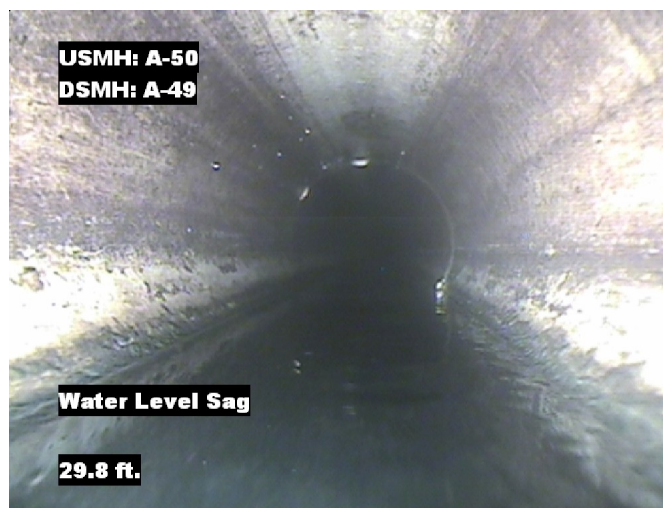
Distance: 29.8 ft.      Grade: 2  
Condition: Water Level Sag  
Remarks: N/A

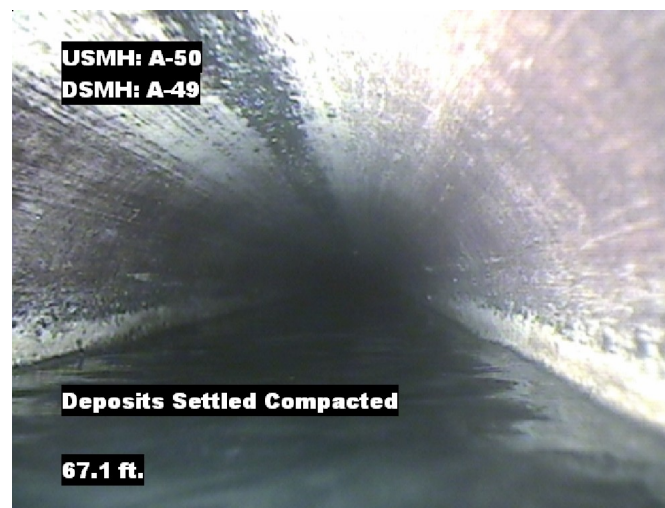
Distance: 67.1 ft.      Grade: 2  
Condition: Deposits Settled Compacted  
Remarks: N/A

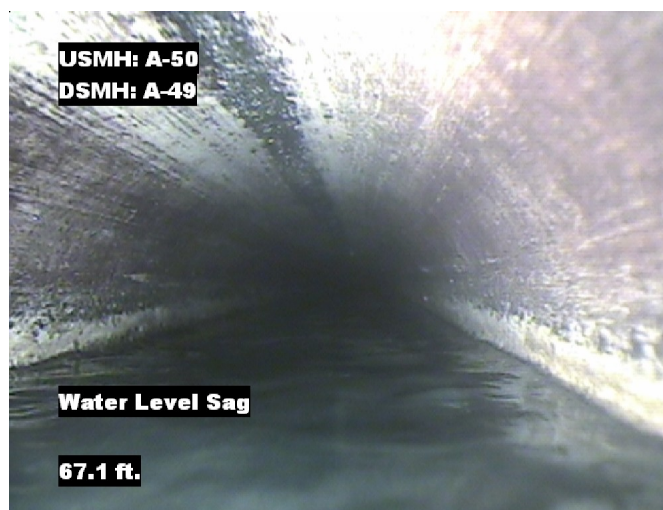
Distance: 67.1 ft.      Grade: 2  
Condition: Water Level Sag  
Remarks: N/A

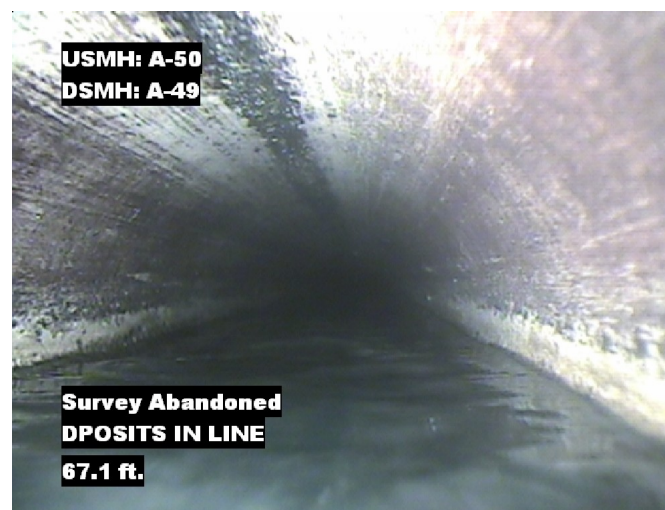
Distance: 67.1 ft.      Grade: 0  
Condition: Survey Abandoned  
Remarks: DPOSITS IN LINE
