Defect Listing

Pipe Segment Refere... A-51_A-50	City Oliver Springs	Street Windrock	Material Concrete Pipe (non-...	Location C... Easement/R...	Sewer Use Sanitary
Upstream MH A-51	Total Length 180	Year Laid	Shape Circular	Location Details	
DS Manhole A-50	Length surveyed 180	Year Renewed	Height 8	Width 8	Pipe Joint... 4

Image Report 4/Page

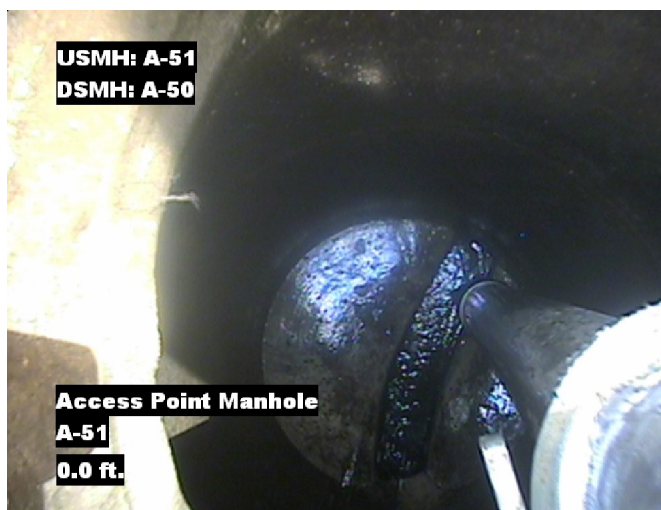
Distance: 0.0 ft. Grade: 0
Condition: Access Point Manhole
Remarks: A-51

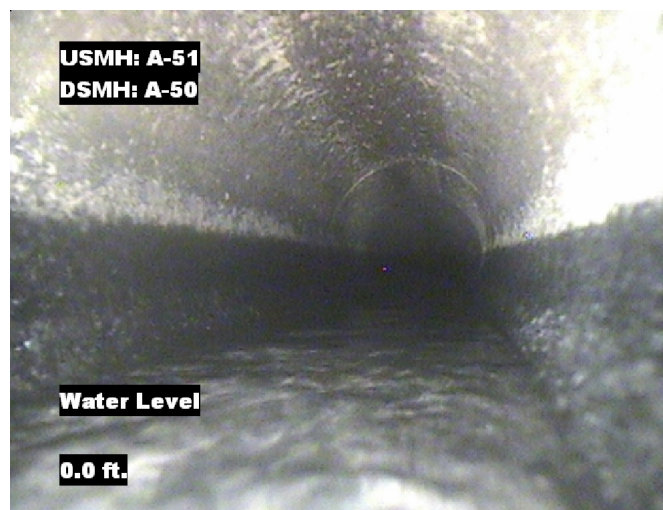
Distance: 0.0 ft. Grade: 0
Condition: Water Level
Remarks: N/A

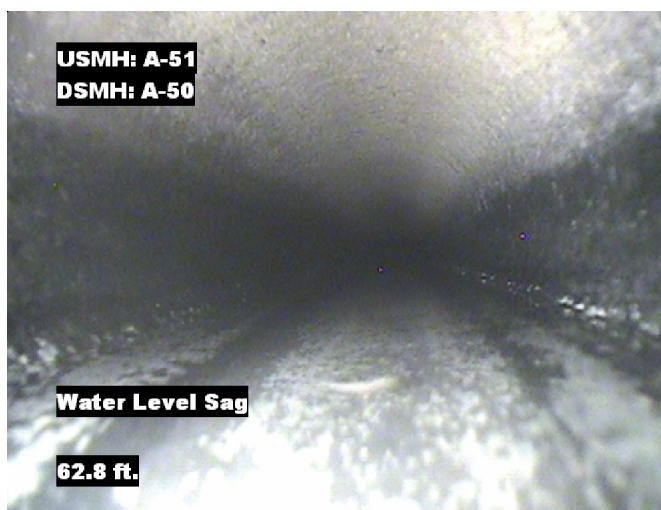
Distance: 62.8 ft. Grade: 2
Condition: Water Level Sag
Remarks: N/A

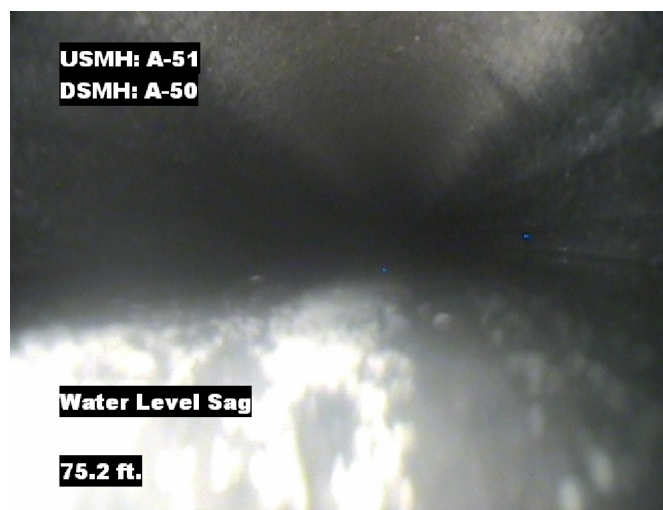
Distance: 75.2 ft. Grade: 3
Condition: Water Level Sag
Remarks: N/A

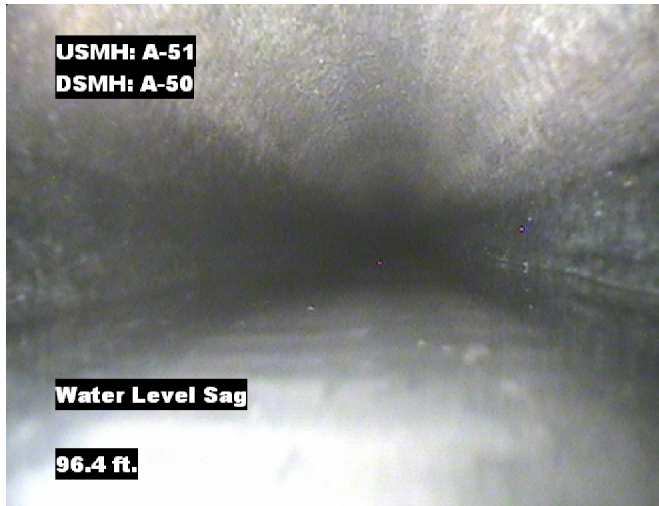
Distance: 96.3 ft. Grade: 2
Condition: Water Level Sag
Remarks: N/A

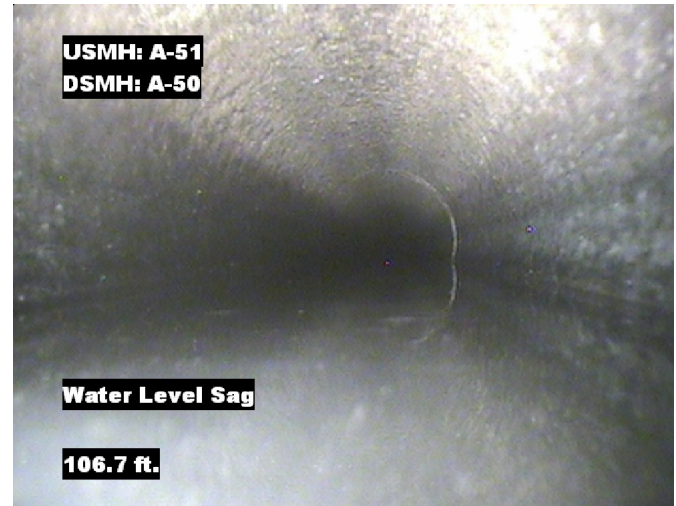
Distance: 106.7 ft. Grade: 3
Condition: Water Level Sag
Remarks: N/A

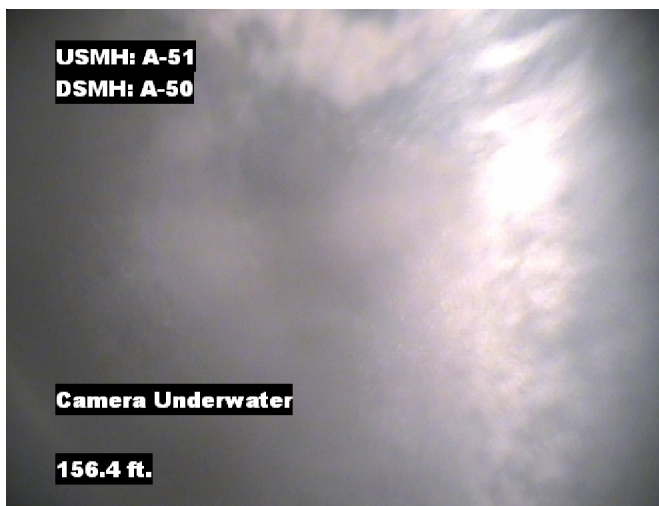
Distance: 156.4 ft. Grade: 4
Condition: Camera Underwater
Remarks: N/A

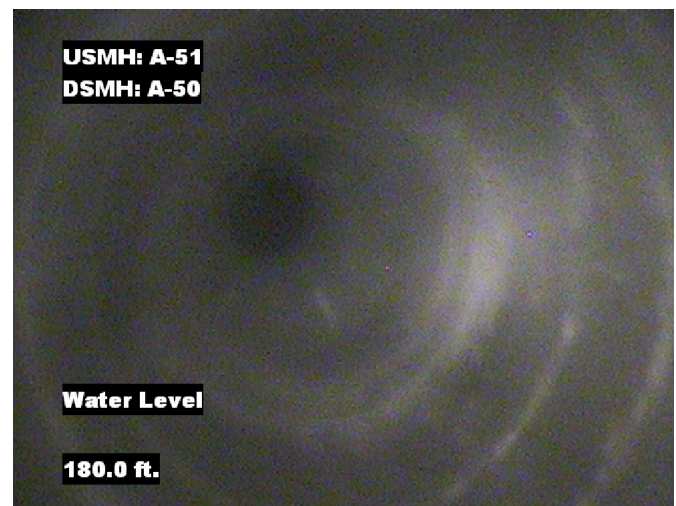
Distance: 180.0 ft. Grade: 0
Condition: Water Level
Remarks: N/A

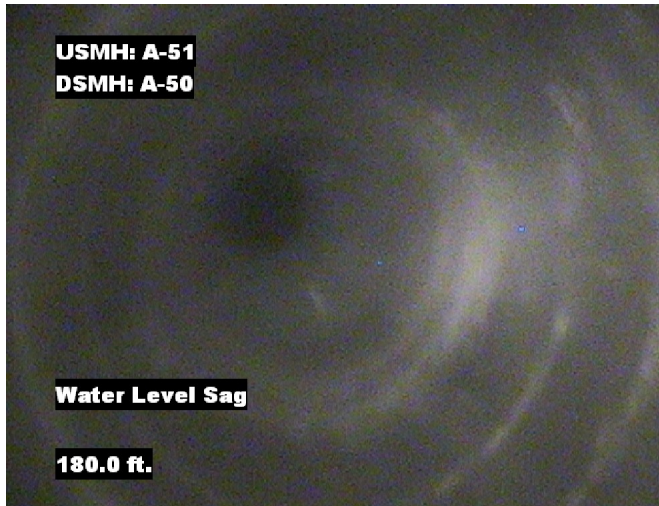
Distance: 180.0 ft. Grade: 3
Condition: Water Level Sag
Remarks: N/A

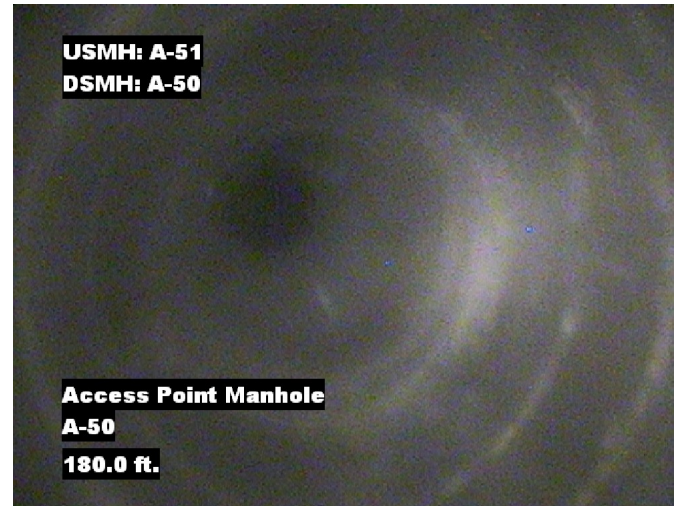
Distance: 180.0 ft. Grade: 0
Condition: Access Point Manhole
Remarks: A-50
