## Defect Listing

Pipe Segment Refere... <b>A-53_A-52</b>	City <b>Oliver Springs</b>	Street <b>Winrock Rd</b>	Material <b>Concrete Pipe (non-...</b>	Location C... <b>Light High...</b>	Sewer Use <b>Sanitary</b>
Upstream MH <b>A-53</b>	Total Length <b>275.5</b>	Year Laid	Shape <b>Circular</b>	Location Details	
DS Manhole <b>A-52</b>	Length surveyed <b>275.5</b>	Year Renewed	Height <b>8</b>	Width <b>8</b>	Pipe Joint... <b>4</b>

SPR <b>1</b>	MPR <b>29</b>	PO Number <b>4397-03</b>	Customer <b>GRW</b>
SPRI <b>1</b>	MPRI <b>2.4</b>	Work Order <b>4397-02</b>	Purpose <b>Pre-Rehabilitation Survey</b>
QSR <b>1100</b>	QMR <b>4232</b>		
OPR <b>30</b>	Surveyed By <b>Charlie Gordon</b>	Direction <b>Downstream</b>	Date <b>20150825</b>
OPRI <b>2.3</b>	Certificate Number <b>U-615-07000491</b>	Pre-Cleaning <b>Heavy Cleaning</b>	Time <b>07:46</b>
	Date Cleaned <b>20150825</b>	End Time <b>08:04</b>	Weather <b>Damp</b>
		Additional Info <b>MAPPING SHOWS DOWNS..</b>

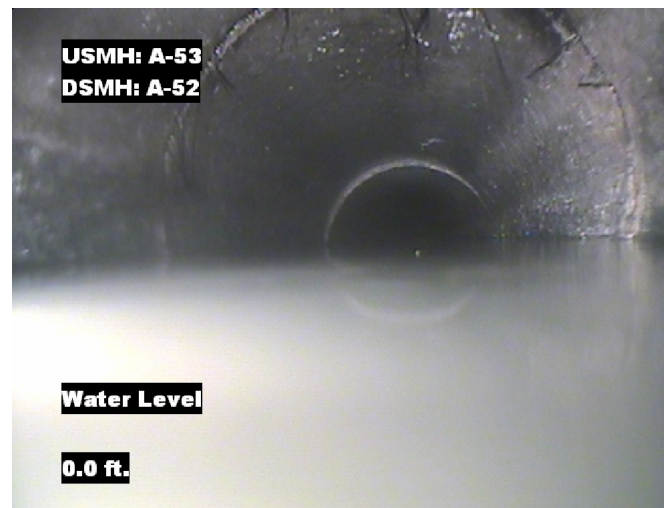
Distance: 0.0 ft. Grade: 0  
Condition: Water Level  
Remarks: N/A

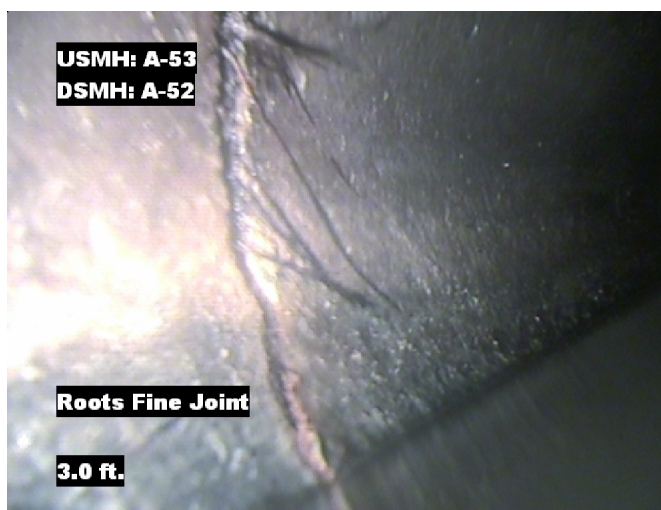
Distance: 3.0 ft. Grade: 1  
Condition: Roots Fine Joint  
Remarks: N/A

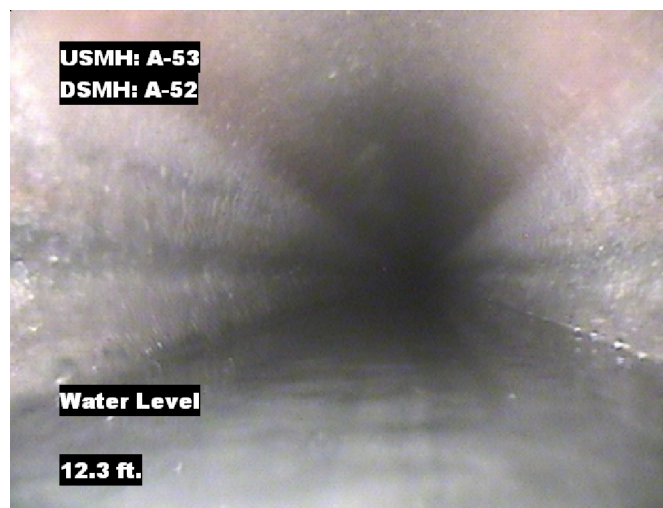
Distance: 12.3 ft. Grade: 0  
Condition: Water Level  
Remarks: N/A

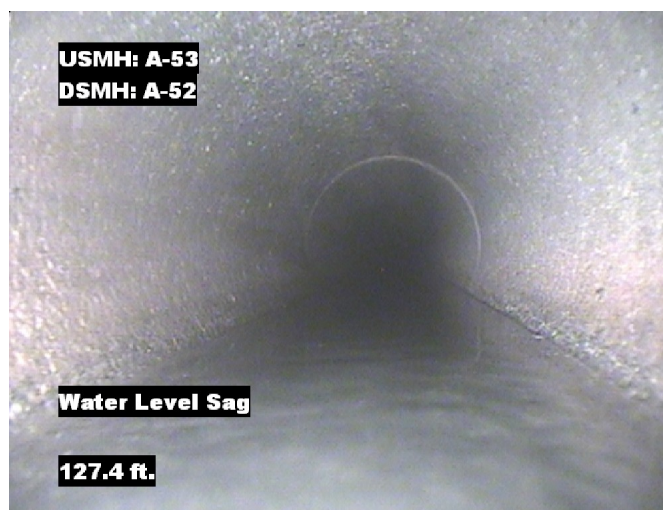
Distance: 127.4 ft. Grade: 2  
Condition: Water Level Sag  
Remarks: N/A

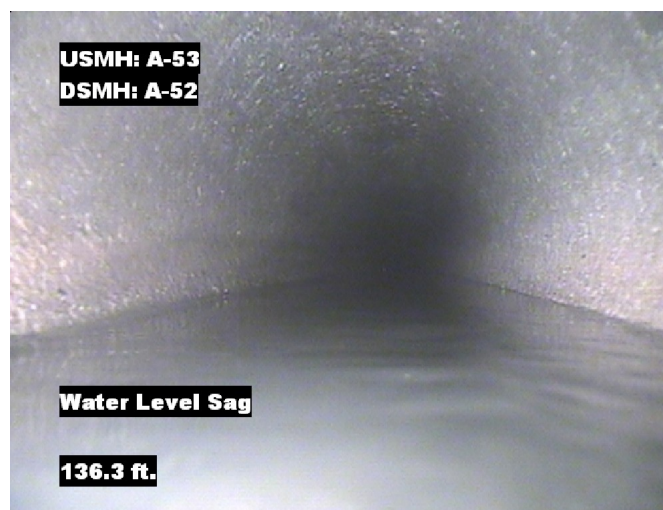
Distance: 136.3 ft. Grade: 2  
Condition: Water Level Sag  
Remarks: N/A

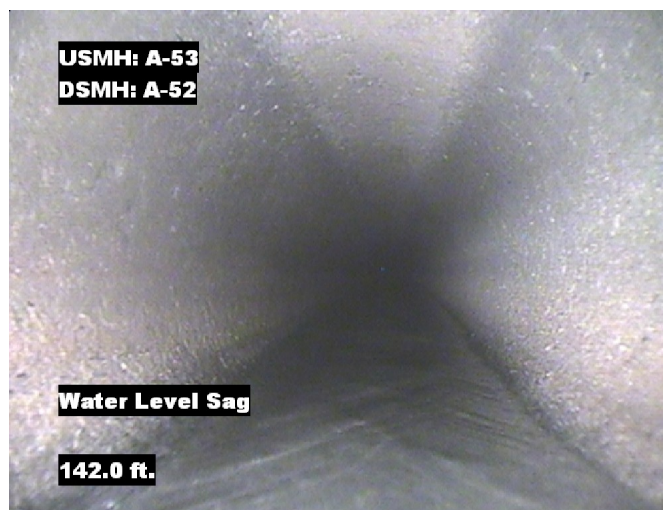
Distance: 142.0 ft. Grade: 2  
Condition: Water Level Sag  
Remarks: N/A

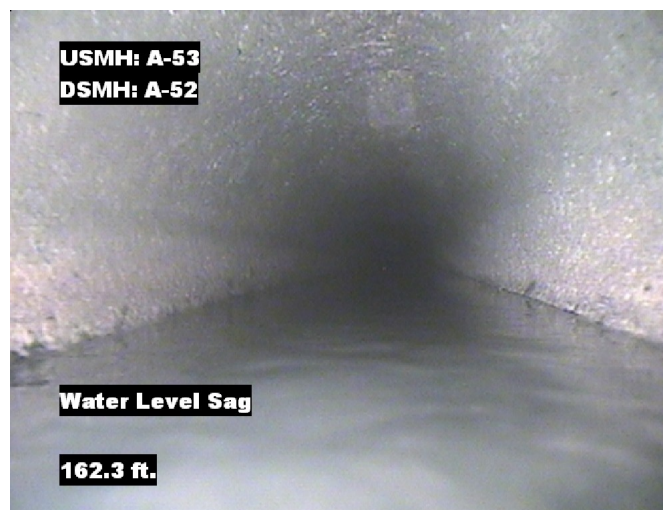
Distance: 162.3 ft. Grade: 2  
Condition: Water Level Sag  
Remarks: N/A

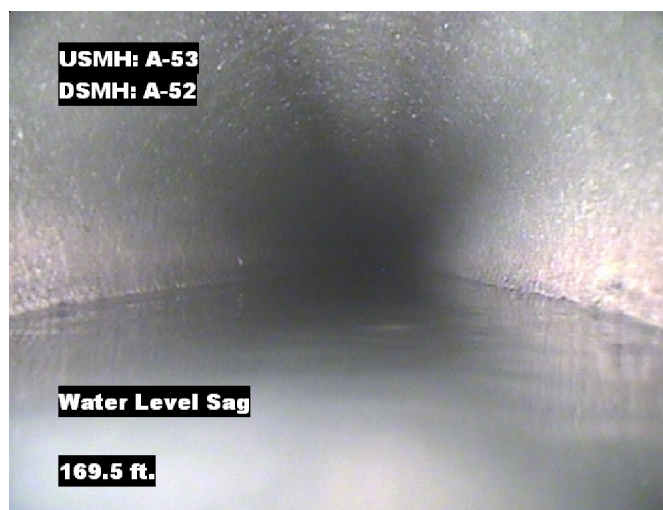
Distance: 169.5 ft. Grade: 3  
Condition: Water Level Sag  
Remarks: N/A

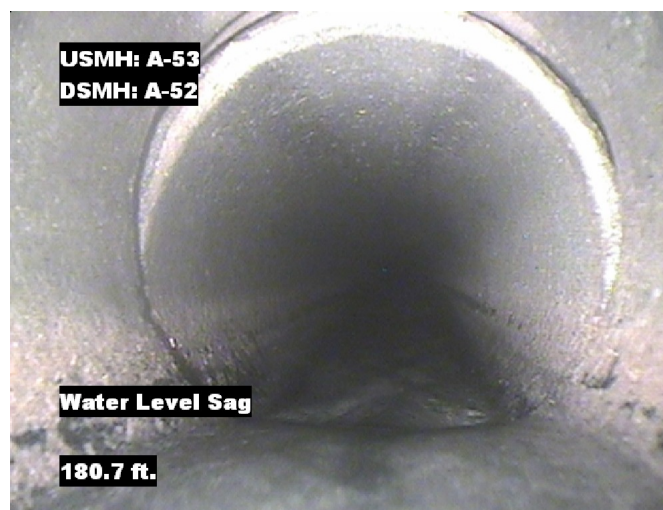
Distance: 180.7 ft. Grade: 3  
Condition: Water Level Sag  
Remarks: N/A

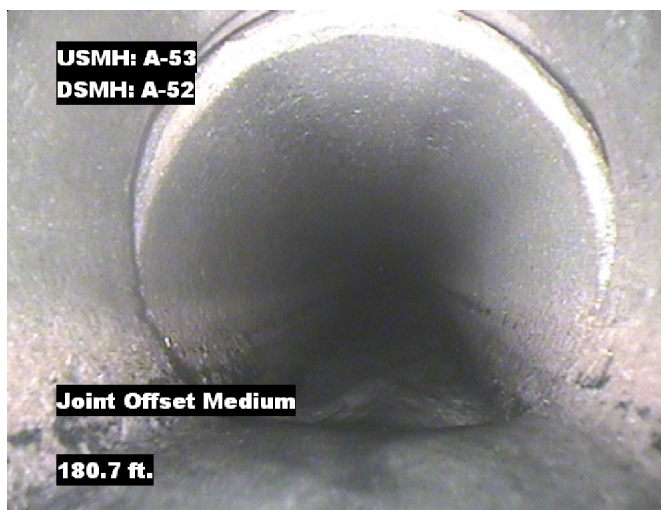
Distance: 180.7 ft. Grade: 1  
Condition: Joint Offset Medium  
Remarks: N/A

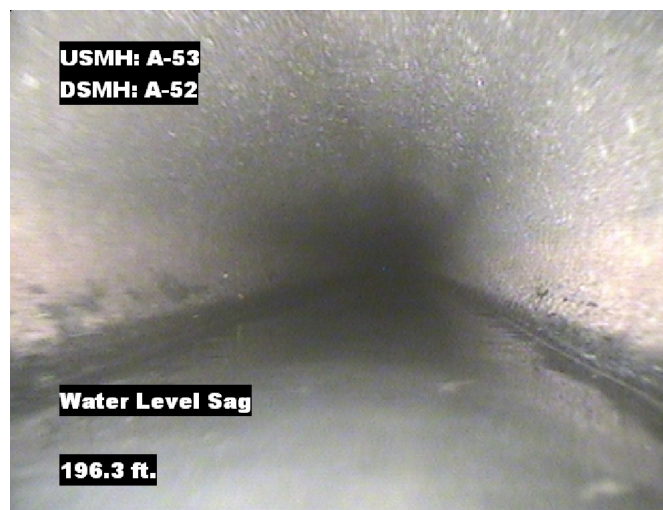
Distance: 196.3 ft. Grade: 2  
Condition: Water Level Sag  
Remarks: N/A

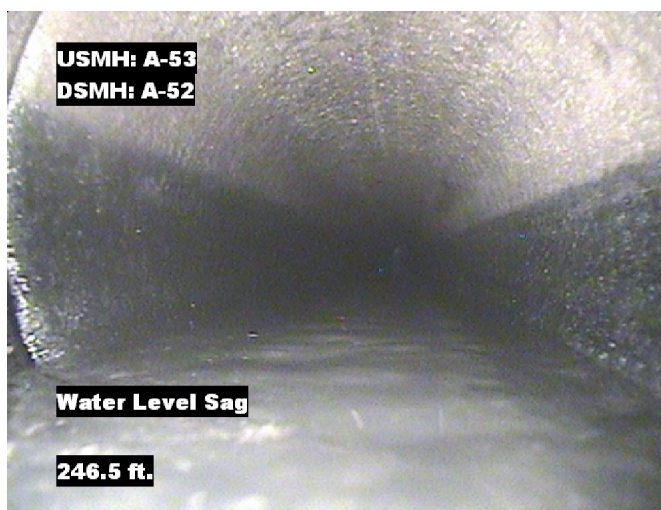
Distance: 246.5 ft. Grade: 2  
Condition: Water Level Sag  
Remarks: N/A

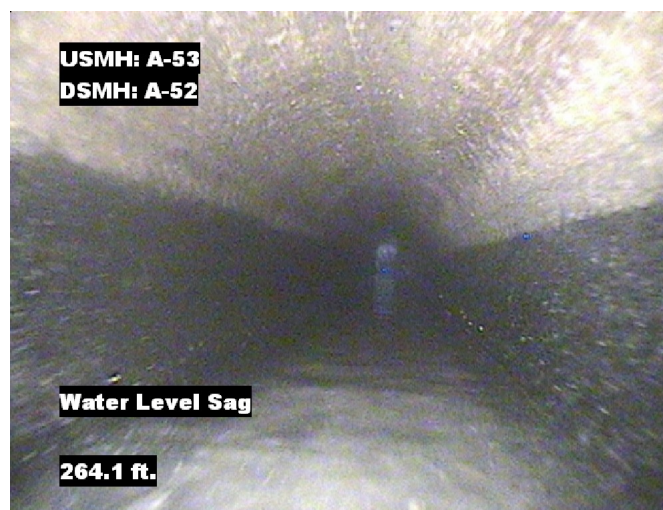
Distance: 263.8 ft. Grade: 2  
Condition: Water Level Sag  
Remarks: N/A

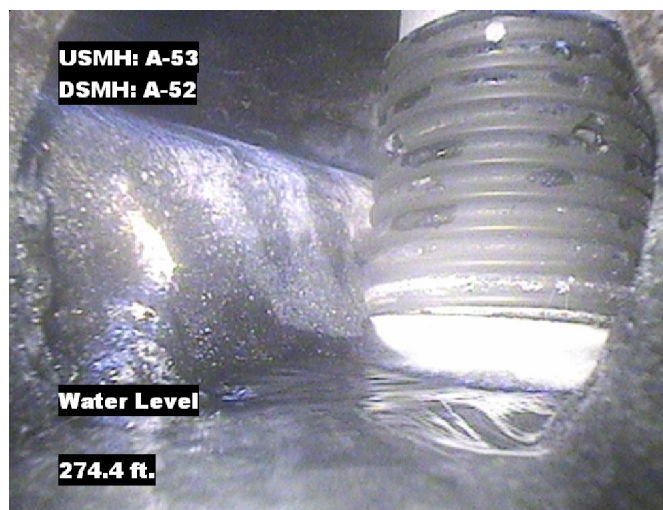
Distance: 274.4 ft.      Grade: 0  
Condition: Water Level  
Remarks: N/A
