## Defect Listing

Pipe Segment Refere... <b>A-54_A-53</b>	City <b>Oliver Springs</b>	Street <b>Windrock Rd</b>	Material <b>Concrete Pipe (non-...</b>	Location C... <b>Light High...</b>	Sewer Use <b>Sanitary</b>
Upstream MH <b>A-54</b>	Total Length <b>273.7</b>	Year Laid	Shape <b>Circular</b>	Location Details	
DS Manhole <b>A-53</b>	Length surveyed <b>11.5</b>	Year Renewed	Height <b>8</b>	Width <b>8</b>	Pipe Joint... <b>4</b>

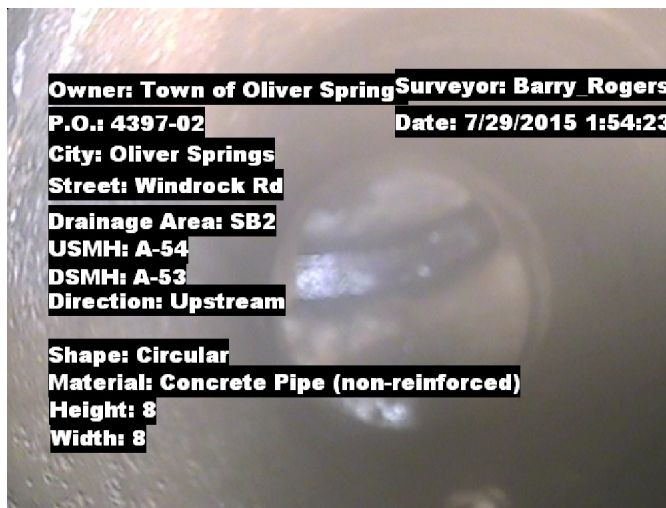
Distance: 0.0 ft. Grade: 0  
Condition: Access Point Manhole  
Remarks: A-53

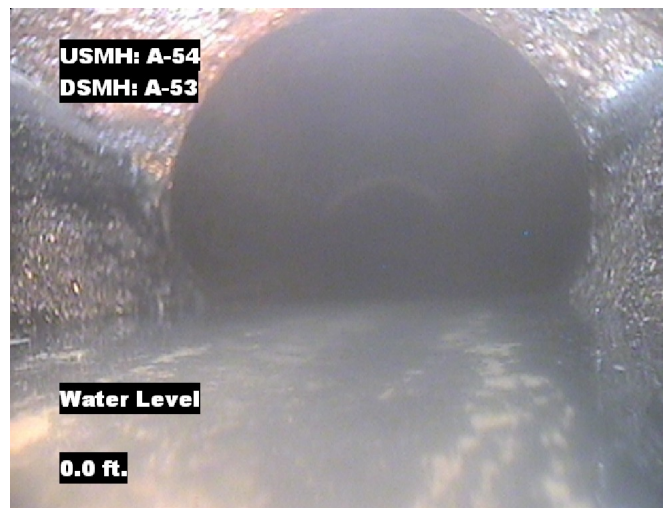
Distance: 0.0 ft. Grade: 0  
Condition: Water Level  
Remarks: N/A

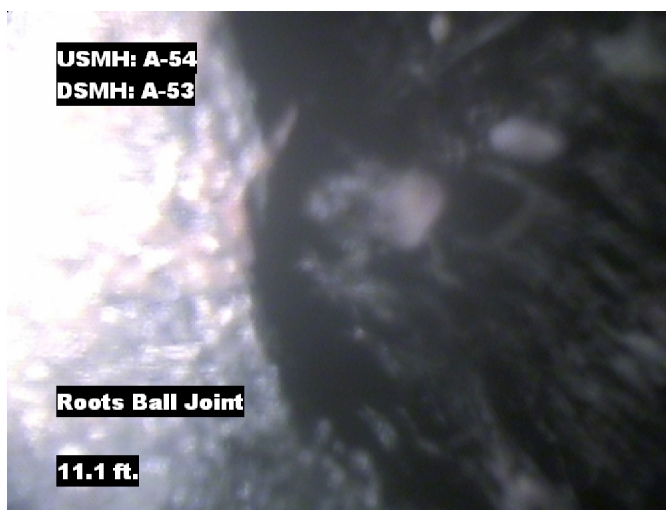
Distance: 11.1 ft. Grade: 4  
Condition: Roots Ball Joint  
Remarks: N/A

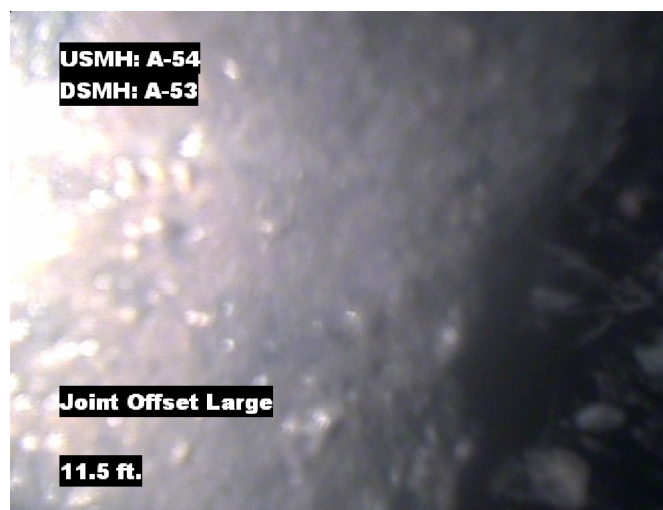
Distance: 11.5 ft. Grade: 2  
Condition: Joint Offset Large  
Remarks: N/A

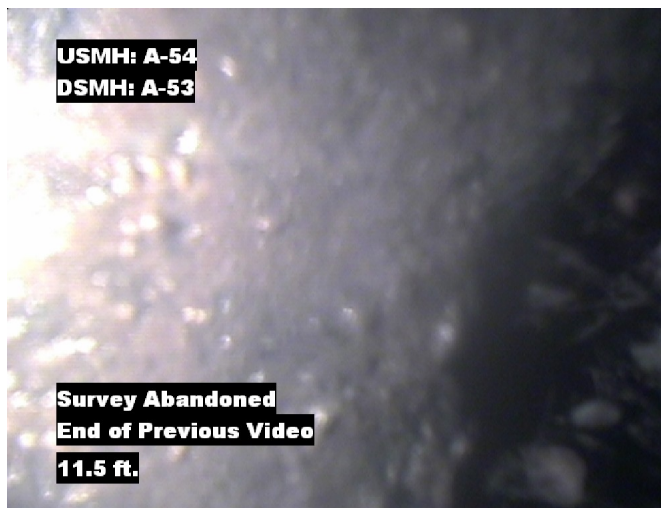
Distance: 11.5 ft.      Grade: 0  
Condition: Survey Abandoned  
Remarks: Survey Complete
