Defect Listing

Pipe Segment Refere... A-55_A-54	City Oliver Springs	Street Windrock Rd	Material Concrete Pipe (non-...	Location C... Light High...	Sewer Use Sanitary
Upstream MH A-55	Total Length 111.7	Year Laid	Shape Circular	Location Details	
DS Manhole A-54	Length surveyed 111.7	Year Renewed	Height 8	Width 8	Pipe Joint... 4

Image Report 4/Page

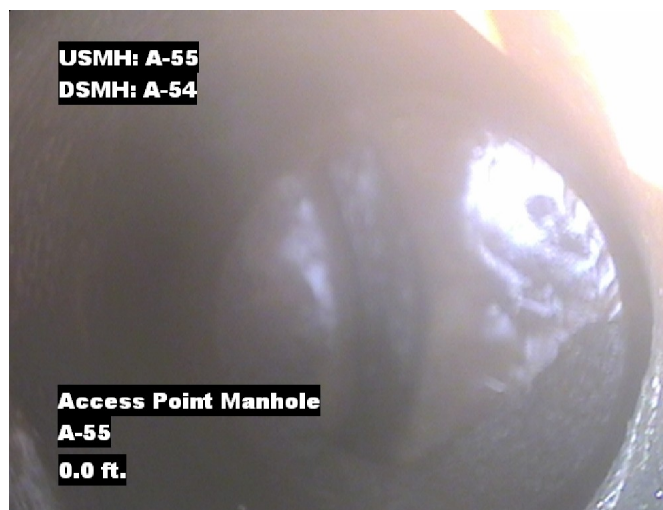
Distance: 0.0 ft. Grade: 0
Condition: Access Point Manhole
Remarks: A-55

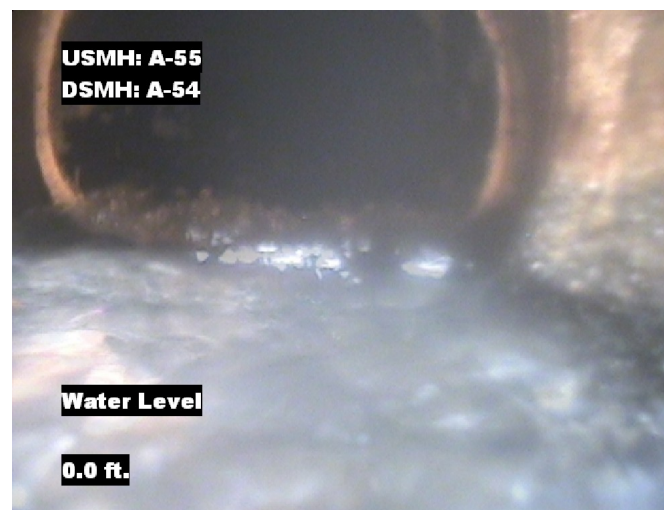
Distance: 0.0 ft. Grade: 0
Condition: Water Level
Remarks: N/A

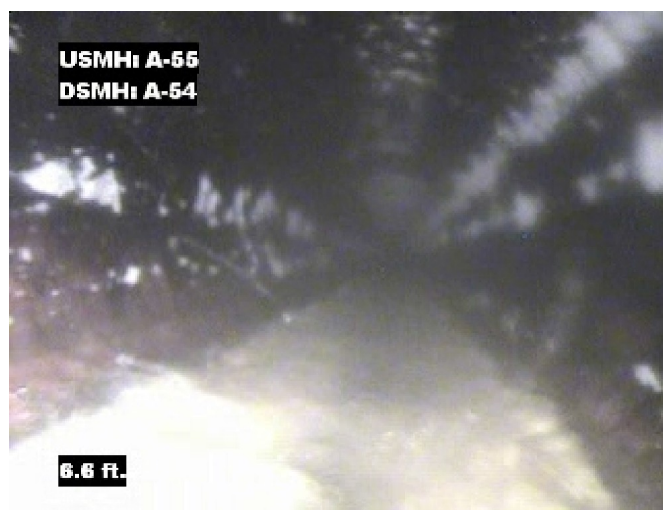
Distance: 6.5 ft. Grade: 2
Condition: Deposits Attached Grease
Remarks: THIS IS A CONTINUOUS DEFECT

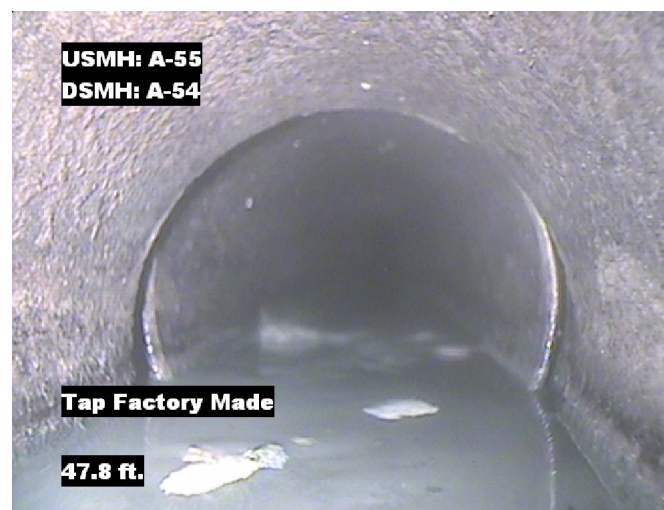
Distance: 47.8 ft. Grade: 0
Condition: Tap Factory Made
Remarks: N/A

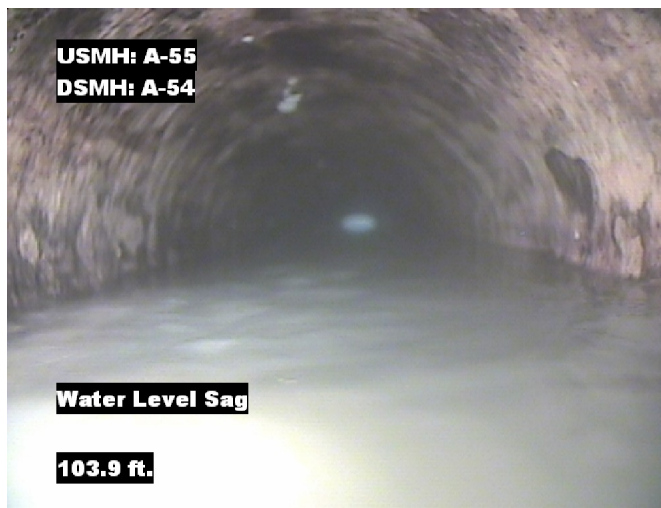
Distance: 103.9 ft. Grade: 4
Condition: Water Level Sag
Remarks: N/A

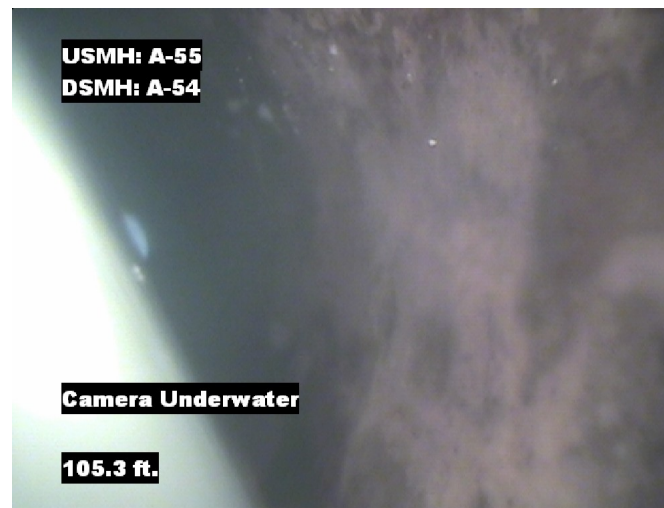
Distance: 105.3 ft. Grade: 4
Condition: Camera Underwater
Remarks: N/A

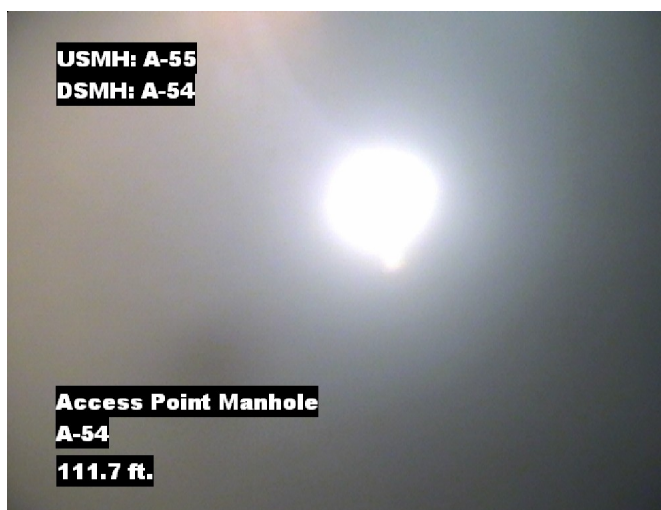
Distance: 111.7 ft. Grade: 0
Condition: Access Point Manhole
Remarks: A-54
