## Defect Listing

Pipe Segment Refere... <b>A-56_A-55</b>	City <b>Oliver Springs</b>	Street <b>Windrock Rd</b>	Material <b>Concrete Pipe (non-...</b>	Location C... <b>Light High...</b>	Sewer Use <b>Sanitary</b>
Upstream MH <b>A-56</b>	Total Length <b>346.1</b>	Year Laid	Shape <b>Circular</b>	Location Details	
DS Manhole <b>A-55</b>	Length surveyed <b>346.1</b>	Year Renewed	Height <b>8</b>	Width <b>8</b>	Pipe Joint... <b>4</b>

SPR <b>N/A</b>	MPR <b>20</b>	PO Number <b>4397-03</b>	Customer <b>GRW</b>
SPRI <b>N/A</b>	MPRI <b>4</b>	Work Order <b>4397-02</b>	Purpose <b>Pre-Rehabilitation Survey</b>
QSR <b>N/A</b>	QMR <b>5143</b>		
OPR <b>20</b>	Surveyed By <b>Barry Rogers</b>	Direction <b>Downstream</b>	Date <b>20150729</b>
OPRI <b>4</b>	Certificate Number <b>U-1012-16405</b>	Pre-Cleaning <b>Jetting</b>	Time <b>09:04</b>
	Date Cleaned <b>20150729</b>	End Time <b>09:40</b>	Weather <b>Dry</b>
			Additional Info

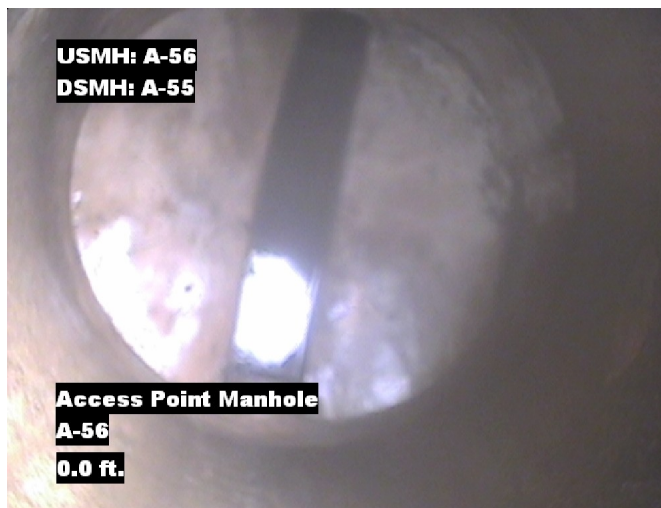
Distance: 0.0 ft. Grade: 0  
Condition: Access Point Manhole  
Remarks: A-56

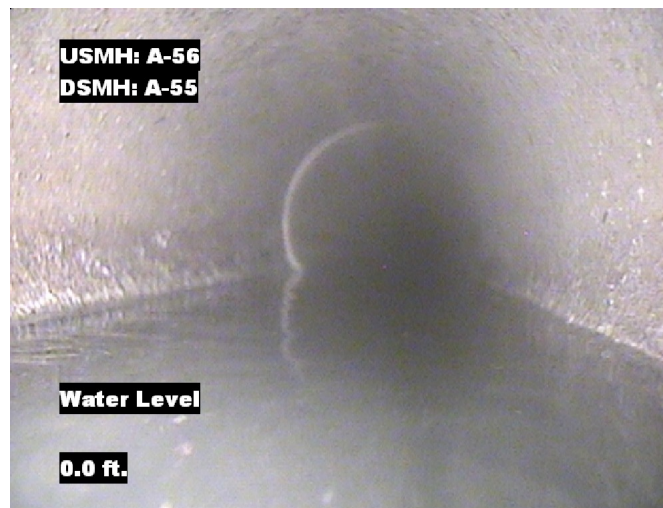
Distance: 0.0 ft. Grade: 0  
Condition: Water Level  
Remarks: N/A

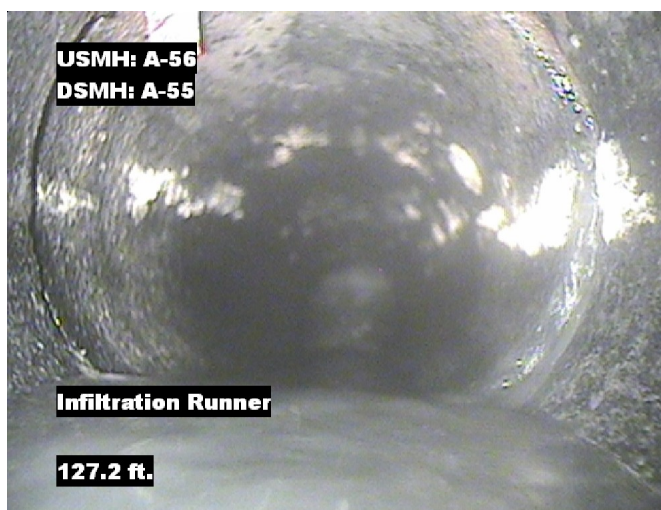
Distance: 127.2 ft. Grade: 4  
Condition: Infiltration Runner  
Remarks: N/A

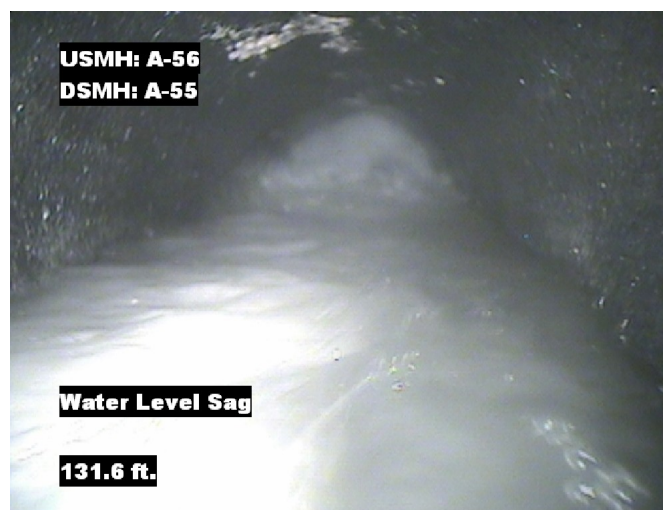
Distance: 131.6 ft. Grade: 3  
Condition: Water Level Sag  
Remarks: N/A

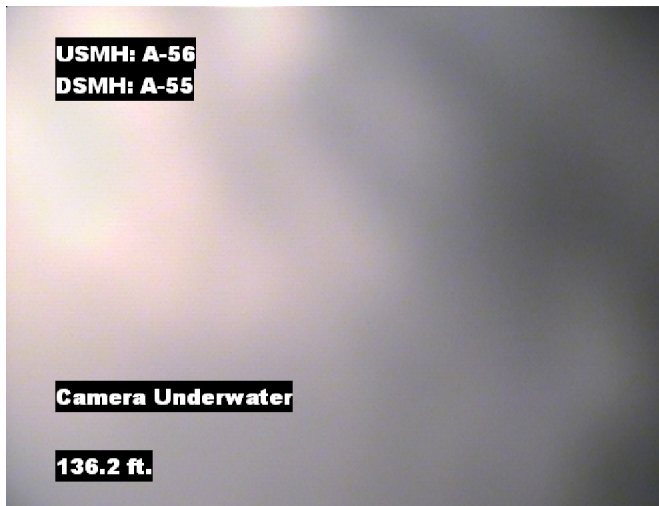
Distance: 136.2 ft. Grade: 4  
Condition: Camera Underwater  
Remarks: N/A

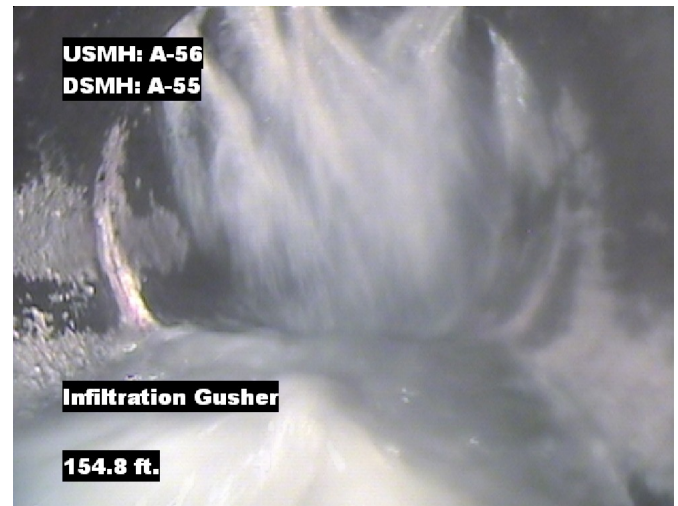
Distance: 154.8 ft. Grade: 5  
Condition: Infiltration Gusher  
Remarks: N/A

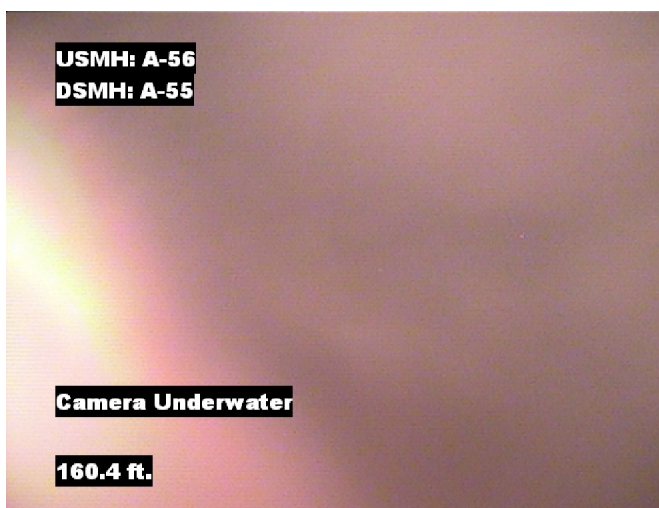
Distance: 160.4 ft. Grade: 4  
Condition: Camera Underwater  
Remarks: N/A

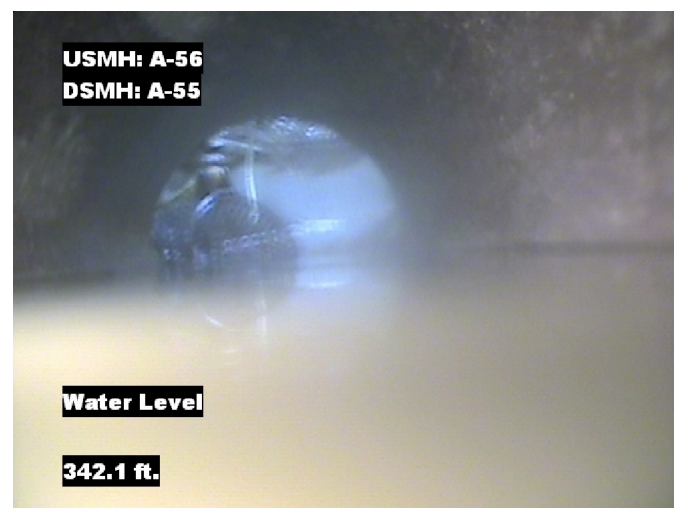
Distance: 342.1 ft. Grade: 0  
Condition: Water Level  
Remarks: N/A

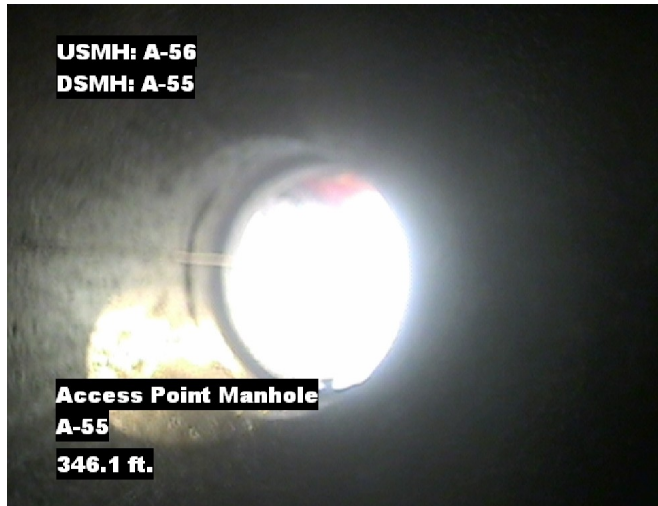
Distance: 346.1 ft. Grade: 0  
Condition: Access Point Manhole  
Remarks: A-55
