Defect Listing

Pipe Segment Refere... A-57_A-56	City Oliver Springs	Street Windrock Rd	Material Concrete Pipe (non-...	Location C... Light High...	Sewer Use Sanitary
Upstream MH A-57	Total Length 332.5	Year Laid	Shape Circular	Location Details	
DS Manhole A-56	Length surveyed 332.5	Year Renewed	Height 8	Width 8	Pipe Joint... 4

SPR 2	MPR 19	PO Number 4397-03	Customer GRW
SPRI 2	MPRI 2.4	Work Order 4397-02	Purpose Pre-Rehabilitation Survey
QSR 2100	QMR 4231		
OPR 21	Surveyed By Barry Rogers	Direction Downstream	Date 20150729
OPRI 2.3	Certificate Number U-1012-16405	Pre-Cleaning Heavy Cleaning	Time 08:24
	Date Cleaned 20150729	End Time 08:48	Weather Damp
			Media label Used Root Saw

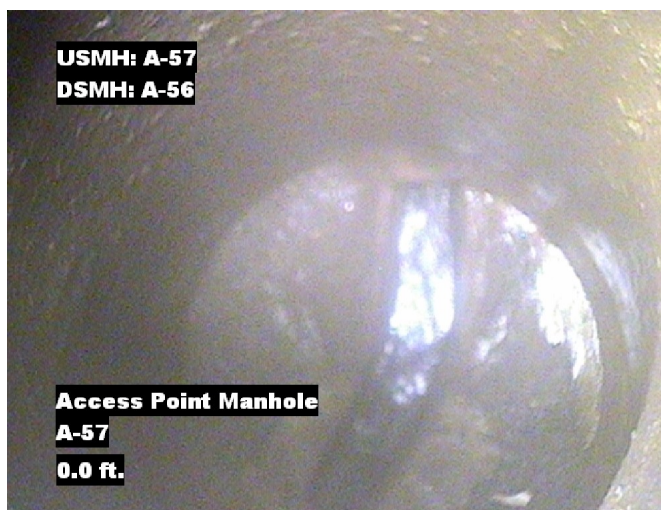
Distance: 0.0 ft. Grade: 0
Condition: Access Point Manhole
Remarks: A-57

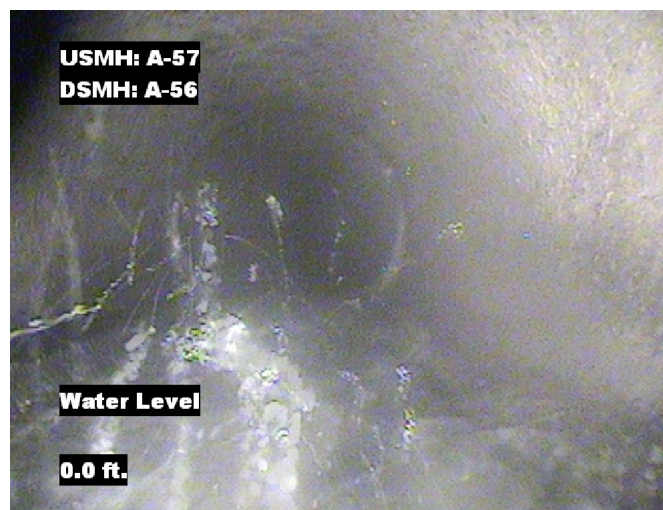
Distance: 0.0 ft. Grade: 0
Condition: Water Level
Remarks: N/A

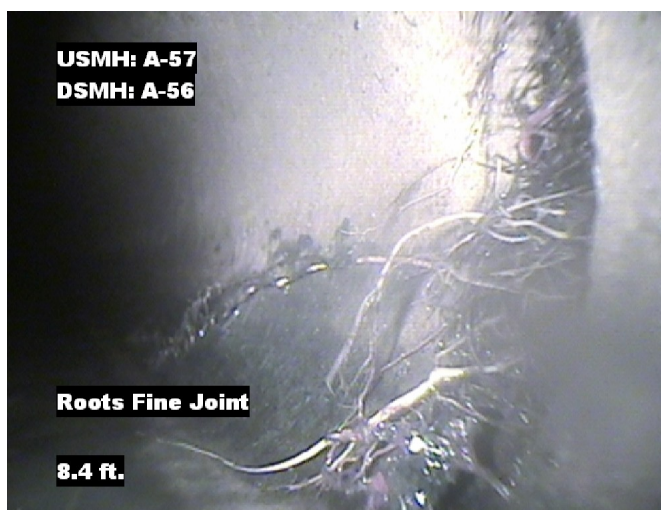
Distance: 8.4 ft. Grade: 1
Condition: Roots Fine Joint
Remarks: N/A

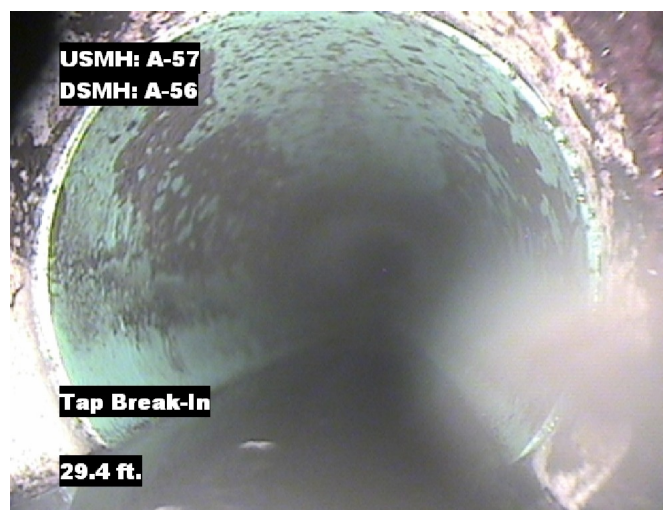
Distance: 29.4 ft. Grade: 0
Condition: Tap Break-In
Remarks: N/A

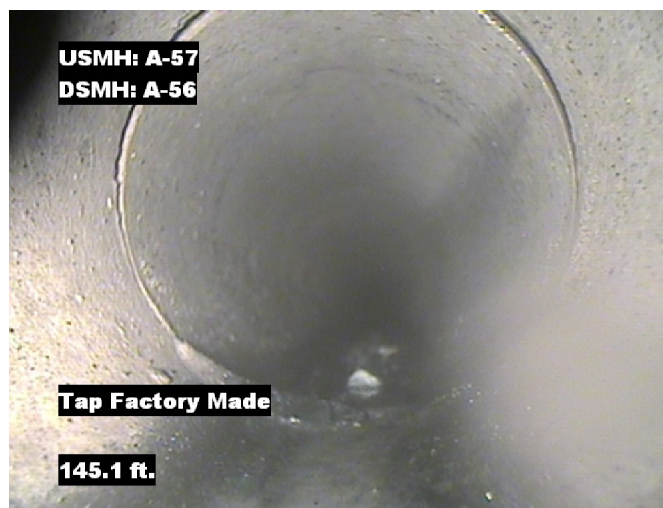
Distance: 145.1 ft. Grade: 0
Condition: Tap Factory Made
Remarks: N/A

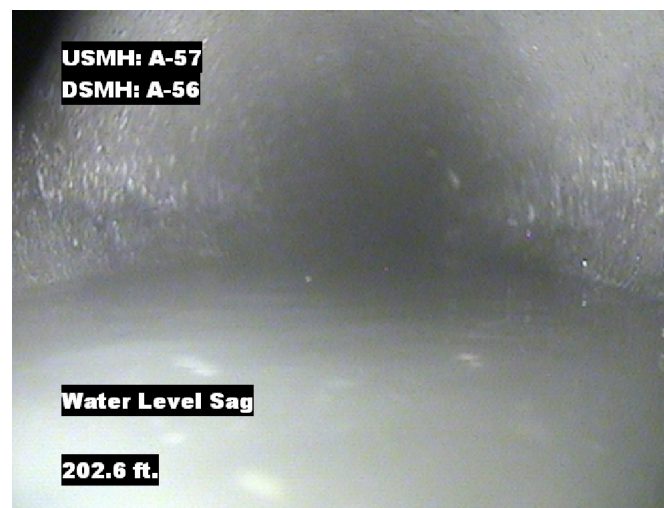
Distance: 202.6 ft. Grade: 2
Condition: Water Level Sag
Remarks: N/A

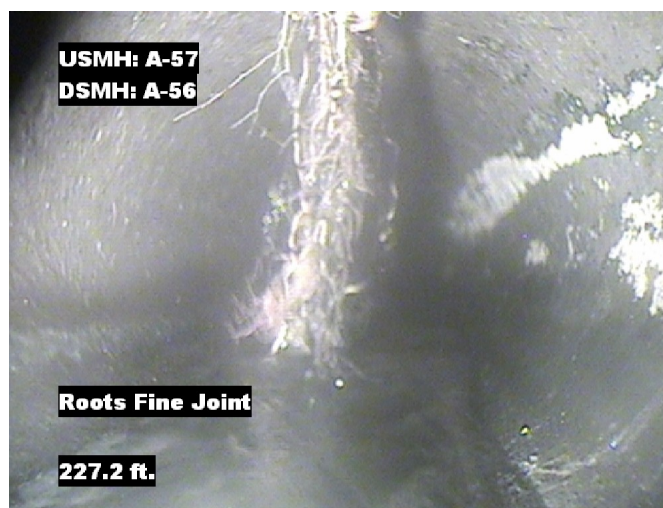
Distance: 227.2 ft. Grade: 1
Condition: Roots Fine Joint
Remarks: N/A

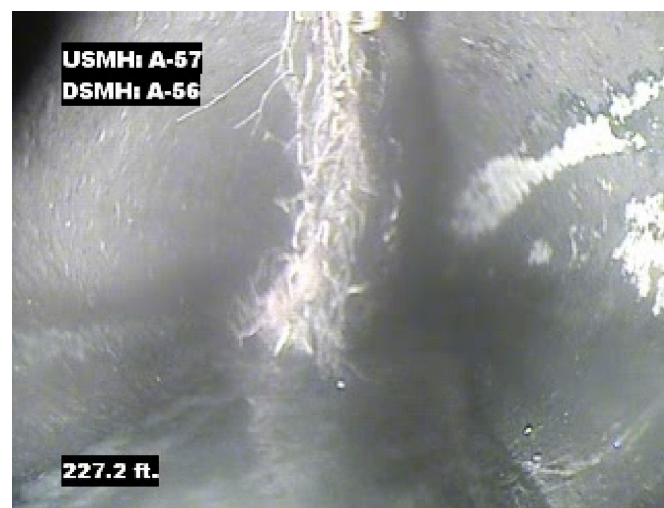
Distance: 227.2 ft. Grade: 3
Condition: Infiltration Dripper
Remarks: N/A

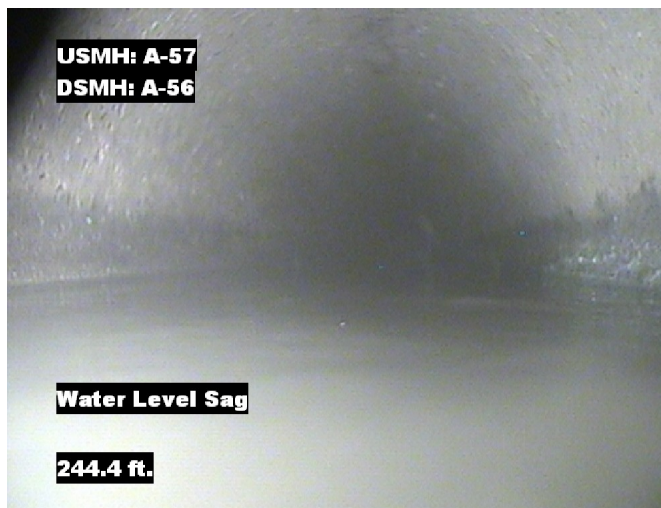
Distance: 244.4 ft. Grade: 2
Condition: Water Level Sag
Remarks: N/A

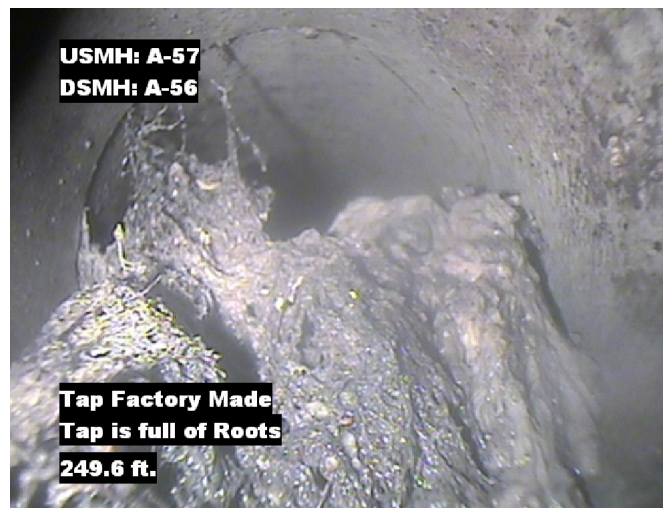
Distance: 249.6 ft. Grade: 0
Condition: Tap Factory Made
Remarks: Tap is full of Roots

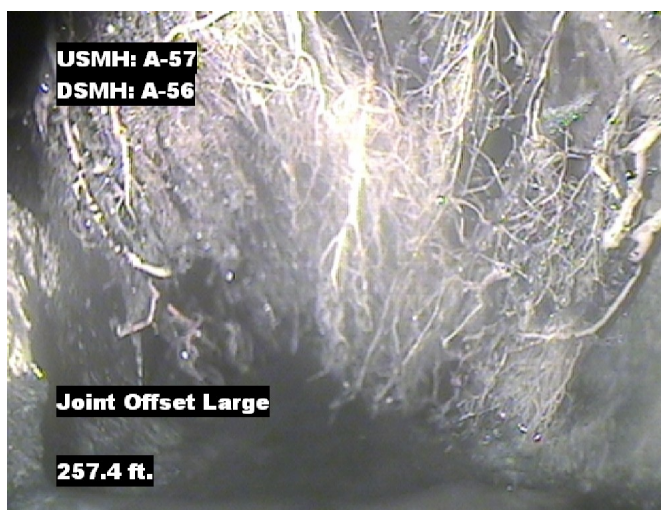
Distance: 257.4 ft. Grade: 2
Condition: Joint Offset Large
Remarks: N/A

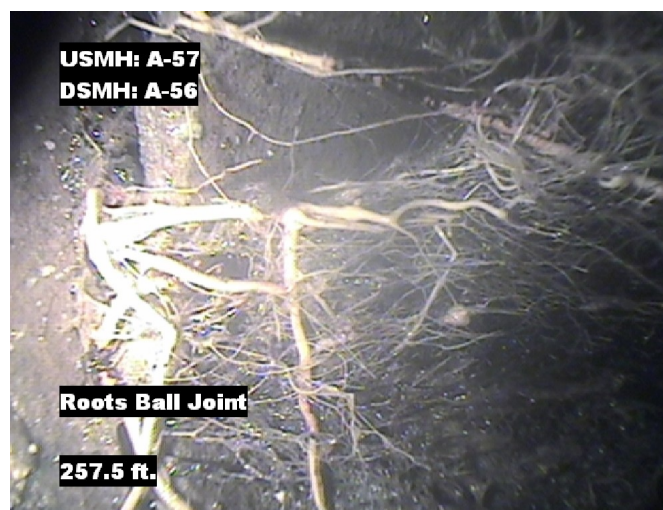
Distance: 257.4 ft. Grade: 4
Condition: Roots Ball Joint
Remarks: N/A

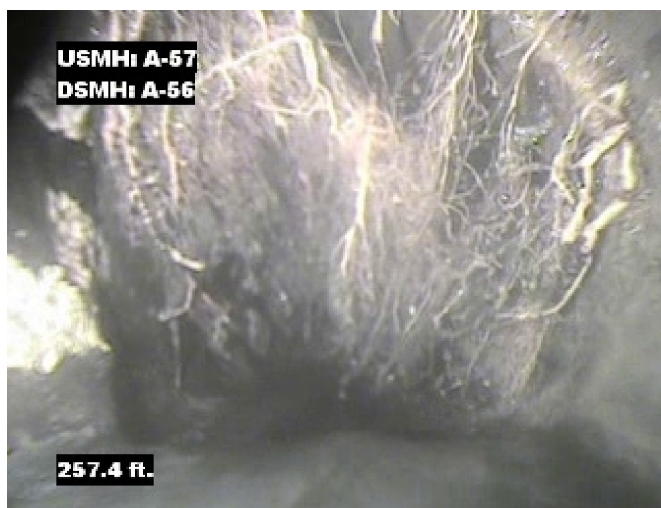
Distance: 257.4 ft. Grade: 4
Condition: Infiltration Runner
Remarks: N/A

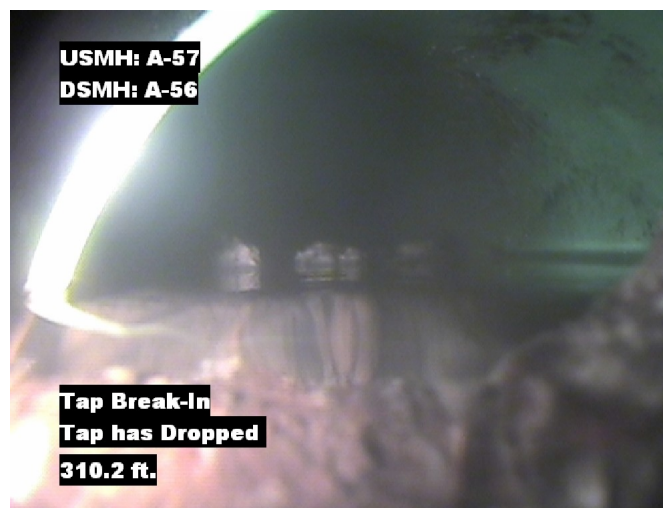
Distance: 310.2 ft. Grade: 0
Condition: Tap Break-In
Remarks: Tap has Dropped

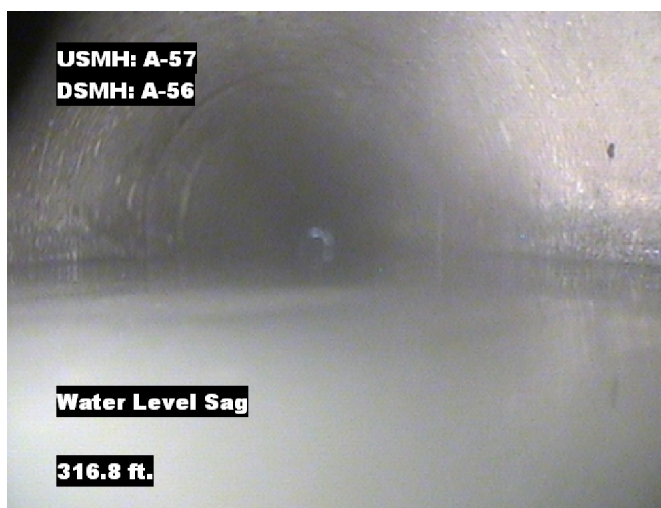
Distance: 316.8 ft. Grade: 2
Condition: Water Level Sag
Remarks: N/A

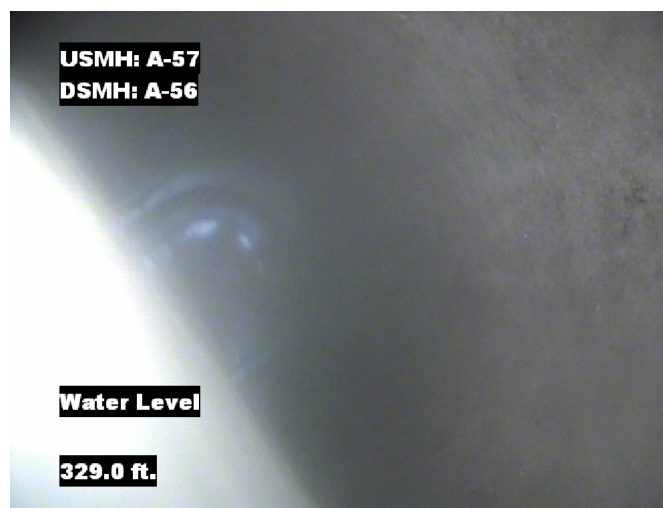
Distance: 329.0 ft. Grade: 0
Condition: Water Level
Remarks: N/A

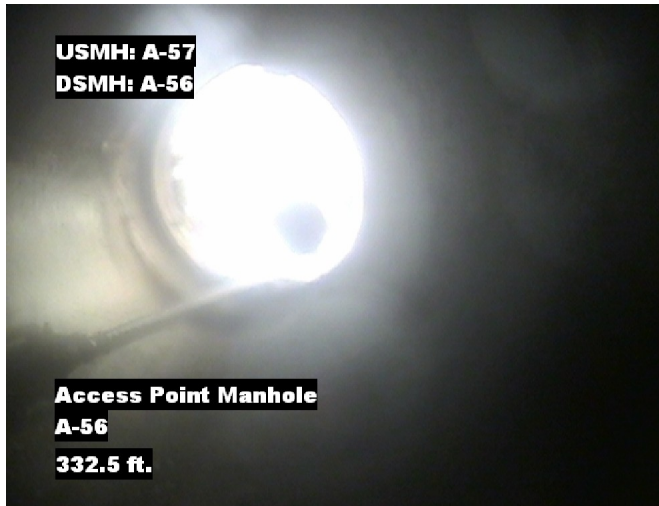
Distance: 332.5 ft. Grade: 0
Condition: Access Point Manhole
Remarks: A-56
