Defect Listing

Pipe Segment Refere...	City	Street	Material	Location C...	Sewer Use
A-58_A-57	Oliver Springs	Windrock Rd	Concrete Pipe (non-...	Light High...	Sanitary
Upstream MH	Total Length	Year Laid	Shape	Location Details	
A-58	394.4		Circular		
DS Manhole	Length surveyed	Year Renewed	Height	Width	Pipe Joint...
A-57	394.4		8	8	4

Image Report 4/Page

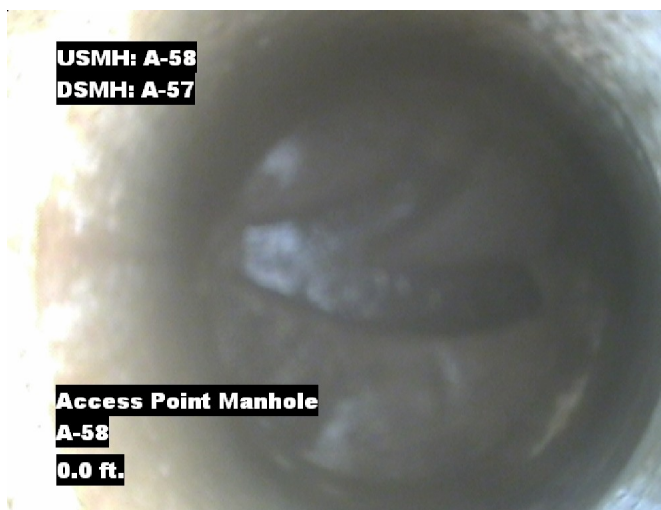
Distance: 0.0 ft. Grade: 0
Condition: Access Point Manhole
Remarks: A-58

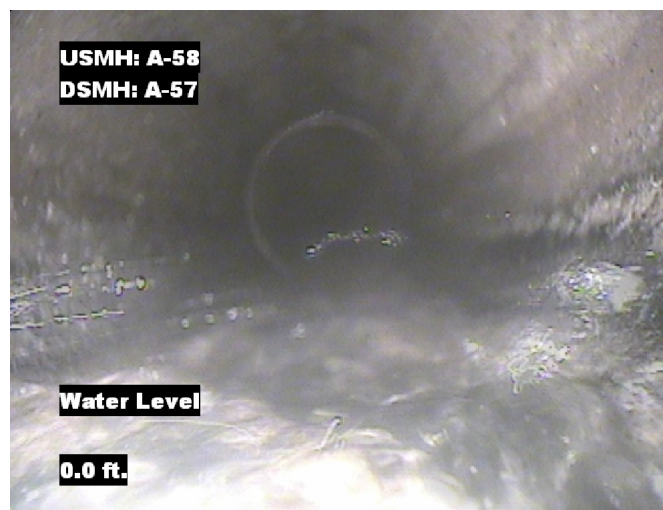
Distance: 0.0 ft. Grade: 0
Condition: Water Level
Remarks: N/A

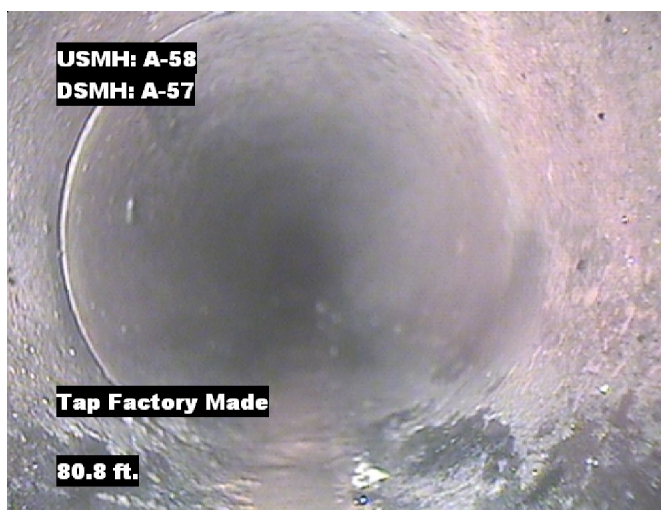
Distance: 80.8 ft. Grade: 0
Condition: Tap Factory Made
Remarks: N/A

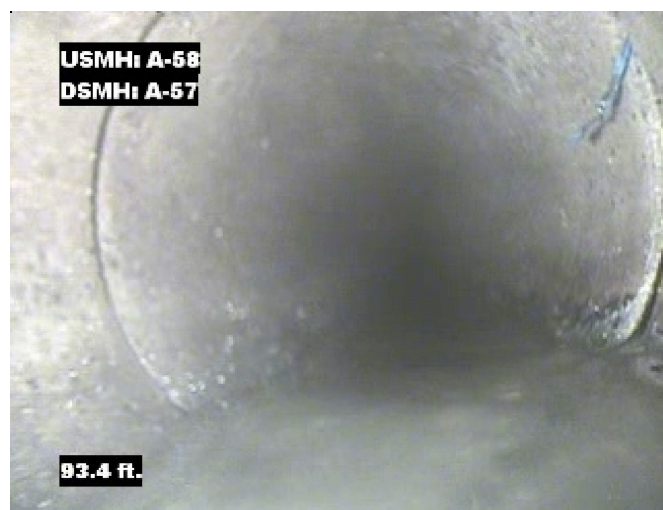
Distance: 93.5 ft. Grade: 2
Condition: Intruding Sealing Ring Broken
Remarks: N/A

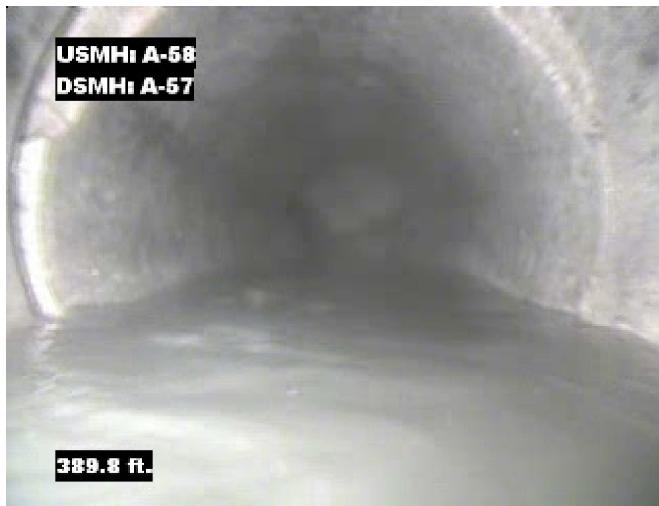
Distance: 389.9 ft. Grade: 0
Condition: General Observation
Remarks: A SMALL PIECE OF PIPE AT THE JOINT IS BROKE OFF

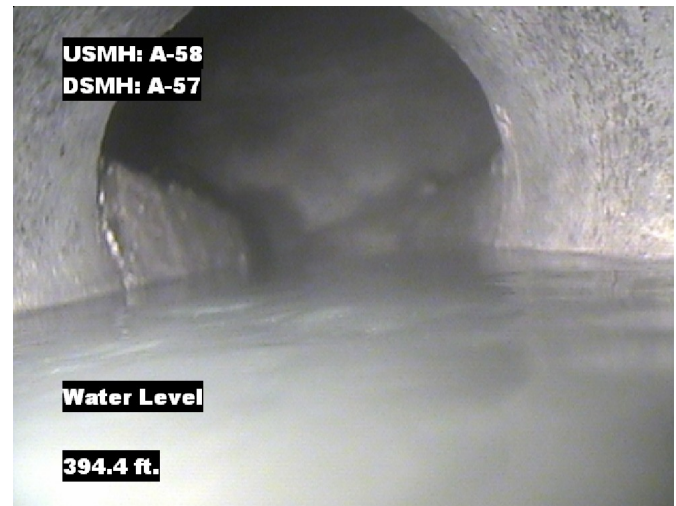
Distance: 394.4 ft. Grade: 0
Condition: Water Level
Remarks: N/A

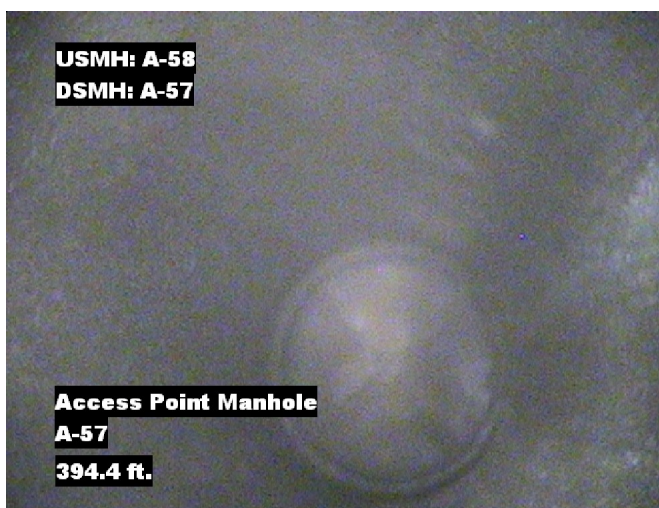
Distance: 394.4 ft. Grade: 0
Condition: Access Point Manhole
Remarks: A-57
