Defect Listing

Pipe Segment Refere... A-60_A-59	City Oliver Springs	Street Green St	Material Concrete Pipe (non-...	Location C... Light High...	Sewer Use Sanitary
Upstream MH A-60	Total Length 160.5	Year Laid	Shape Circular	Location Details	
DS Manhole A-59	Length surveyed 160.5	Year Renewed	Height 8	Width 8	Pipe Joint... 4

SPR 6	MPR N/A	PO Number 4397-03	Customer GRW
SPRI 3	MPRI N/A	Work Order 4397-02	Purpose Pre-Rehabilitation Survey
QSR 5111	QMR N/A		
OPR 6	Surveyed By Charlie Gordon	Direction Downstream	Date 20150901
OPRI 3	Certificate Number U-615-07000491	Pre-Cleaning No Pre-Cleaning	Time 14:15
	Date Cleaned	End Time 14:31	Weather Dry
			Media label
			Additional Info

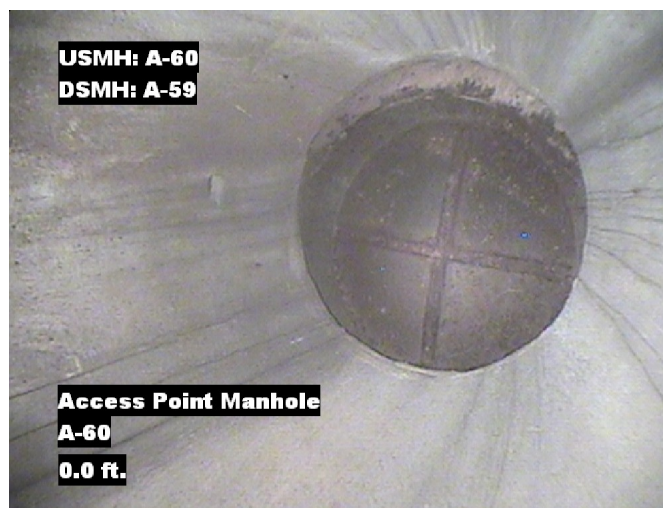
Distance: 0.0 ft. Grade: 0
Condition: Access Point Manhole
Remarks: A-60

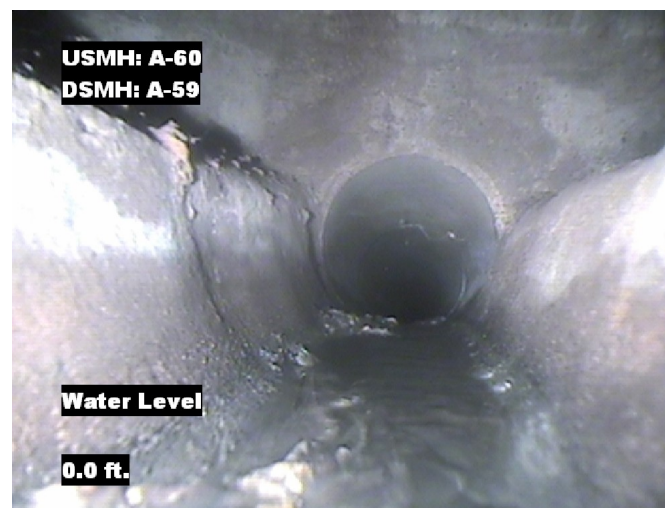
Distance: 0.0 ft. Grade: 0
Condition: Water Level
Remarks: N/A

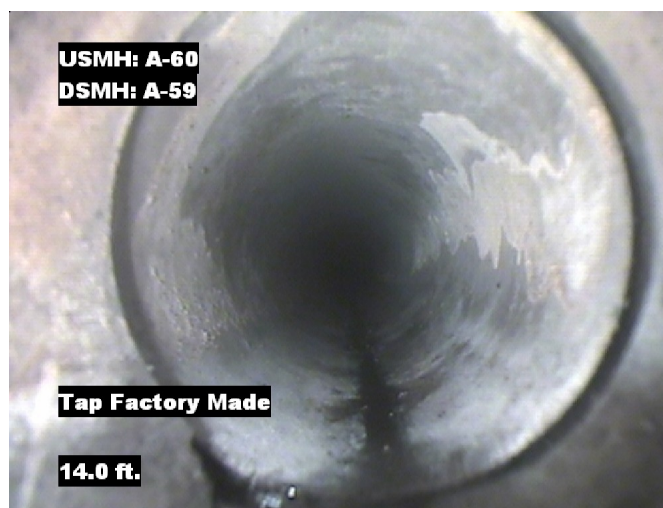
Distance: 14.0 ft. Grade: 0
Condition: Tap Factory Made
Remarks: N/A

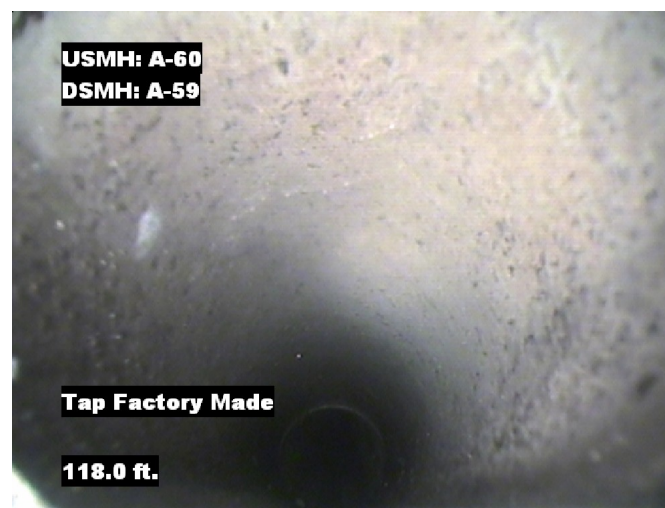
Distance: 118.0 ft. Grade: 0
Condition: Tap Factory Made
Remarks: N/A

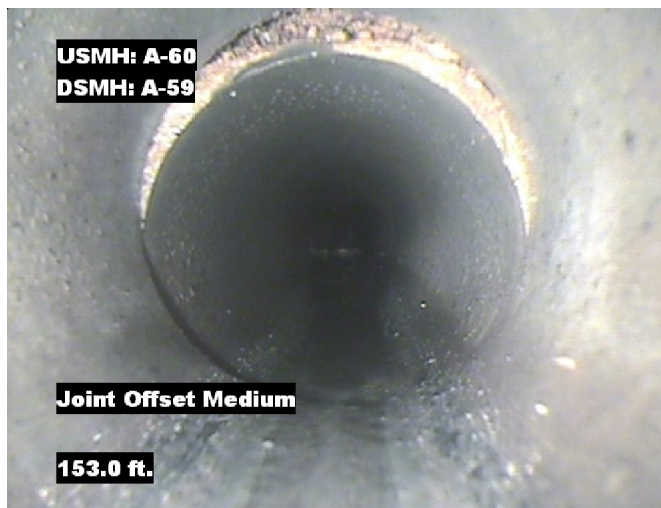
Distance: 153.0 ft. Grade: 1
Condition: Joint Offset Medium
Remarks: N/A

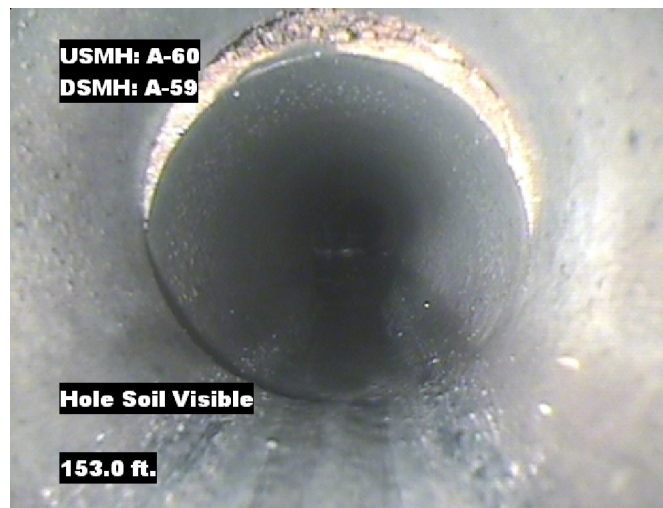
Distance: 153.0 ft. Grade: 5
Condition: Hole Soil Visible
Remarks: N/A

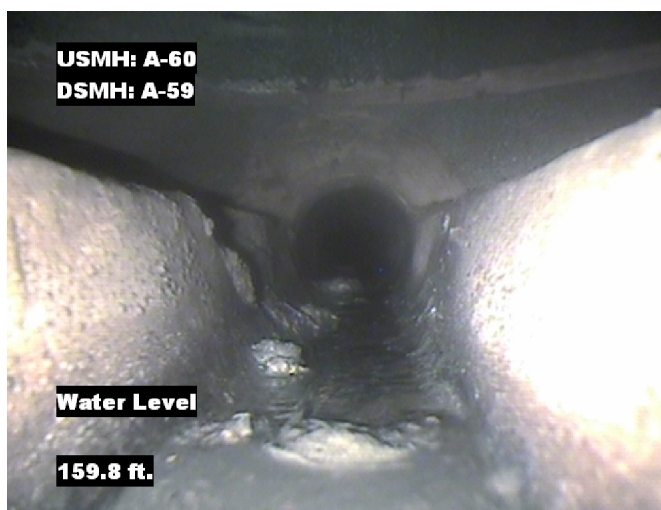
Distance: 159.8 ft. Grade: 0
Condition: Water Level
Remarks: N/A

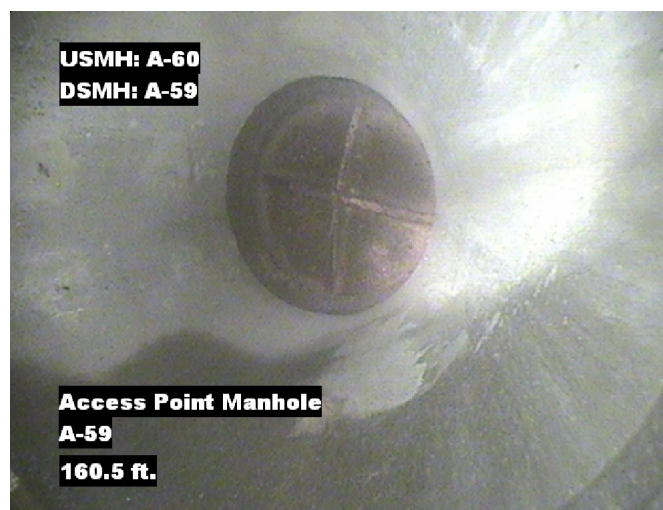
Distance: 160.5 ft. Grade: 0
Condition: Access Point Manhole
Remarks: A-59
