Defect Listing

Pipe Segment Refere... A-61_A-60	City Oliver Springs	Street Green St.	Material Concrete Pipe (non-...	Location C... Light High...	Sewer Use Sanitary
Upstream MH A-61	Total Length 359	Year Laid	Shape Circular	Location Details	
DS Manhole A-60	Length surveyed 359	Year Renewed	Height 8	Width 8	Pipe Joint... 4

SPR N/A	MPR N/A	PO Number 4397-03	Customer GRW
SPRI N/A	MPRI N/A	Work Order 4397-02	Purpose Pre-Rehabilitation Survey
QSR N/A	QMR N/A		
OPR N/A	Surveyed By Charlie Gordon	Direction Downstream	Date 20150901
OPRI N/A	Certificate Number U-615-07000491	Pre-Cleaning No Pre-Cleaning	Time 13:50
	Date Cleaned	End Time 14:10	Weather Dry
		Additional Info

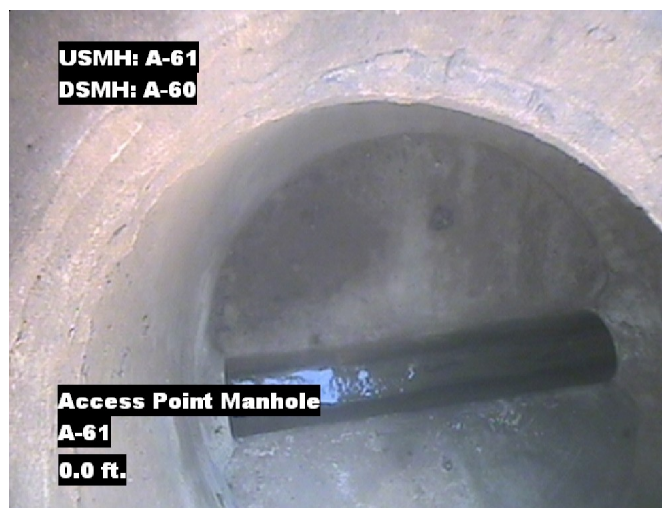
Distance: 0.0 ft. Grade: 0
Condition: Access Point Manhole
Remarks: A-61

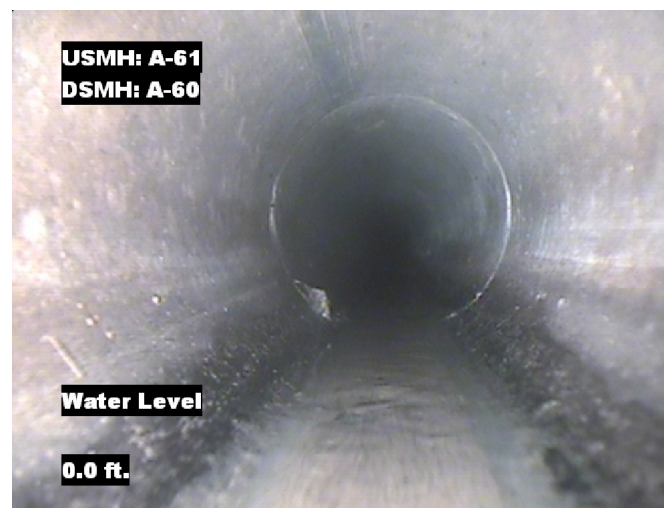
Distance: 0.0 ft. Grade: 0
Condition: Water Level
Remarks: N/A

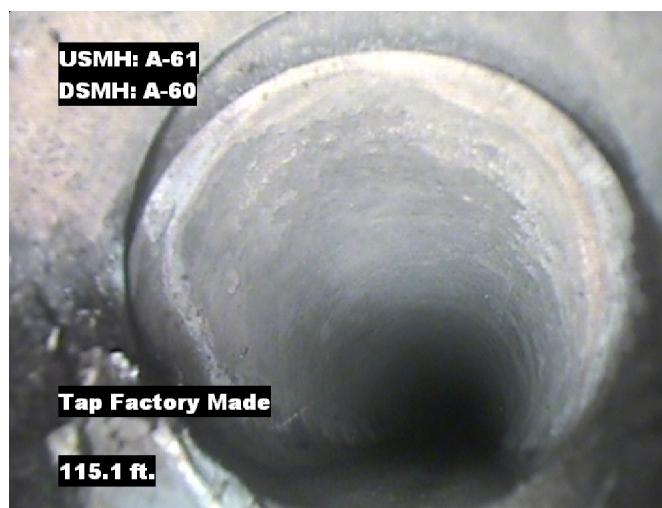
Distance: 115.1 ft. Grade: 0
Condition: Tap Factory Made
Remarks: N/A

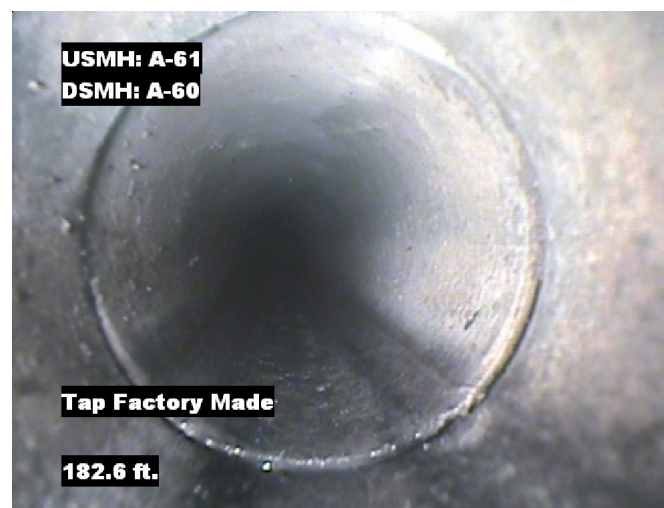
Distance: 182.6 ft. Grade: 0
Condition: Tap Factory Made
Remarks: N/A

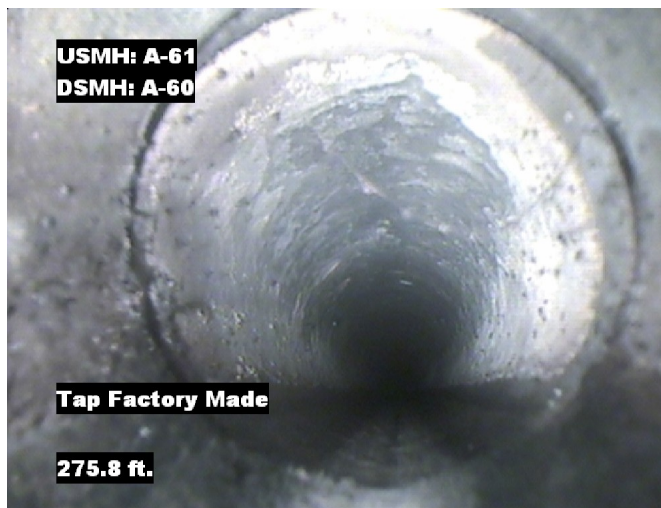
Distance: 275.8 ft. Grade: 0
Condition: Tap Factory Made
Remarks: N/A

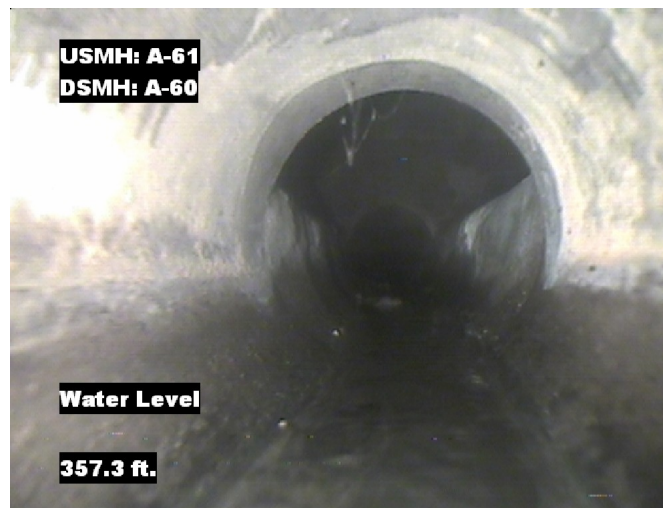
Distance: 357.4 ft. Grade: 0
Condition: Water Level
Remarks: N/A

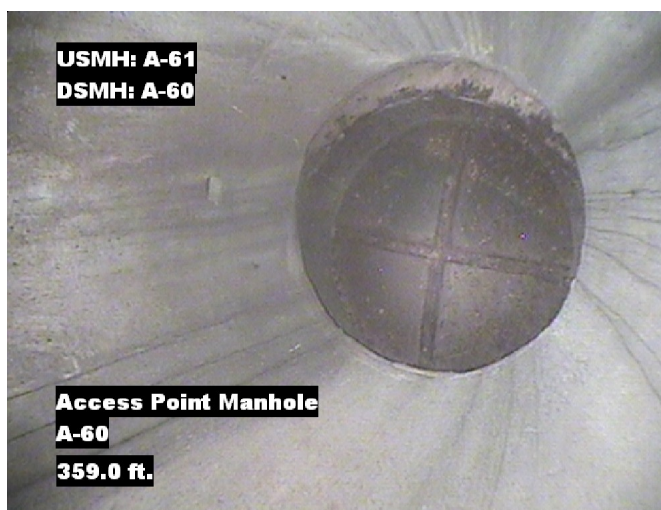
Distance: 359.0 ft. Grade: 0
Condition: Access Point Manhole
Remarks: A-60
