### Defect Listing

Pipe Segment Refere... <b>A-62_A-61</b>	<b>City</b> <b>Oliver Springs</b>	<b>Street</b> <b>Green St</b>	<b>Material</b> <b>Concrete Pipe (non-...</b>	<b>Location C...</b> <b>Light High...</b>	<b>Sewer Use</b> <b>Sanitary</b>
<b>Upstream MH</b> <b>A-62</b>	Total Length <b>238.9</b>	Year Laid	<b>Shape</b> <b>Circular</b>	Location Details	
<b>DS Manhole</b> <b>A-61</b>	<b>Length surveyed</b> <b>238.9</b>	Year Renewed	<b>Height</b> <b>8</b>	Width <b>8</b>	Pipe Joint... <b>4</b>

SPR <b>5</b>	MPR <b>2</b>	PO Number <b>4397-03</b>		<b>Customer</b> <b>GRW</b>	
SPRI <b>5</b>	MPRI <b>2</b>	Work Order <b>4397-02</b>		Purpose <b>Pre-Rehabilitation Survey</b>	
QSR <b>5100</b>	QMR <b>2100</b>	<b>Direction</b> <b>Downstream</b>	<b>Date</b> <b>20150728</b>	<b>Media label</b>	
OPR <b>7</b>	<b>Surveyed By</b> <b>Barry_Rogers</b>	<b>Pre-Cleaning</b> <b>Jetting</b>	<b>Time</b> <b>08:40</b>	<b>Weather</b> <b>Dry</b>	
OPRI <b>3.5</b>	<b>Certificate Number</b> <b>U-1012-16405</b>	<b>Date Cleaned</b> <b>20150728</b>	<b>End Time</b> <b>08:53</b>	<b>Additional Info</b>

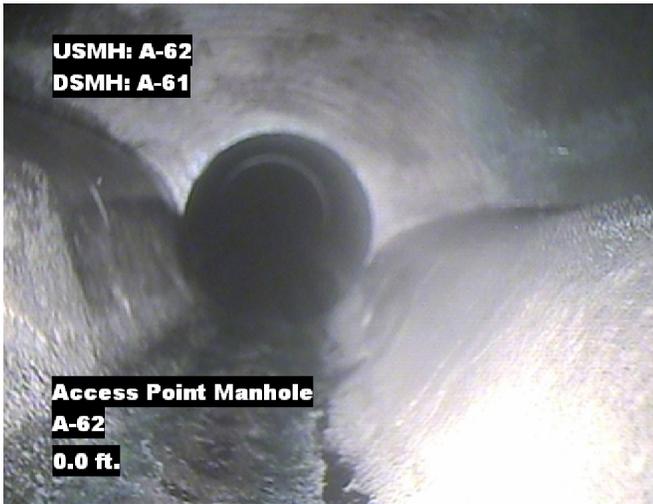
Distance: 0.0 ft.      Grade: 0  
 Condition: Access Point Manhole  
 Remarks: A-62

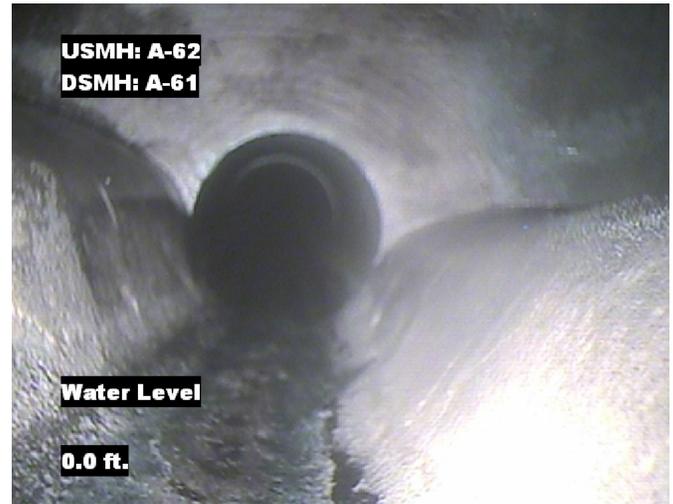
Distance: 0.0 ft.      Grade: 0  
 Condition: Water Level  
 Remarks: N/A

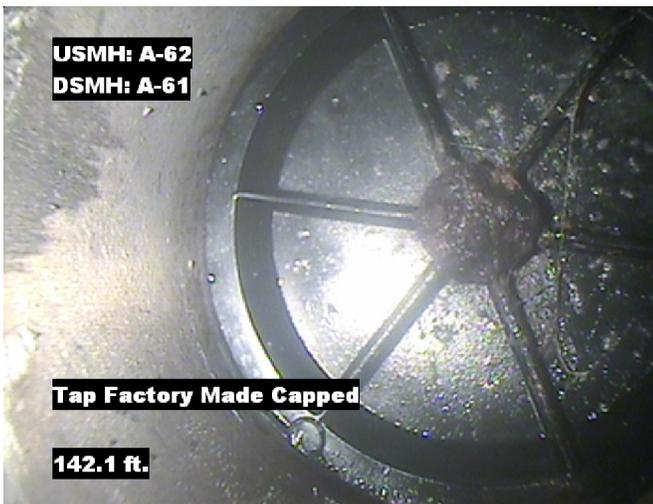
Distance: 142.1 ft.      Grade: 0  
 Condition: Tap Factory Made Capped  
 Remarks: N/A

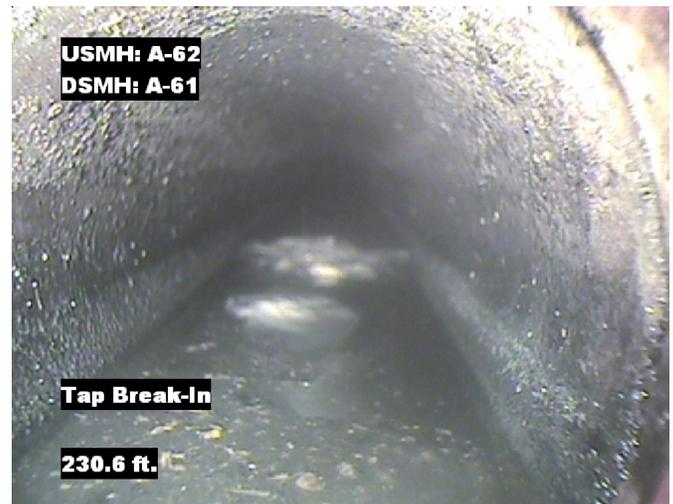
Distance: 230.6 ft.      Grade: 0  
 Condition: Tap Break-In  
 Remarks: N/A

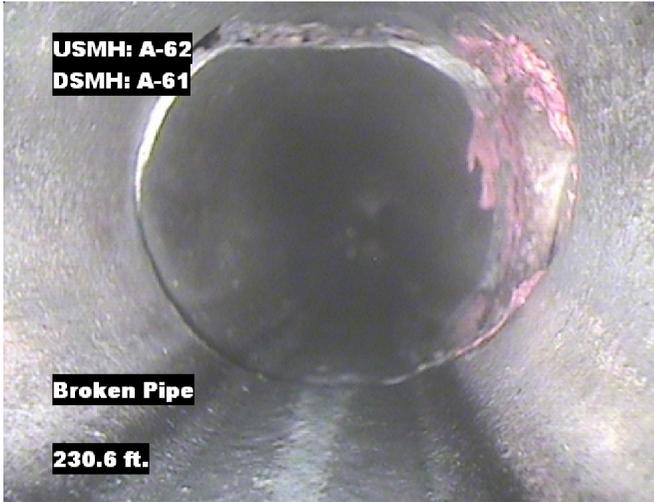
**Distance:** 230.6 ft.      **Grade:** 5  
**Condition:** Broken Pipe  
**Remarks:** N/A

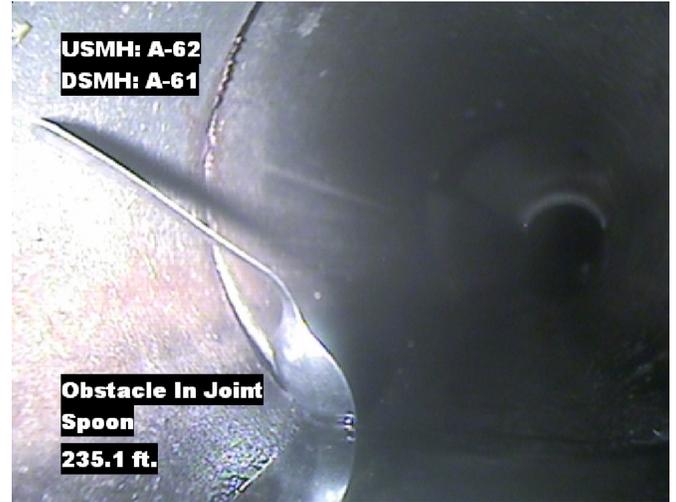
**Distance:** 235.1 ft.      **Grade:** 2  
**Condition:** Obstacle In Joint  
**Remarks:** Spoon

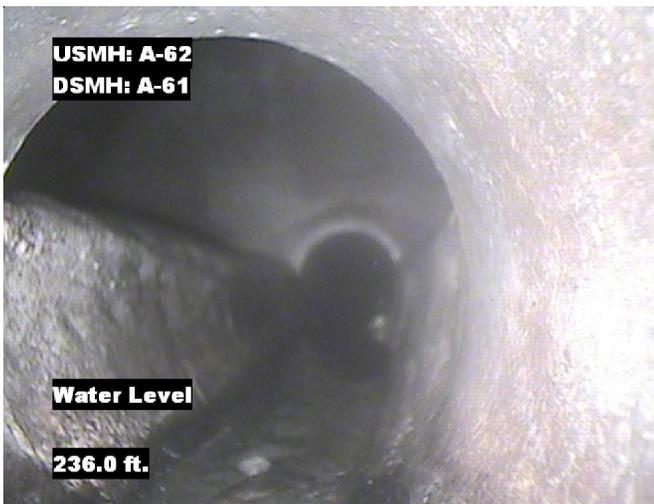
**Distance:** 236.0 ft.      **Grade:** 0  
**Condition:** Water Level  
**Remarks:** N/A

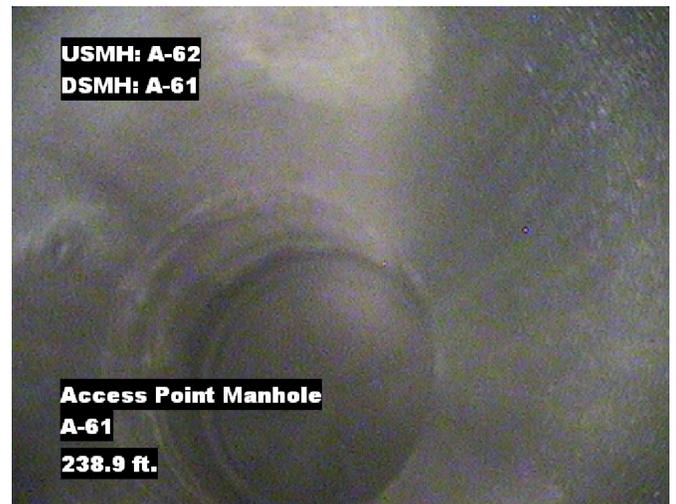
**Distance:** 238.9 ft.      **Grade:** 0  
**Condition:** Access Point Manhole  
**Remarks:** A-61
