Defect Listing

Pipe Segment Refere... A-64_A-63	City Oliver Springs	Street Lookout Avenue	Material Concrete Pipe (non-...	Location C... Light High...	Sewer Use Sanitary
Upstream MH A-64	Total Length 195.1	Year Laid	Shape Circular	Location Details	
DS Manhole A-63	Length surveyed 107.4	Year Renewed	Height 8	Width 8	Pipe Joint... 4

Image Report 4/Page

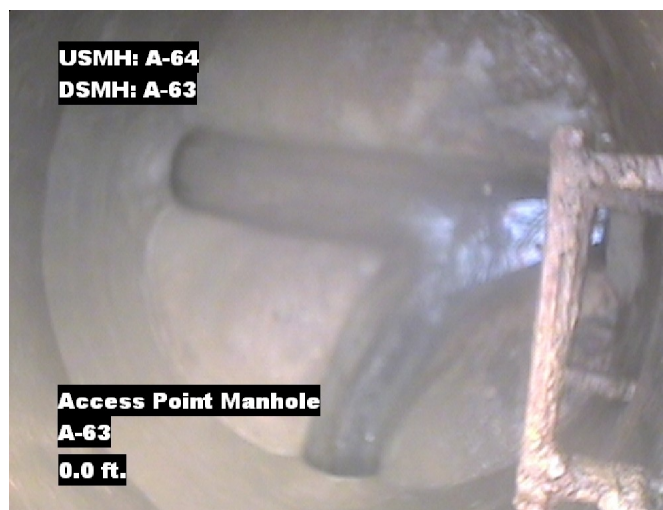
Distance: 0.0 ft. Grade: 0
Condition: Access Point Manhole
Remarks: A-63

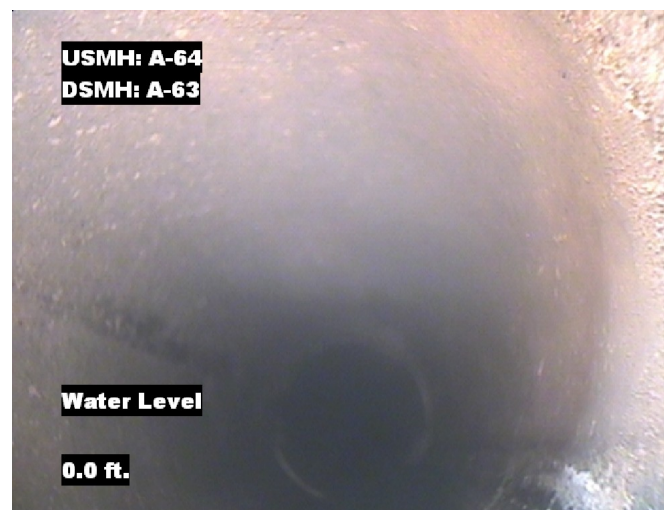
Distance: 0.0 ft. Grade: 0
Condition: Water Level
Remarks: N/A

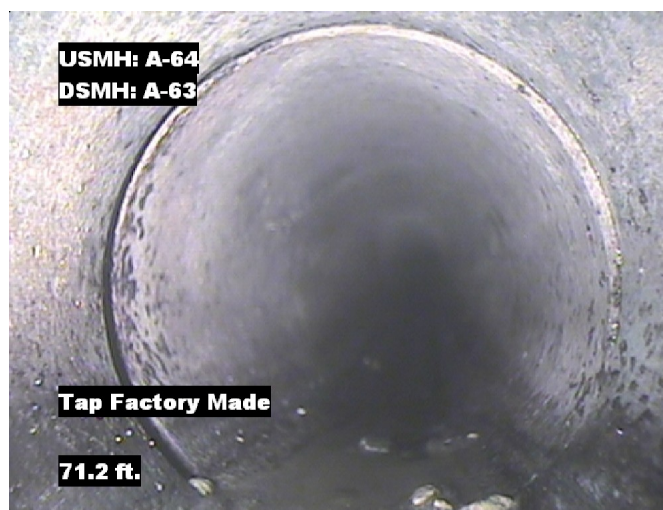
Distance: 71.2 ft. Grade: 0
Condition: Tap Factory Made
Remarks: N/A

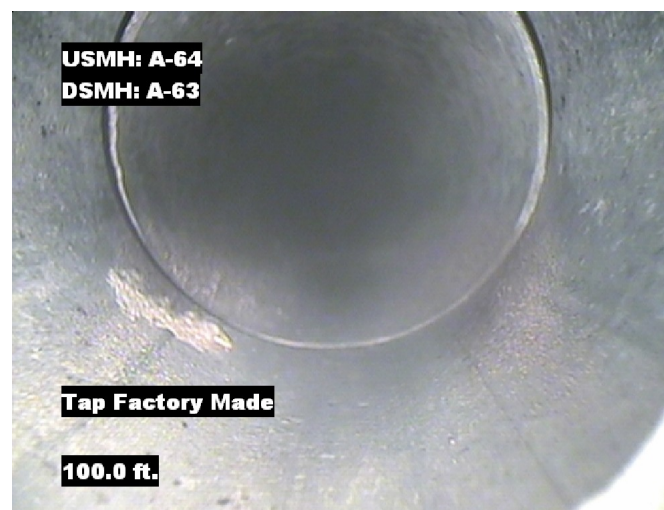
Distance: 100.0 ft. Grade: 0
Condition: Tap Factory Made
Remarks: N/A

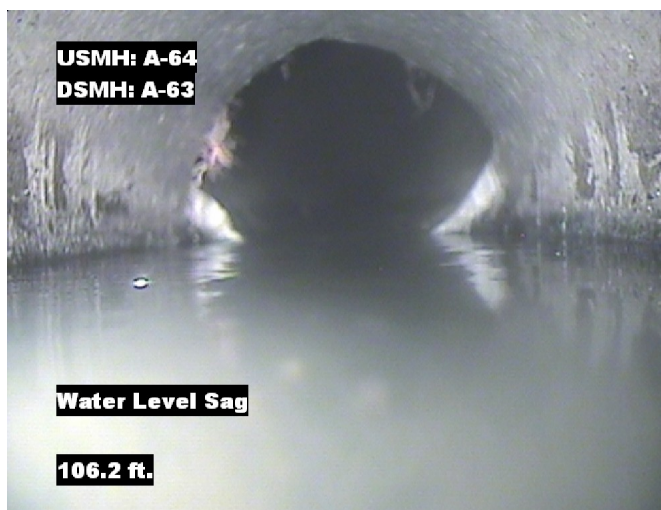
Distance: 106.2 ft. Grade: 3
Condition: Water Level Sag
Remarks: N/A

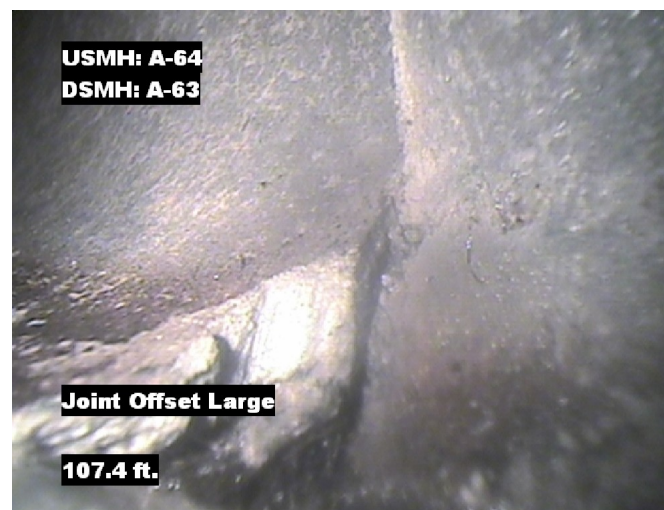
Distance: 107.4 ft. Grade: 2
Condition: Joint Offset Large
Remarks: N/A

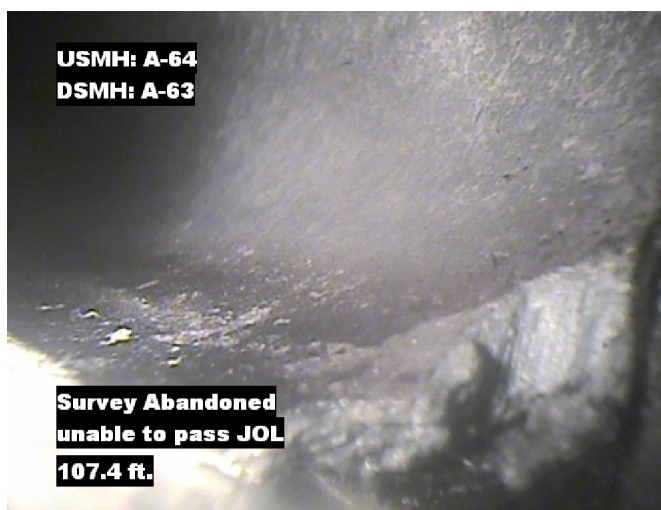
Distance: 107.4 ft. Grade: 0
Condition: Survey Abandoned
Remarks: unable to pass JOL
