Defect Listing

Pipe Segment Refere... A-65_A-64	City Oliver Springs	Street Lookout	Material Concrete Pipe (non-...	Location C... Light High...	Sewer Use Sanitary
Upstream MH A-65	Total Length 166.1	Year Laid	Shape Circular	Location Details	
DS Manhole A-64	Length surveyed 166.1	Year Renewed	Height 8	Width 8	Pipe Joint... 4

SPR N/A	MPR 2	PO Number 4397-03		Customer GRW	
SPRI N/A	MPRI 2	Work Order 4397-02		Purpose Pre-Rehabilitation Survey	
QSR N/A	QMR 2100				
OPR 2	Surveyed By Barry Rogers	Direction Downstream	Date 20150727	Media label	
OPRI 2	Certificate Number U-1012-16405	Pre-Cleaning Jetting	Time 14:41	Weather Dry	
Date Cleaned 20150727			End Time 14:53	Additional Info

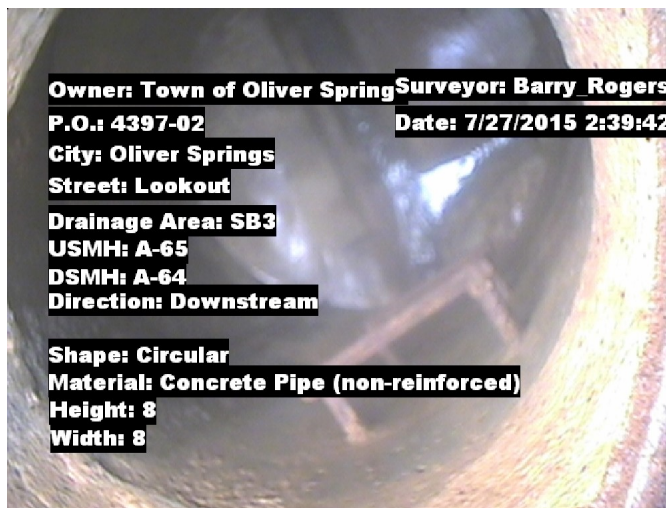
Distance: 0.0 ft. Grade: 0
Condition: Access Point Manhole
Remarks: A-65

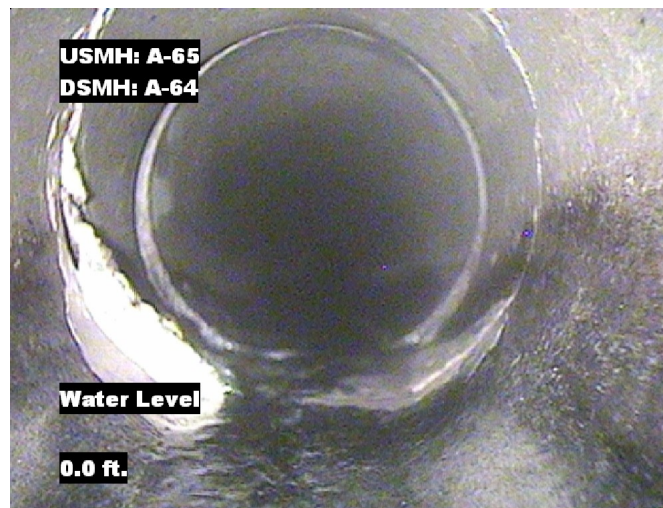
Distance: 0.0 ft. Grade: 0
Condition: Water Level
Remarks: N/A

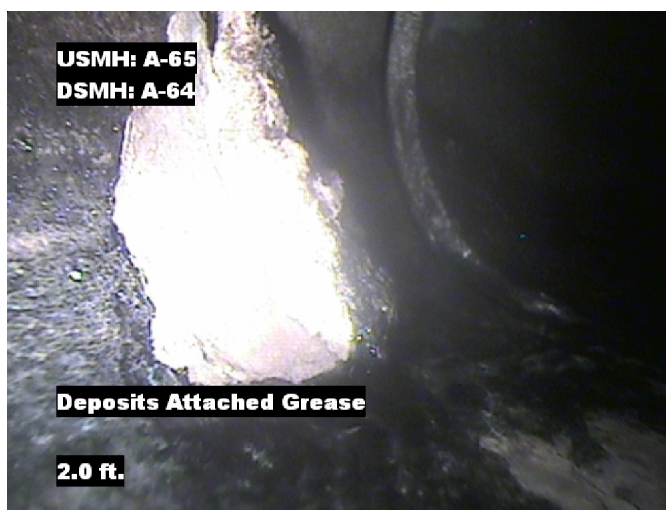
Distance: 2.0 ft. Grade: 2
Condition: Deposits Attached Grease
Remarks: N/A

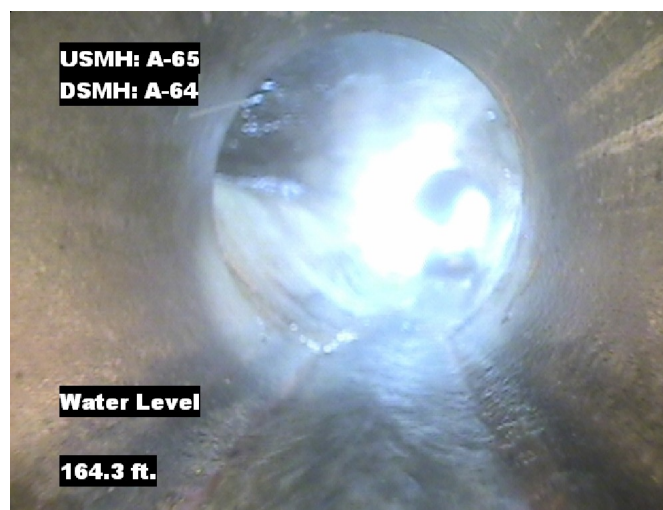
Distance: 164.2 ft. Grade: 0
Condition: Water Level
Remarks: N/A

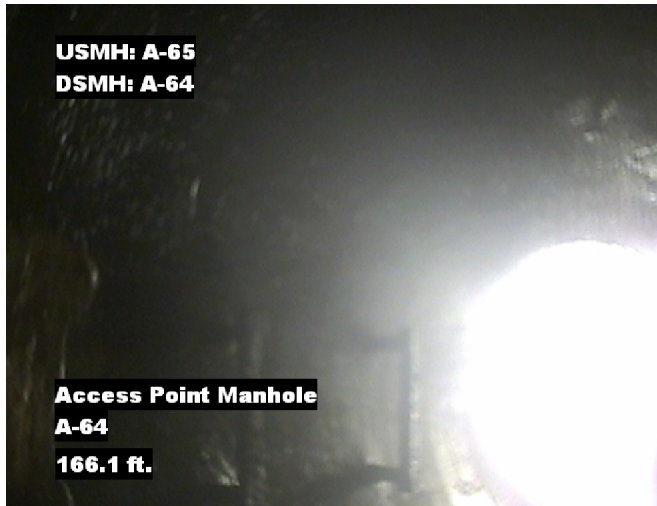
Distance: 166.1 ft. Grade: 0
Condition: Access Point Manhole
Remarks: A-64
