## Defect Listing

Pipe Segment Refere... <b>A-66_A-65</b>	<b>City</b> <b>Oliver Springs</b>	<b>Street</b> <b>Lookout Avenue</b>	<b>Material</b> <b>Concrete Pipe (non-...</b>	<b>Location C...</b> <b>Light High...</b>	<b>Sewer Use</b> <b>Sanitary</b>
<b>Upstream MH</b> <b>A-66</b>	Total Length <b>193.7</b>	Year Laid	<b>Shape</b> <b>Circular</b>	Location Details	
<b>DS Manhole</b> <b>A-65</b>	<b>Length surveyed</b> <b>193.7</b>	Year Renewed	<b>Height</b> <b>8</b>	Width <b>8</b>	Pipe Joint... <b>4</b>

SPR <b>6</b>	MPR <b>4</b>	PO Number <b>4397-03</b>	<b>Customer</b> <b>GRW</b>
SPRI <b>1.5</b>	MPRI <b>4</b>	Work Order <b>4397-02</b>	Purpose <b>Pre-Rehabilitation Survey</b>
QSR <b>3113</b>	QMR <b>4100</b>		
OPR <b>10</b>	<b>Surveyed By</b> <b>Barry Rogers</b>	<b>Direction</b> <b>Upstream</b>	<b>Date</b> <b>20150727</b>
OPRI <b>2</b>	<b>Certificate Number</b> <b>U-1012-16405</b>	<b>Pre-Cleaning</b> <b>Jetting</b>	<b>Time</b> <b>12:54</b>
	<b>Date Cleaned</b> <b>20150727</b>	<b>End Time</b> <b>13:05</b>	<b>Weather</b> <b>Dry</b>
			<b>Media label</b>
			<b>Additional Info</b>

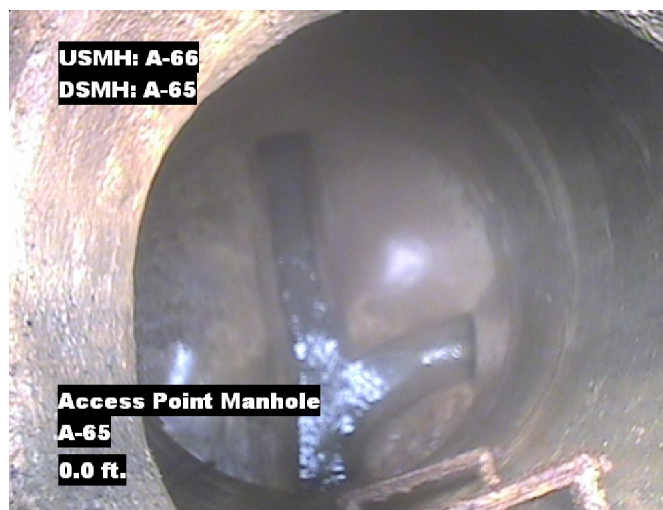
Distance: 0.0 ft. Grade: 0  
Condition: Access Point Manhole  
Remarks: A-65

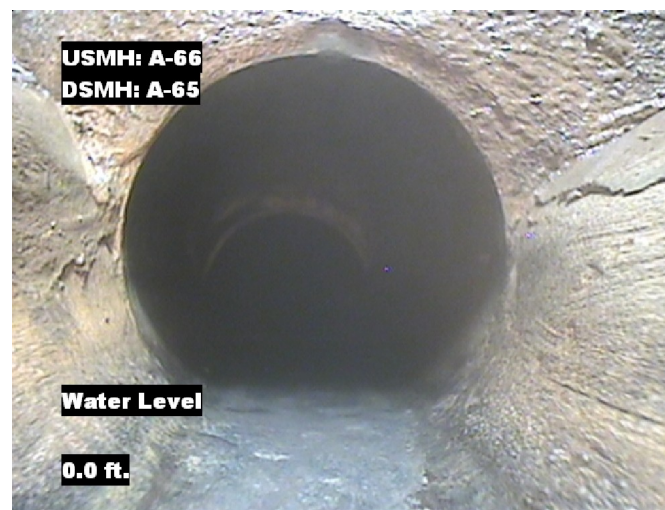
Distance: 0.0 ft. Grade: 0  
Condition: Water Level  
Remarks: N/A

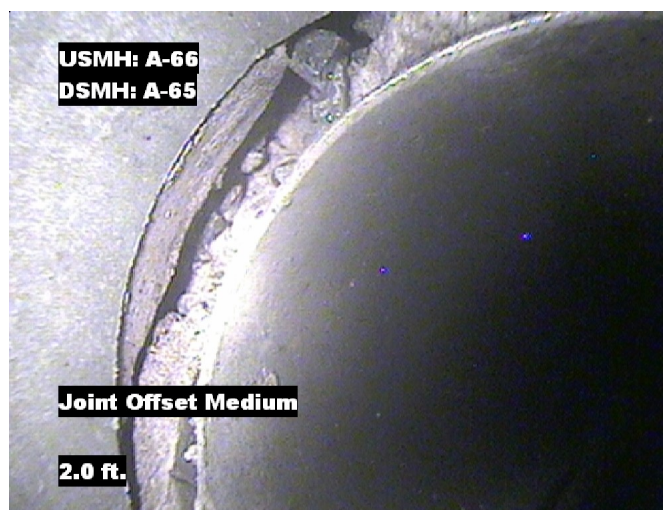
Distance: 2.0 ft. Grade: 1  
Condition: Joint Offset Medium  
Remarks: N/A

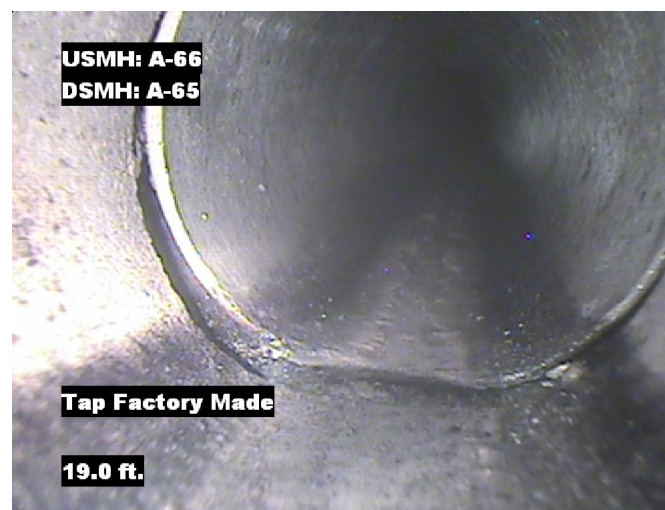
Distance: 19.0 ft. Grade: 0  
Condition: Tap Factory Made  
Remarks: N/A

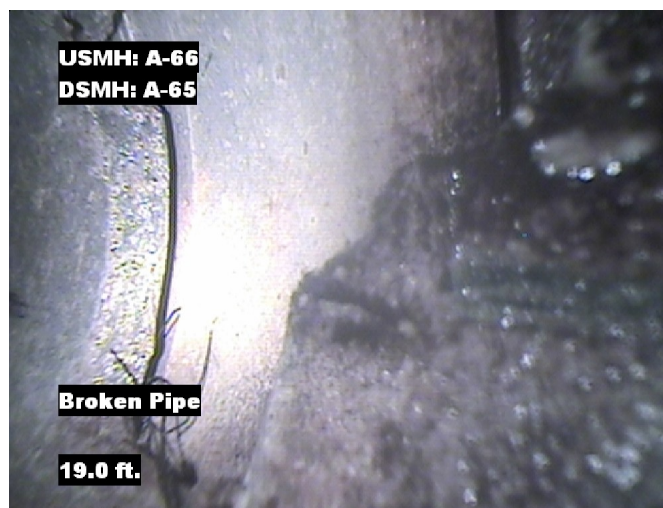
Distance: 19.0 ft. Grade: 3  
Condition: Broken Pipe  
Remarks: N/A

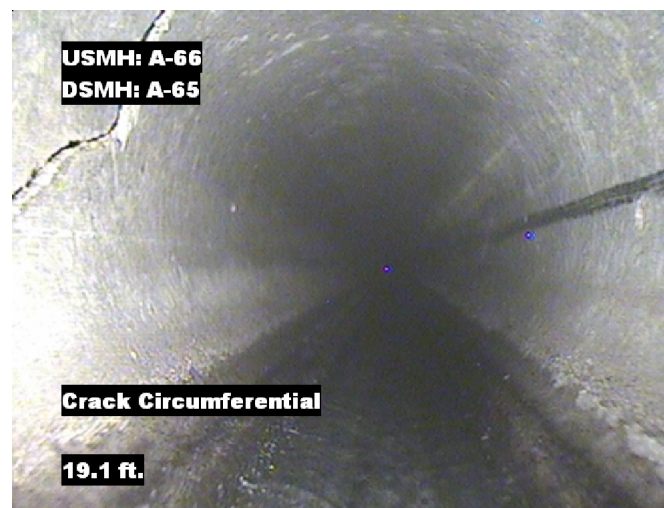
Distance: 19.1 ft. Grade: 1  
Condition: Crack Circumferential  
Remarks: N/A

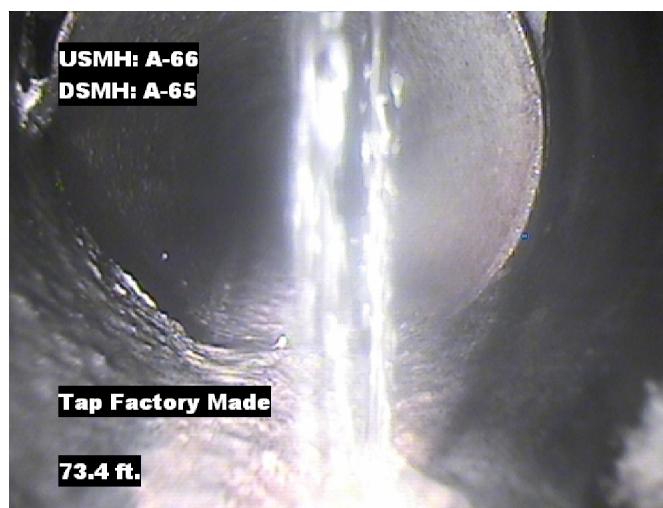
Distance: 73.4 ft. Grade: 0  
Condition: Tap Factory Made  
Remarks: N/A

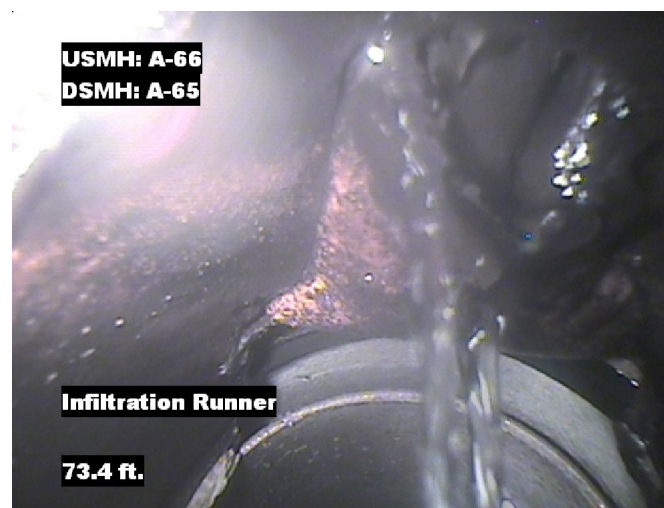
Distance: 73.4 ft. Grade: 4  
Condition: Infiltration Runner  
Remarks: N/A

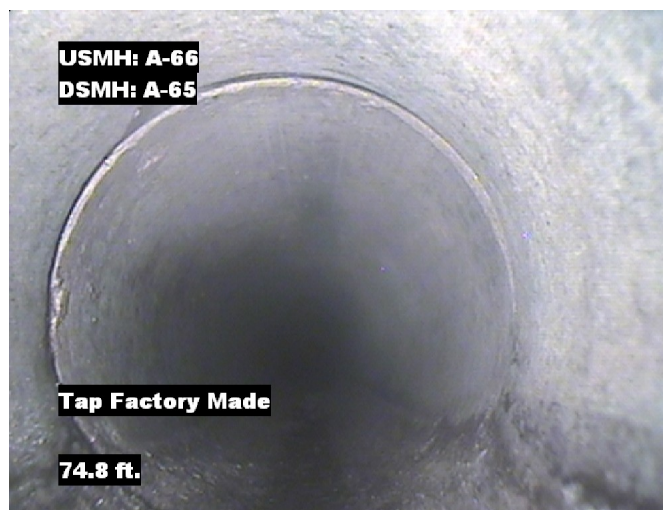
Distance: 74.8 ft. Grade: 0  
Condition: Tap Factory Made  
Remarks: N/A

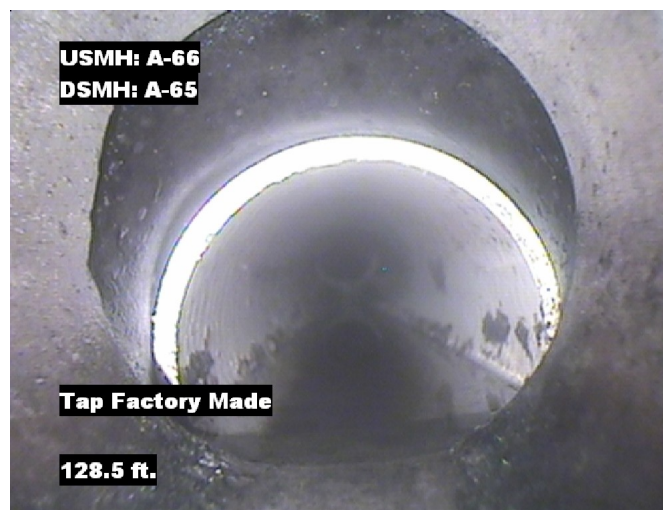
Distance: 128.5 ft. Grade: 0  
Condition: Tap Factory Made  
Remarks: N/A

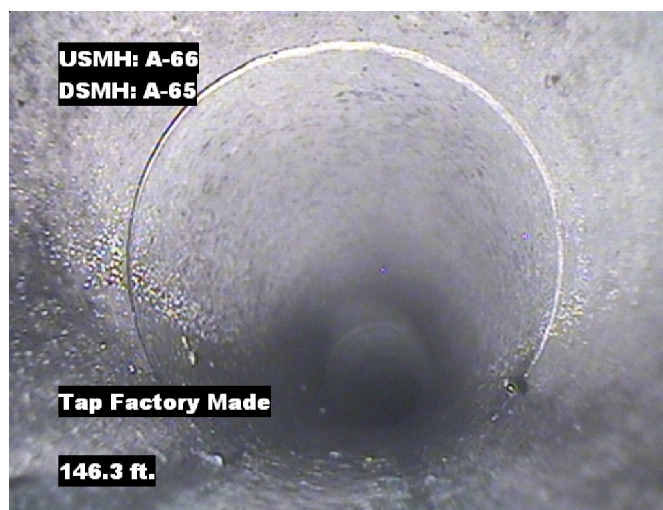
Distance: 146.3 ft. Grade: 0  
Condition: Tap Factory Made  
Remarks: N/A

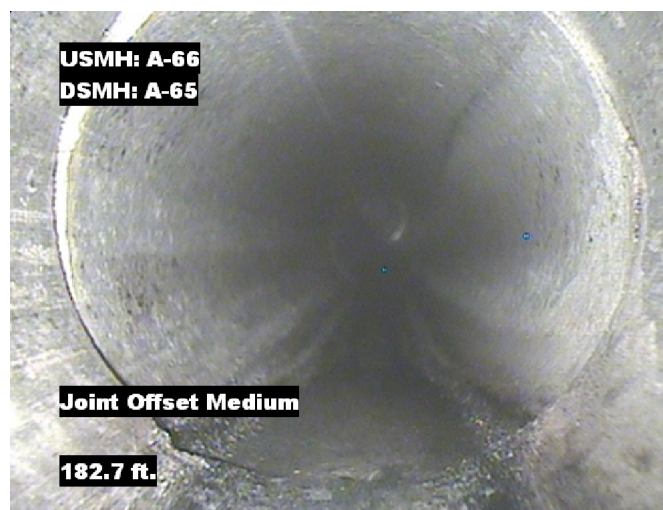
Distance: 182.7 ft. Grade: 1  
Condition: Joint Offset Medium  
Remarks: N/A

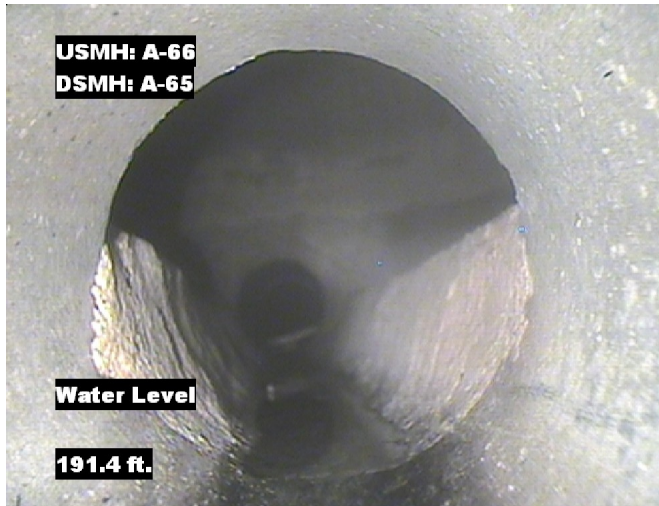
Distance: 191.4 ft. Grade: 0  
Condition: Water Level  
Remarks: N/A

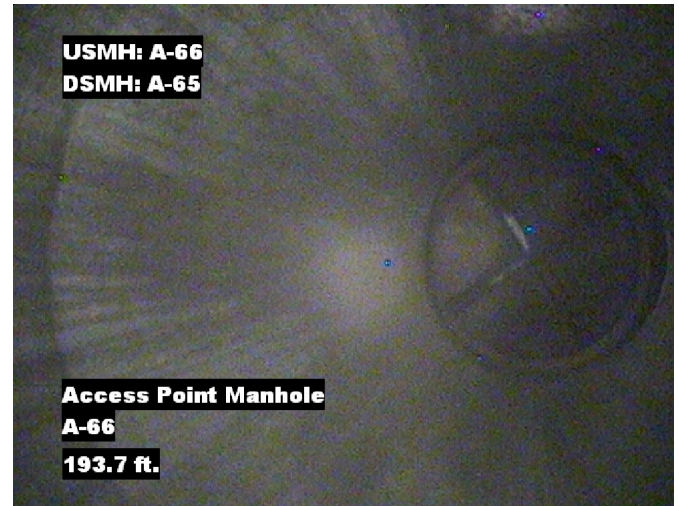
Distance: 193.7 ft. Grade: 0  
Condition: Access Point Manhole  
Remarks: A-66
