Defect Listing

Pipe Segment Refere... A-67_A-66	City Oliver Springs	Street lookout Ave.	Material Concrete Pipe (non-...	Location C... Light High...	Sewer Use Sanitary
Upstream MH A-67	Total Length 312.8	Year Laid	Shape Circular	Location Details	
DS Manhole A-66	Length surveyed 312.8	Year Renewed	Height 8	Width 8	Pipe Joint... 4

SPR 6	MPR N/A	PO Number 4397-03	Customer GRW
SPRI 1.5	MPRI N/A	Work Order 4397-02	Purpose Pre-Rehabilitation Survey
QSR 3113	QMR N/A		
OPR 6	Surveyed By Barry Rogers	Direction Downstream	Date 20150727
OPRI 1.5	Certificate Number U-1012-16405	Pre-Cleaning Jetting	Time 13:30
	Date Cleaned 20150727	End Time 13:46	Weather Dry
		Additional Info

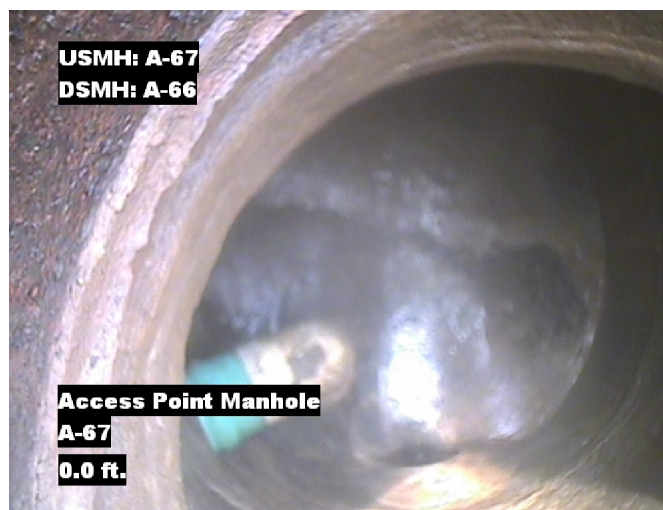
Distance: 0.0 ft. Grade: 0
Condition: Access Point Manhole
Remarks: A-67

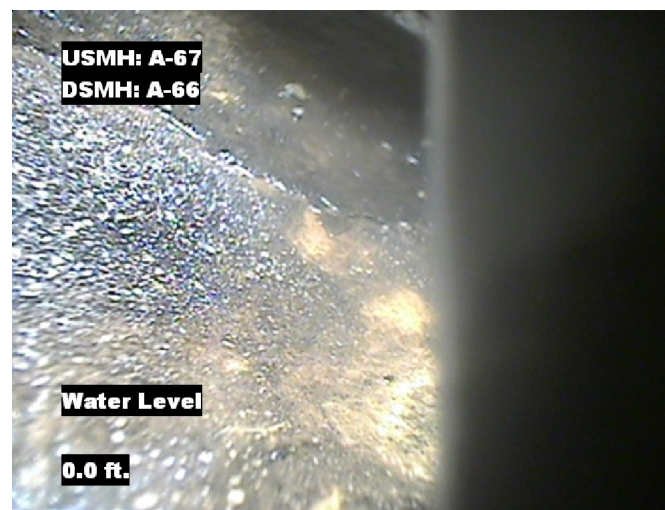
Distance: 0.0 ft. Grade: 0
Condition: Water Level
Remarks: N/A

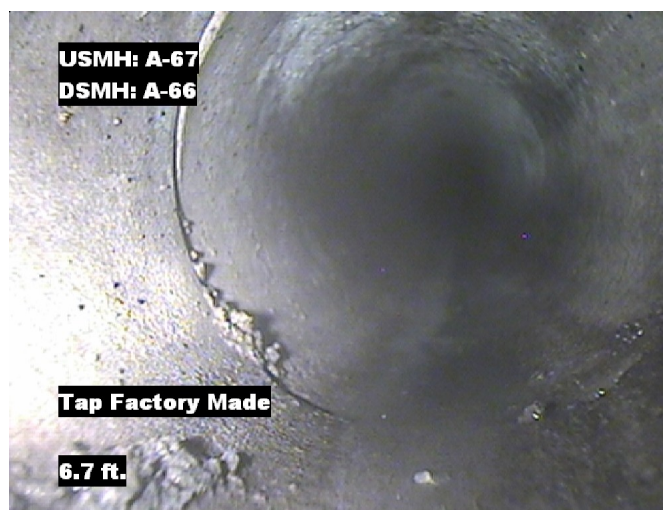
Distance: 6.7 ft. Grade: 0
Condition: Tap Factory Made
Remarks: N/A

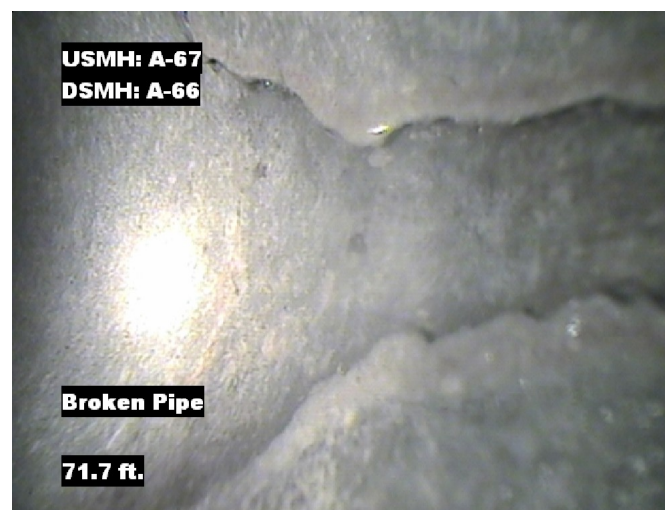
Distance: 71.7 ft. Grade: 3
Condition: Broken Pipe
Remarks: N/A

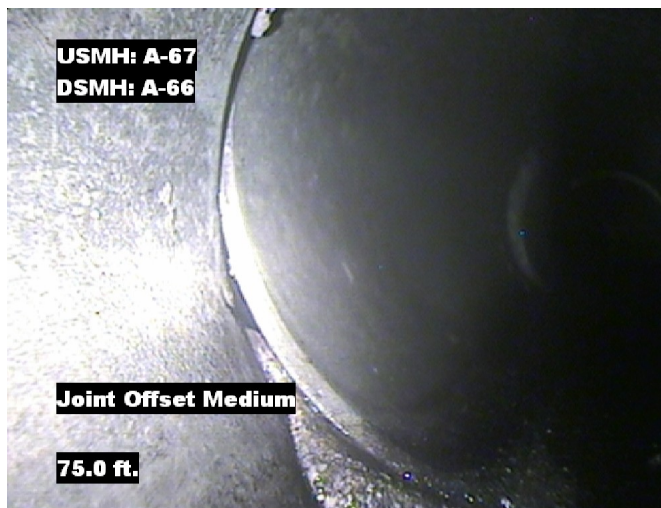
Distance: 75.0 ft. Grade: 1
Condition: Joint Offset Medium
Remarks: N/A

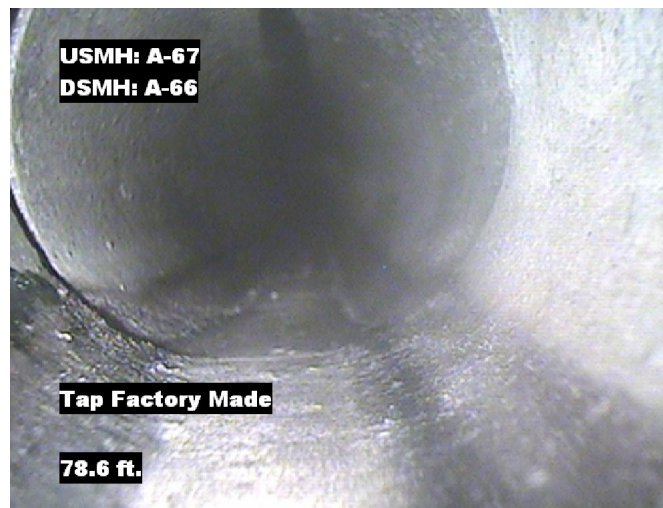
Distance: 78.6 ft. Grade: 0
Condition: Tap Factory Made
Remarks: N/A

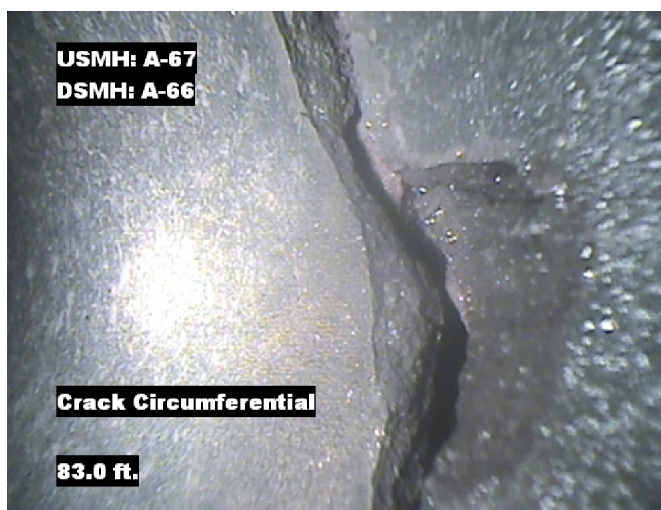
Distance: 83.0 ft. Grade: 1
Condition: Crack Circumferential
Remarks: N/A

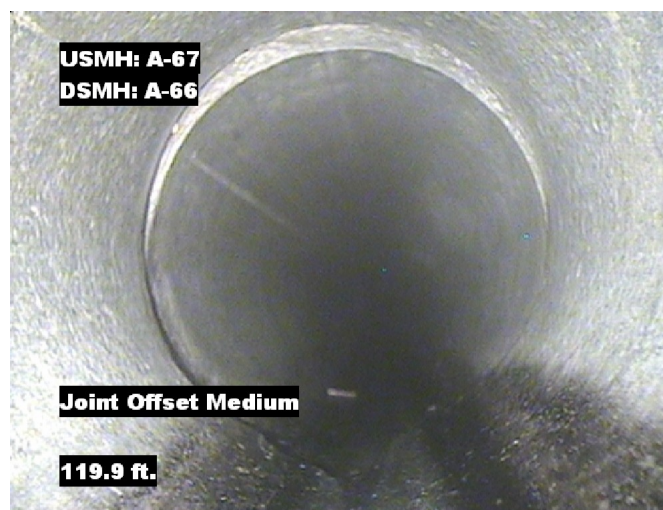
Distance: 119.9 ft. Grade: 1
Condition: Joint Offset Medium
Remarks: N/A

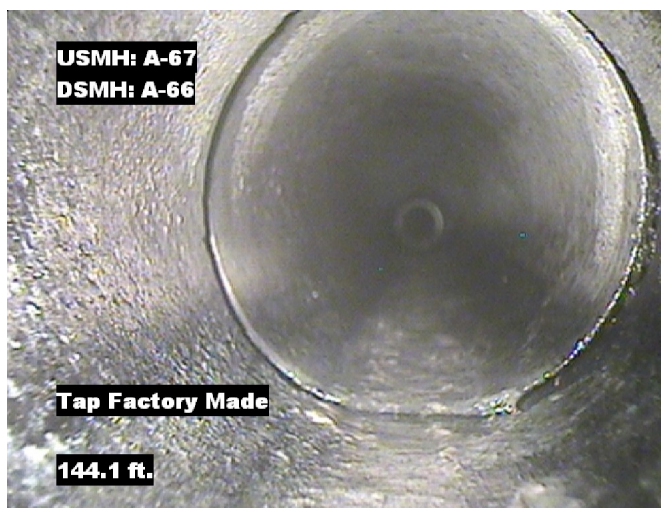
Distance: 144.1 ft. Grade: 0
Condition: Tap Factory Made
Remarks: N/A

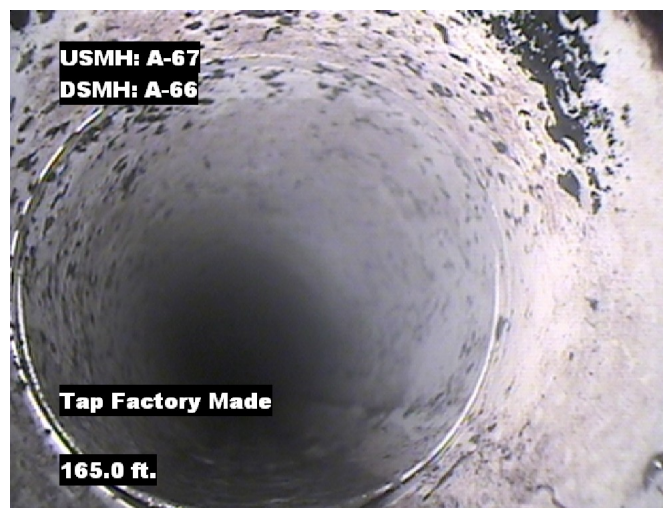
Distance: 165.0 ft. Grade: 0
Condition: Tap Factory Made
Remarks: N/A

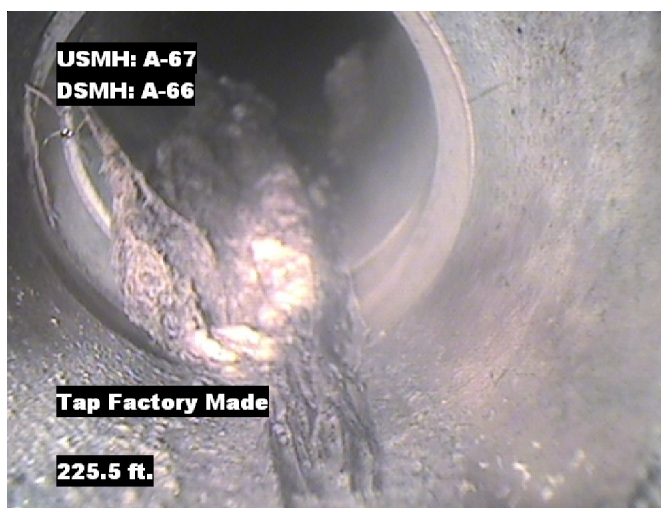
Distance: 225.5 ft. Grade: 0
Condition: Tap Factory Made
Remarks: N/A

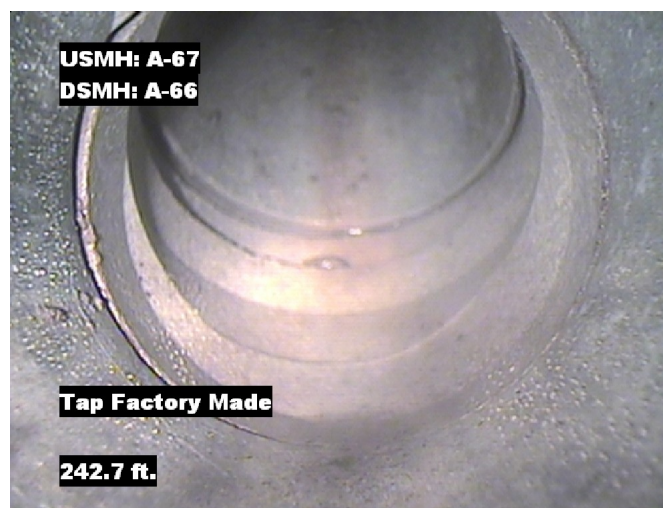
Distance: 242.7 ft. Grade: 0
Condition: Tap Factory Made
Remarks: N/A

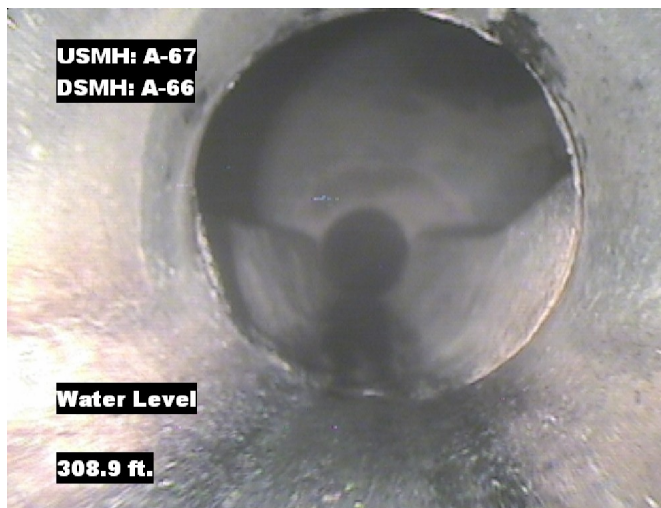
Distance: 308.8 ft. Grade: 0
Condition: Water Level
Remarks: N/A

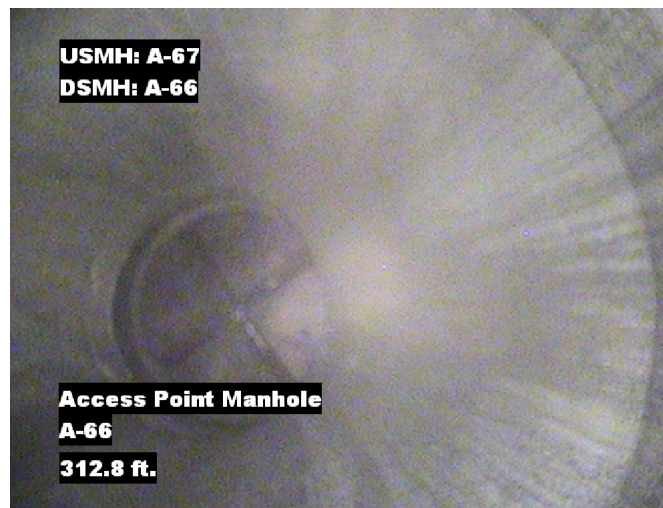
Distance: 312.8 ft. Grade: 0
Condition: Access Point Manhole
Remarks: A-66
