## Defect Listing

Pipe Segment Refere... <b>A1-2_A1-1</b>	City <b>Oliver Springs</b>	Street <b>Kington Ave</b>	Material <b>Concrete Pipe (non-...</b>	Location C... <b>Yard</b>	Sewer Use <b>Sanitary</b>
Upstream MH <b>A1-2</b>	Total Length <b>22.1</b>	Year Laid	Shape <b>Circular</b>	Location Details	
DS Manhole <b>A1-1</b>	Length surveyed <b>10.2</b>	Year Renewed	Height <b>8</b>	Width <b>8</b>	Pipe Joint... <b>4</b>

SPR <b>3</b>	MPR <b>4</b>	PO Number <b>4397-03</b>	Customer <b>GRW</b>
SPRI <b>3</b>	MPRI <b>4</b>	Work Order <b>4397-02</b>	Purpose <b>Pre-Rehabilitation Survey</b>
QSR <b>3100</b>	QMR <b>4100</b>		
OPR <b>7</b>	Surveyed By <b>Charlie Gordon</b>	Direction <b>Upstream</b>	Date <b>20150824</b>
OPRI <b>3.5</b>	Certificate Number <b>U-615-07000491</b>	Pre-Cleaning <b>Jetting</b>	Time <b>12:35</b>
	Date Cleaned <b>20150824</b>	End Time <b>12:40</b>	Weather <b>Dry</b>
		Additional Info <b>CAMERA CANNOT PASS ...</b>

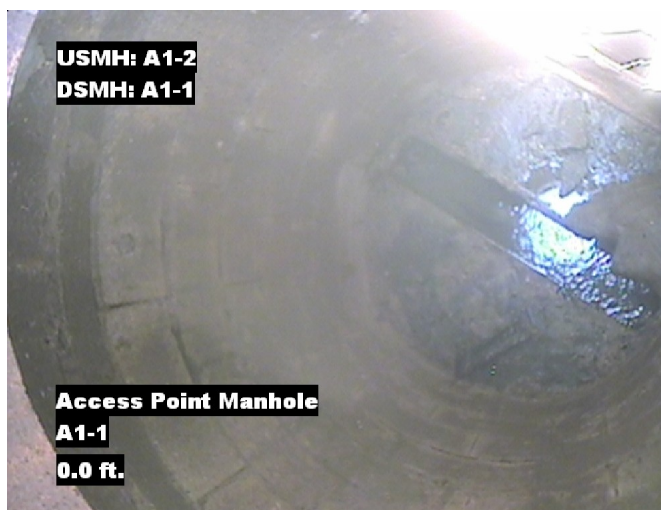
Distance: 0.0 ft. Grade: 0  
Condition: Access Point Manhole  
Remarks: A1-1

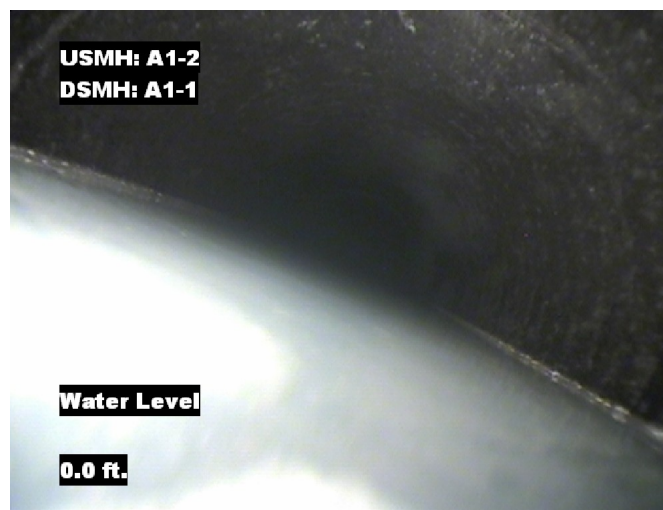
Distance: 0.0 ft. Grade: 0  
Condition: Water Level  
Remarks: N/A

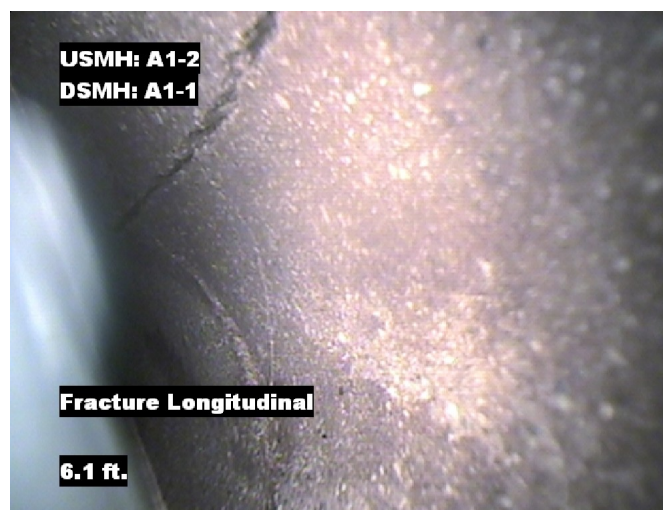
Distance: 6.1 ft. Grade: 3  
Condition: Fracture Longitudinal  
Remarks: N/A

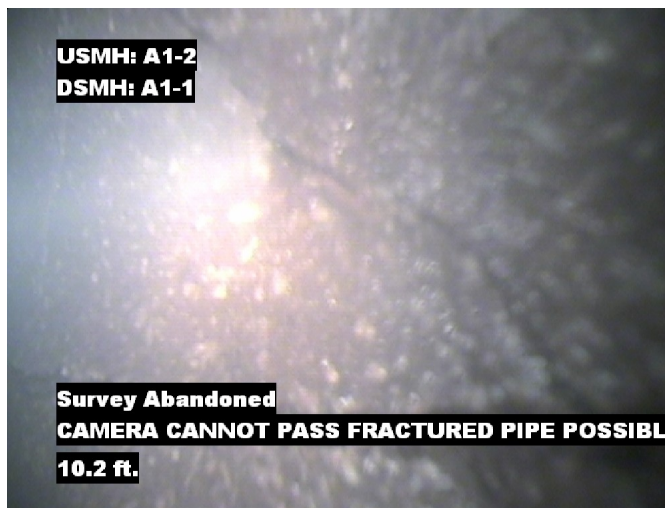
Distance: 10.2 ft. Grade: 0  
Condition: Survey Abandoned  
Remarks: CAMERA CANNOT PASS FRACTURED  
PIPE POSSIBLE BROKEN
