## Defect Listing

Pipe Segment Refere...	City	Street	Material	Location C...	Sewer Use
<b>A1-3_A1-2</b>	<b>Oliver springs</b>	<b>Kington ave</b>	<b>PolyVinyl Chloride</b>	<b>Yard</b>	<b>Sanitary</b>
Upstream MH	Total Length	Year Laid	Shape	Location Details	
<b>A1-3</b>	<b>254.1</b>		<b>Circular</b>		
DS Manhole	Length surveyed	Year Renewed	Height	Width	Pipe Joint...
<b>A1-2</b>	<b>254.1</b>		<b>8</b>	<b>8</b>	<b>13</b>

SPR	2	MPR	18	PO Number	Customer
SPRI	2	MPRI	2	<b>4397-03</b>	<b>GRW</b>
QSR	2100	QMR	2900	Work Order	Purpose
				<b>4397-02</b>	<b>Pre-Rehabilitation Survey</b>
OPR	20	Surveyed By	Direction	Date	Media label
OPRI	2	<b>Charlie Gordon</b>	<b>Upstream</b>	<b>20150824</b>	
		Certificate Number	Pre-Cleaning	Time	Weather
		<b>U-615-07000491</b>	<b>Jetting</b>	<b>10:18</b>	<b>Dry</b>
		Date Cleaned	End Time	Additional Info	
		<b>20150824</b>	<b>10:37</b>

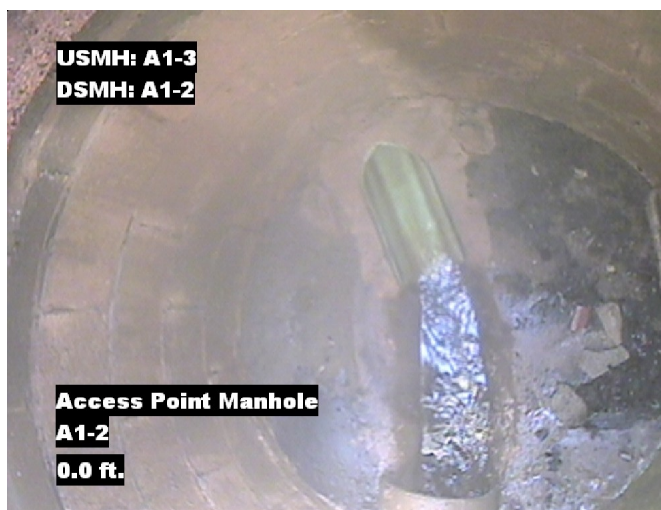
Distance: 0.0 ft. Grade: 0  
Condition: Access Point Manhole  
Remarks: A1-2

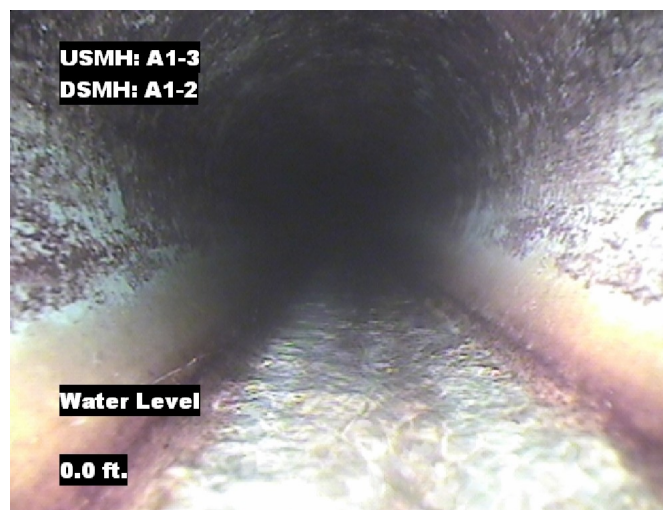
Distance: 0.0 ft. Grade: 0  
Condition: Water Level  
Remarks: N/A

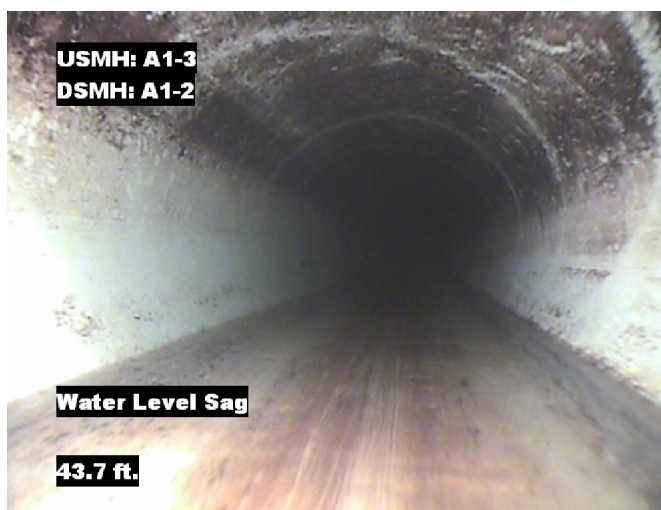
Distance: 43.7 ft. Grade: 2  
Condition: Water Level Sag  
Remarks: N/A

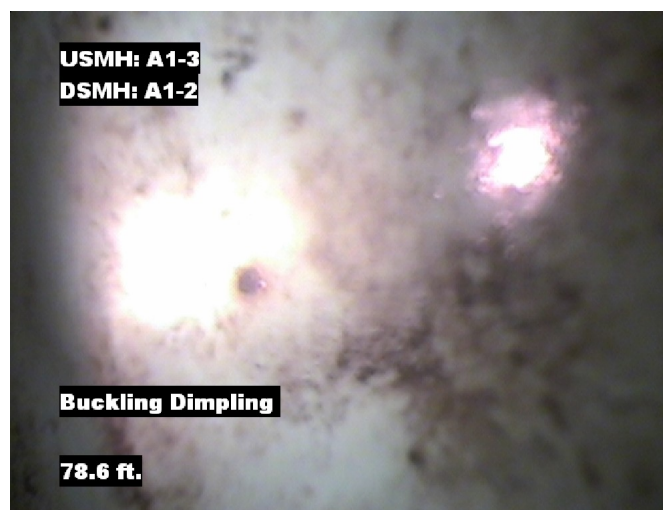
Distance: 78.6 ft. Grade: 0  
Condition: Buckling Dimpling  
Remarks: N/A

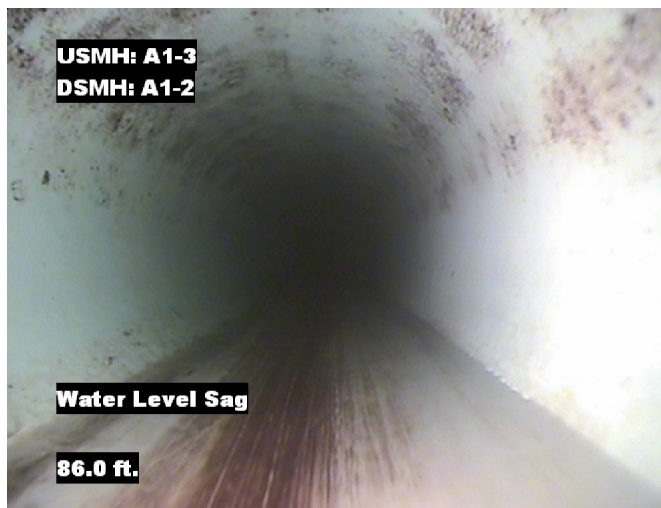
Distance: 86.0 ft. Grade: 2  
Condition: Water Level Sag  
Remarks: N/A

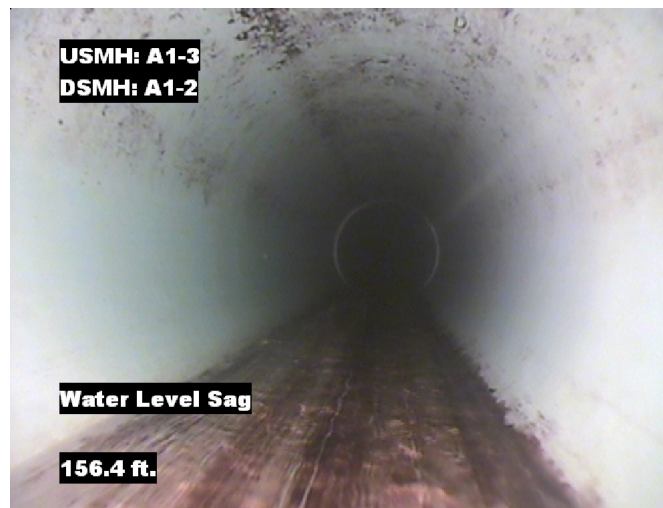
Distance: 156.4 ft. Grade: 2  
Condition: Water Level Sag  
Remarks: N/A

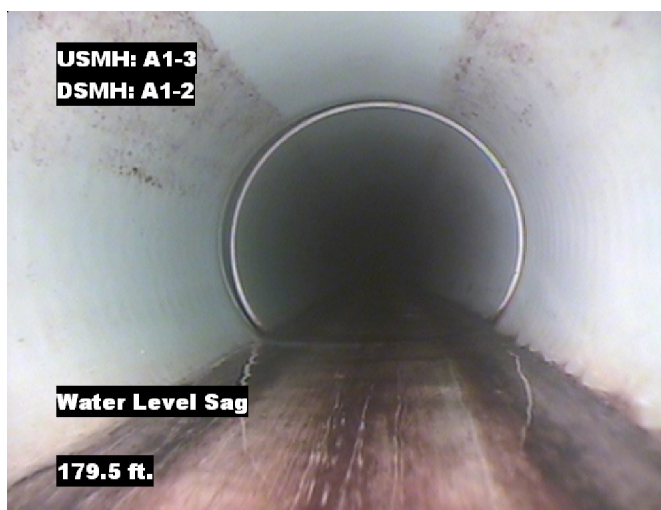
Distance: 179.5 ft. Grade: 2  
Condition: Water Level Sag  
Remarks: N/A

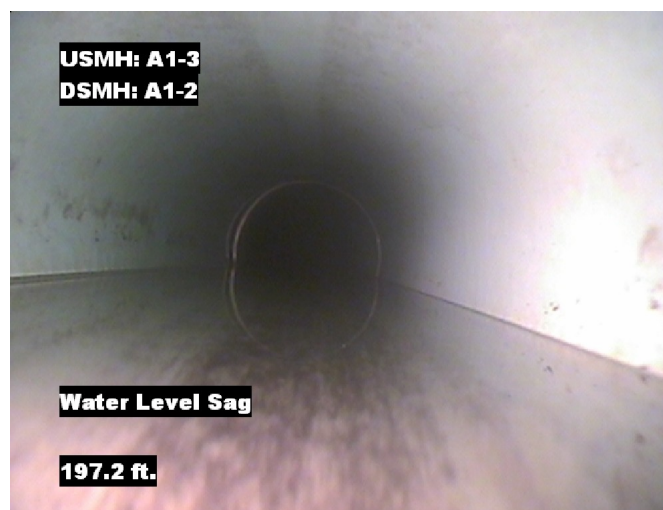
Distance: 197.2 ft. Grade: 2  
Condition: Water Level Sag  
Remarks: N/A

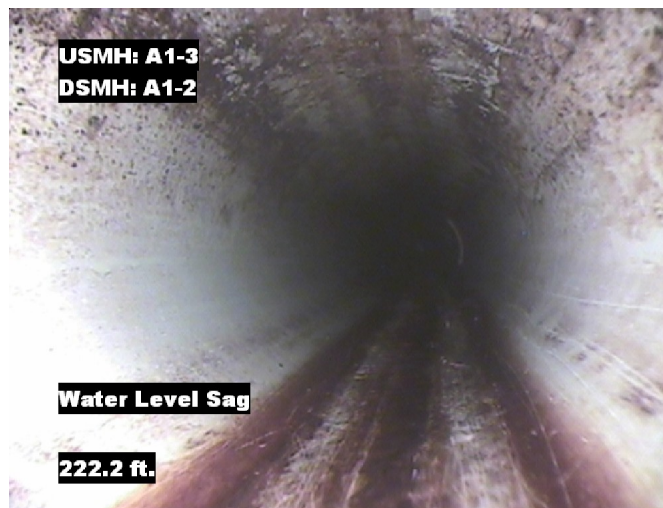
Distance: 222.2 ft. Grade: 2  
Condition: Water Level Sag  
Remarks: N/A

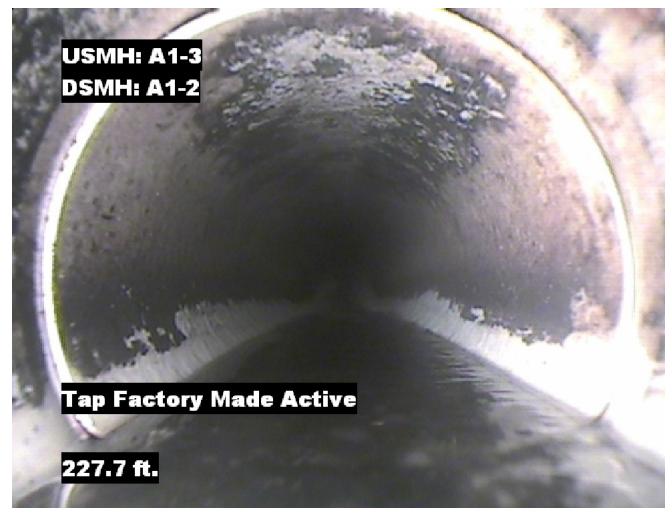
Distance: 227.7 ft. Grade: 0  
Condition: Tap Factory Made Active  
Remarks: N/A

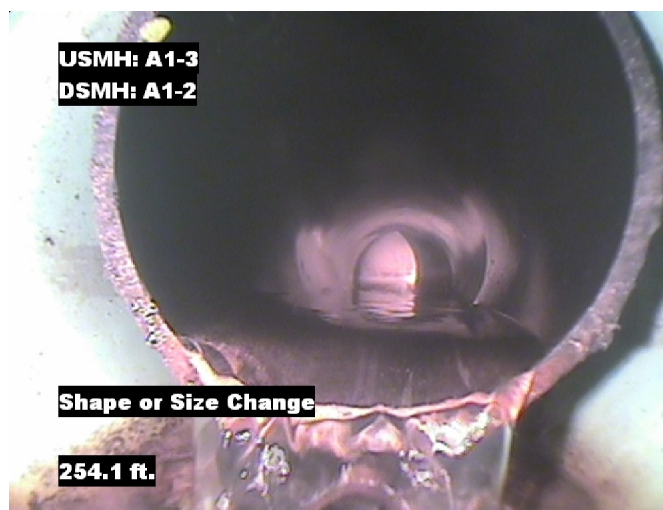
Distance: 254.1 ft. Grade: 0  
Condition: Shape or Size Change  
Remarks: N/A

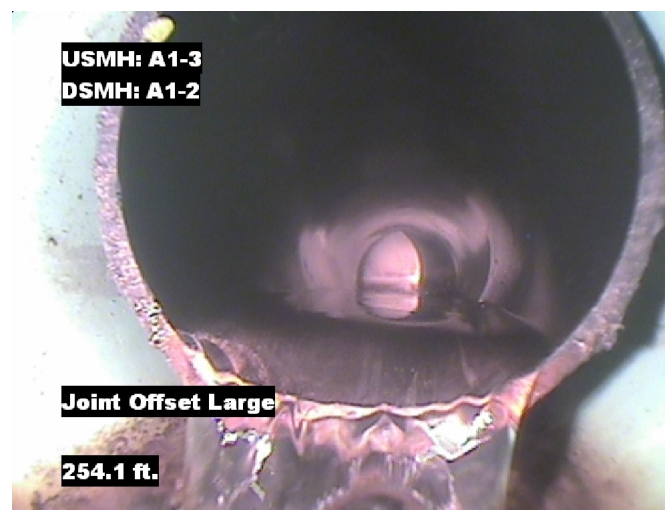
Distance: 254.1 ft. Grade: 2  
Condition: Joint Offset Large  
Remarks: N/A

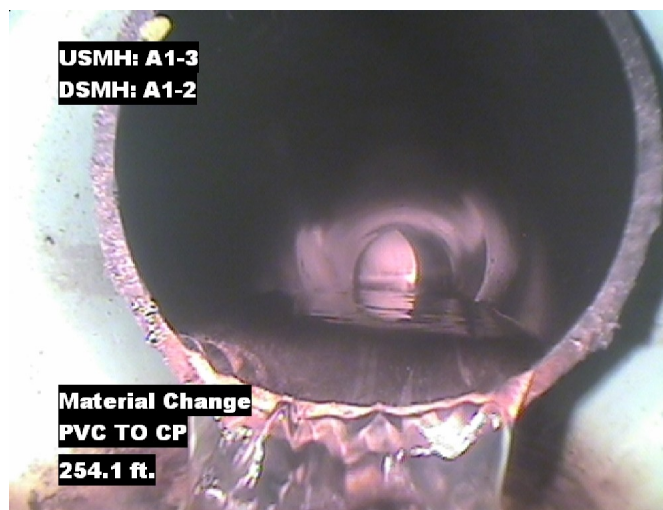
Distance: 254.1 ft. Grade: 0  
Condition: Material Change  
Remarks: PVC TO CP

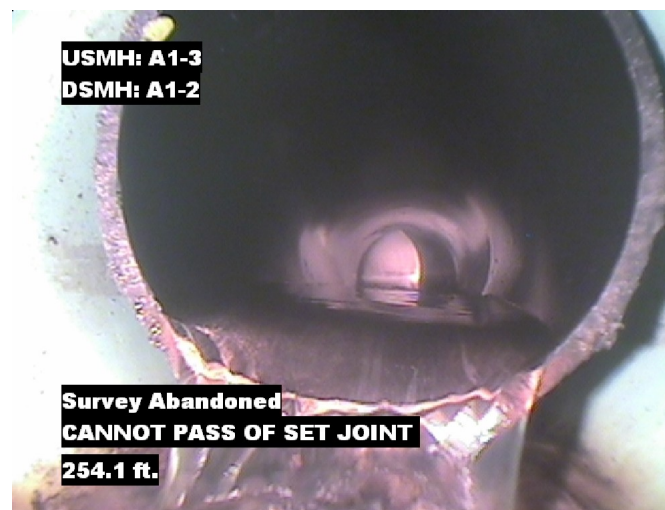
Distance: 254.1 ft. Grade: 0  
Condition: Survey Abandoned  
Remarks: CANNOT PASS OF SET JOINT
