## Defect Listing

Pipe Segment Refere... <b>A1-4_A1-3</b>	City <b>Oliver Springs</b>	Street <b>Kington Ave</b>	Material <b>Concrete Pipe (non-...</b>	Location C... <b>Other</b>	Sewer Use <b>Sanitary</b>
Upstream MH <b>A1-4</b>	Total Length <b>273.9</b>	Year Laid	Shape <b>Circular</b>	Location Details <b>football field</b>	
DS Manhole <b>A1-3</b>	Length surveyed <b>273.9</b>	Year Renewed	Height <b>8</b>	Width <b>8</b>	Pipe Joint... <b>4</b>

SPR <b>N/A</b>	MPR <b>21</b>	PO Number <b>4397-03</b>		Customer <b>GRW</b>	
SPRI <b>N/A</b>	MPRI <b>2.1</b>	Work Order <b>4397-02</b>		Purpose <b>Pre-Rehabilitation Survey</b>	
QSR <b>N/A</b>	QMR <b>3129</b>				
OPR <b>21</b>	Surveyed By <b>Charlie Gordon</b>	Direction <b>Upstream</b>	Date <b>20150824</b>	Media label	
OPRI <b>2.1</b>	Certificate Number <b>U-615-07000491</b>	Pre-Cleaning <b>Jetting</b>	Time <b>09:13</b>	Weather <b>Dry</b>	
Date Cleaned <b>20150824</b>			End Time <b>09:32</b>	Additional Info

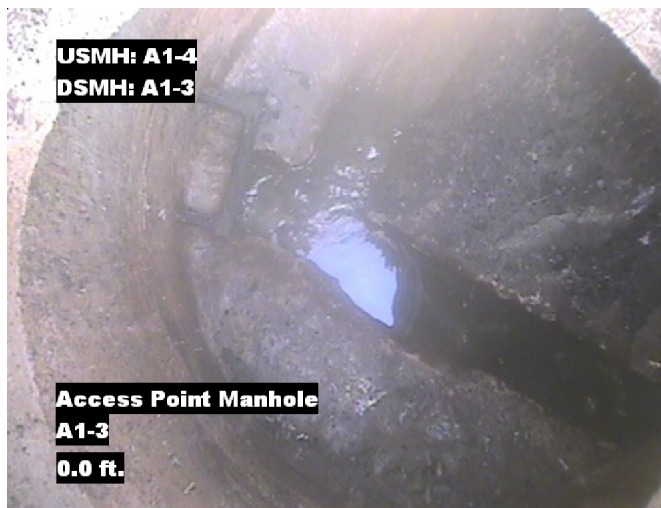
Distance: 0.0 ft. Grade: 0  
Condition: Access Point Manhole  
Remarks: A1-3

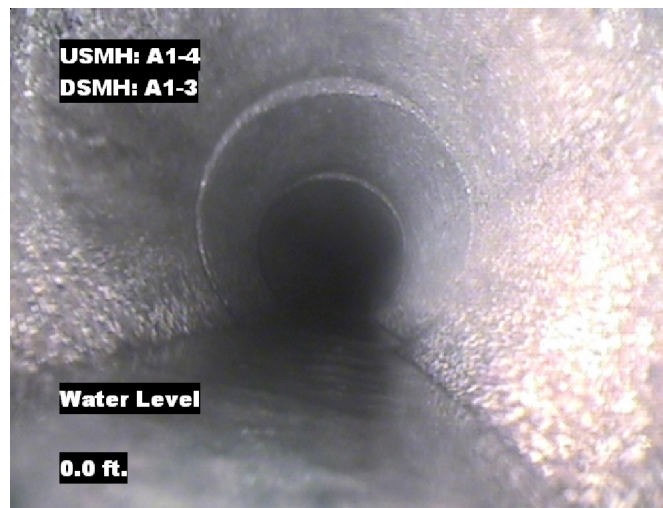
Distance: 0.0 ft. Grade: 0  
Condition: Water Level  
Remarks: N/A

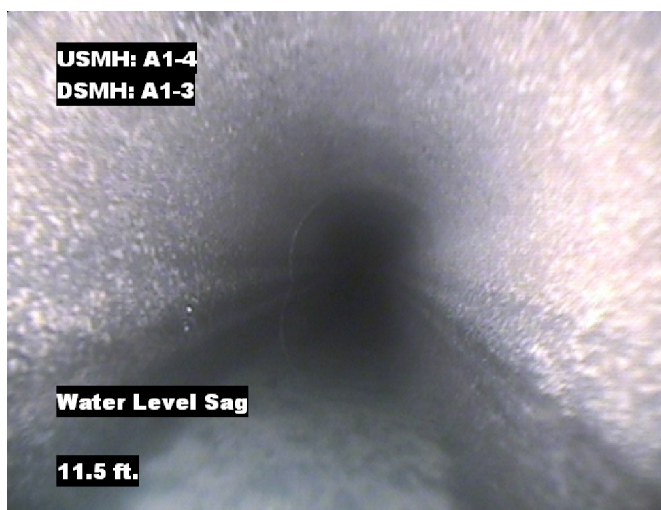
Distance: 11.5 ft. Grade: 2  
Condition: Water Level Sag  
Remarks: N/A

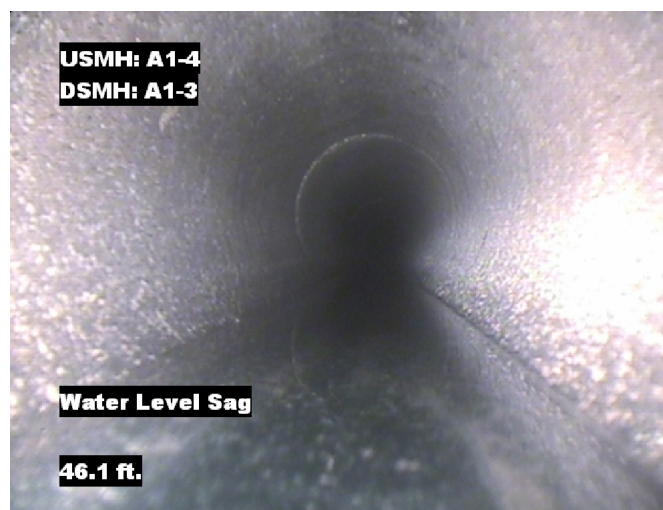
Distance: 46.1 ft. Grade: 2  
Condition: Water Level Sag  
Remarks: N/A

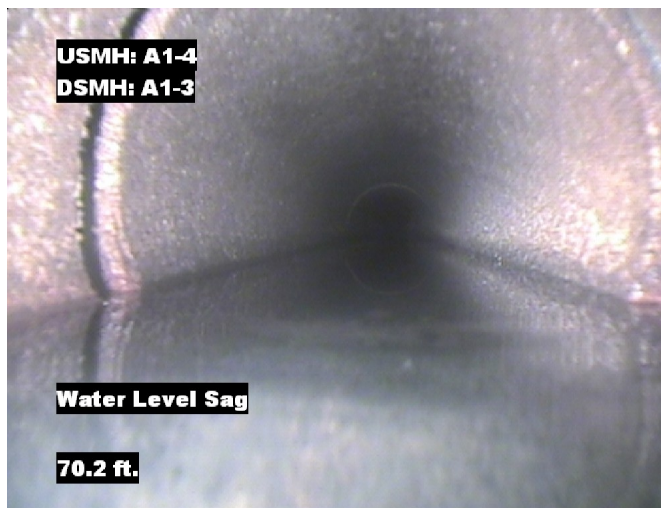
Distance: 70.0 ft. Grade: 2  
Condition: Water Level Sag  
Remarks: N/A

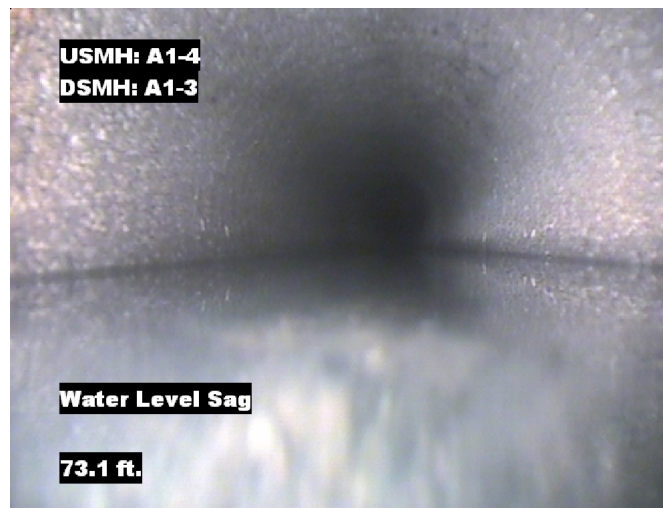
Distance: 73.1 ft. Grade: 3  
Condition: Water Level Sag  
Remarks: N/A

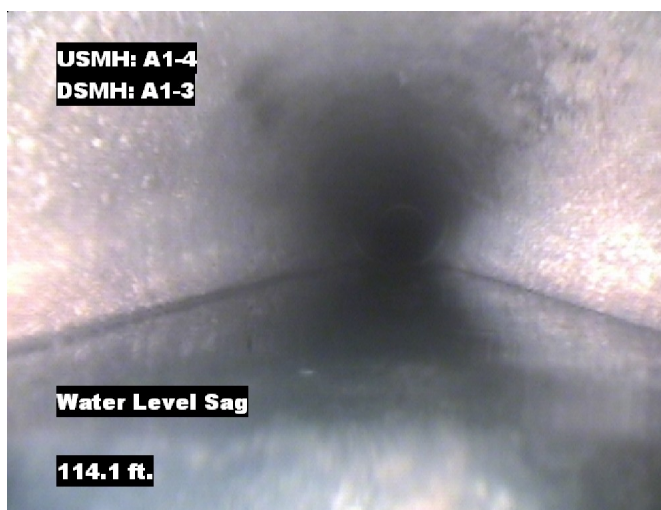
Distance: 114.1 ft. Grade: 2  
Condition: Water Level Sag  
Remarks: N/A

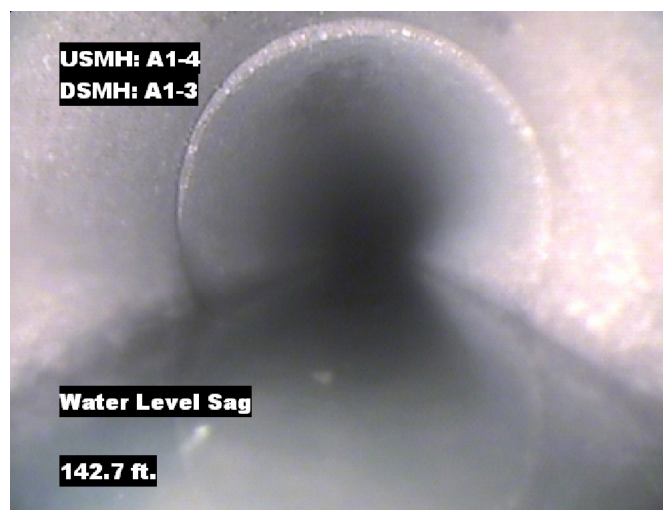
Distance: 142.7 ft. Grade: 2  
Condition: Water Level Sag  
Remarks: N/A

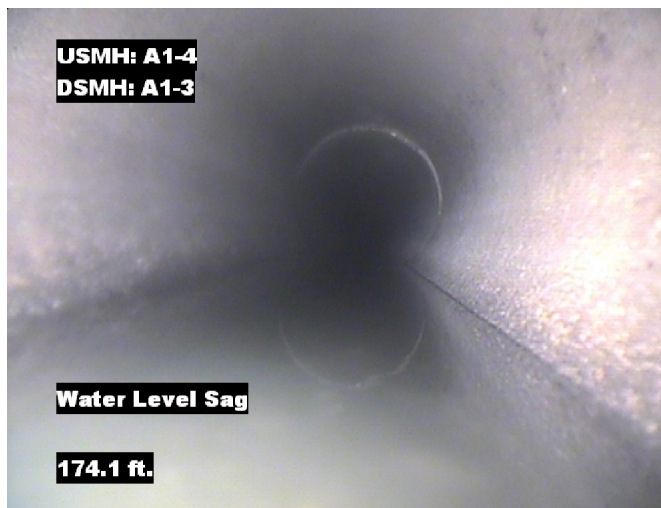
Distance: 174.1 ft. Grade: 2  
Condition: Water Level Sag  
Remarks: N/A

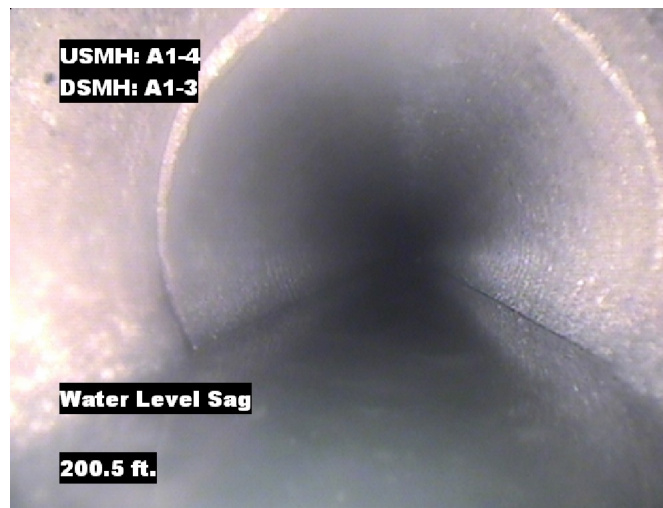
Distance: 200.5 ft. Grade: 2  
Condition: Water Level Sag  
Remarks: N/A

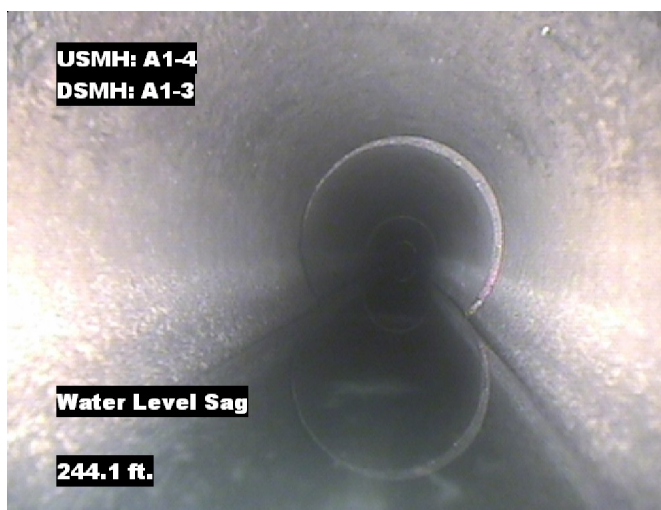
Distance: 244.1 ft. Grade: 2  
Condition: Water Level Sag  
Remarks: N/A

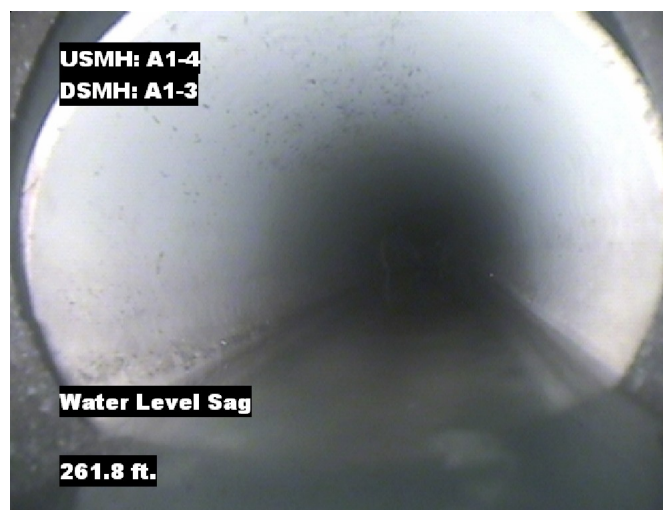
Distance: 261.8 ft. Grade: 2  
Condition: Water Level Sag  
Remarks: N/A

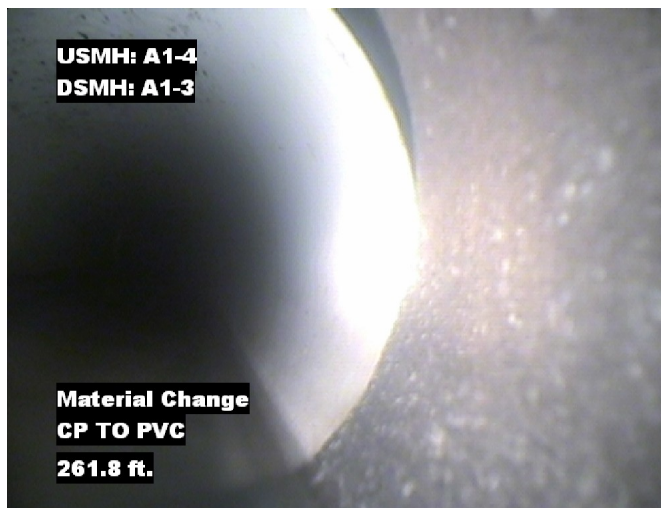
Distance: 261.8 ft. Grade: 0  
Condition: Material Change  
Remarks: CP TO PVC

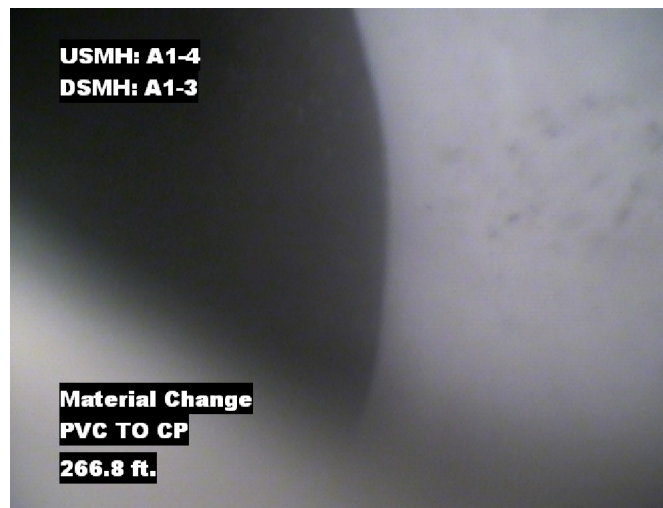
Distance: 266.8 ft. Grade: 0  
Condition: Material Change  
Remarks: PVC TO CP

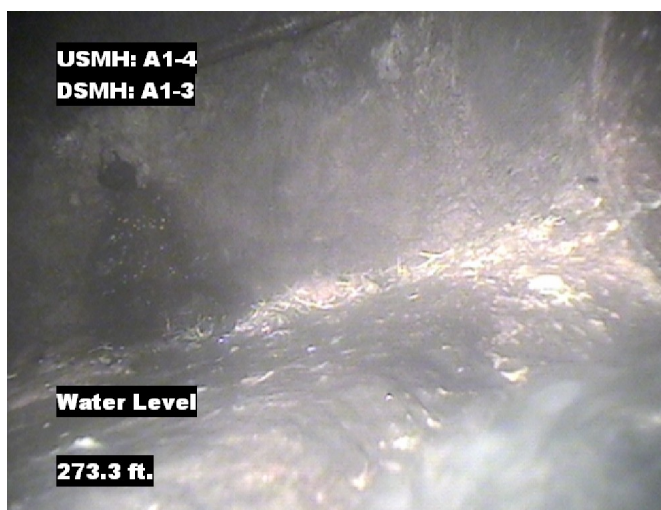
Distance: 273.3 ft. Grade: 0  
Condition: Water Level  
Remarks: N/A

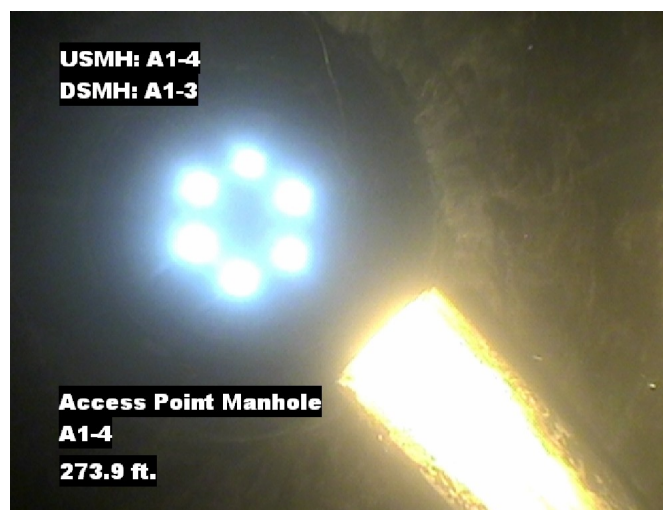
Distance: 273.9 ft. Grade: 0  
Condition: Access Point Manhole  
Remarks: A1-4
