Defect Listing

Pipe Segment Refere		City		Street	Mat	Material		Sewer Use
A10-1_A10-1A		Oliver Springs		Walker Dr	Concrete F	Concrete Pipe (non		Sanitary
Upstream MH A10-1		Total Length 129.8		Year Laid	Sha	Shape Circular		Details
					Circ			
DS Manhole		Length surveyed		Year Renewed Height		Width	Pipe Joint	
A10	A10-1A		9.8		8	8	4	
SPR	2	MPR	N/A	PO Number		Customer		
0001		MDDI		4397-03 Work Order		GRW Purpose		
SPRI	2	MPRI	N/A					
QSR	2100	QMR	N/A	4397-02		Pre-Rehabilitation Survey		
OF	PR	Surveyed By		Direction	Da	Date		alabel
2	2	Charlie Gordon		Downstream	2015	20150817		
OF	PRI	Certificate Number		Pre-Cleaning	Tir	Time		
2		U-615-07000491		Jetting	12	12:37		
		Date C	leaned	End	End Time		Additional Info	
		2015	0817	12	12:51

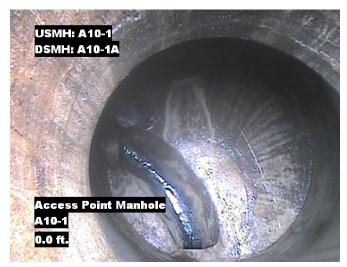
Distance: 0.0 ft. Grade: 0

Condition: Access Point Manhole

Remarks: A10-1

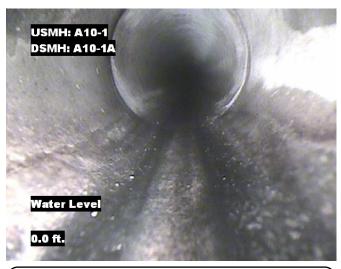
Distance: 0.0 ft. Grade: 0

Condition: Water Level

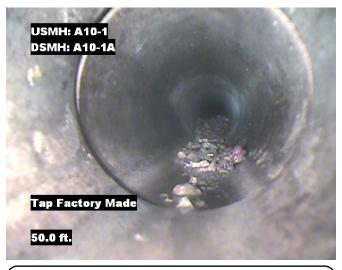
Distance: 50.0 ft. Grade: 0

Condition: Tap Factory Made

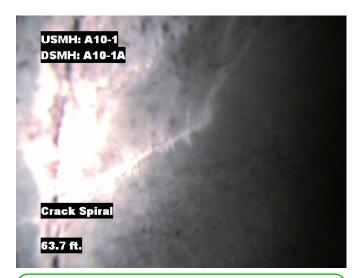
Distance: 63.7 ft. Grade: 2

Condition: Crack Spiral

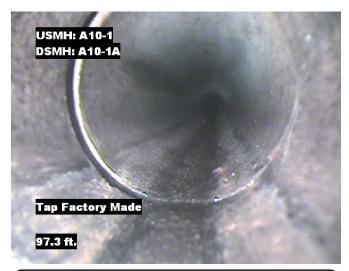
Distance: 97.3 ft. Grade: 0

Condition: Tap Factory Made

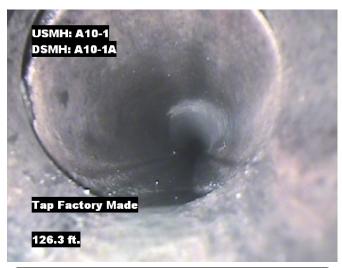
Distance: 126.3 ft. Grade: (

Condition: Tap Factory Made

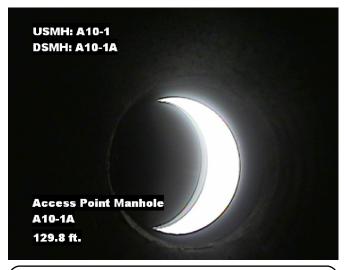
Distance: 129.8 ft. Grade: 0

Condition: Access Point Manhole

Remarks: A10-1A
