Defect Listing

Pipe Segment Refere		City		Street	Mat	Material		Sewer Use	
A10-1	_A9-2	Oliver	Springs	Walker Dr	Concrete F	Concrete Pipe (non		Sanitary	
Upstream MH		Total Length		Year Laid	Sh	Shape		n Details	
A10	-1A	173	3.3		Circ	Circular			
DS Ma	inhole	Length s	surveyed	Year Renewed	Height	ght Width Pipe Joint			
A9	A9-2		3.3		8	8	4		
SPR	N/A	MPR	2	PO Number			Customer		
0001		MDDI		4397-03 Work Order		GRW			
SPRI	N/A	MPRI	2				Purpose		
QSR	N/A	QMR	2100	4397-02		Pre-	-Rehabilitation Survey		
OF	PR	Surve	ed By	Direction	Da	Date		Media label	
2	!	Charlie Gordon		Downstream	2015	20150817			
OF	RI	Certificate Number		Pre-Cleaning	Tir	Time			
2 U-615-0700		7000491	Jetting 12		12:56				
	Date Cleaned				End	End Time		Additional Info	
	20150817					13:09

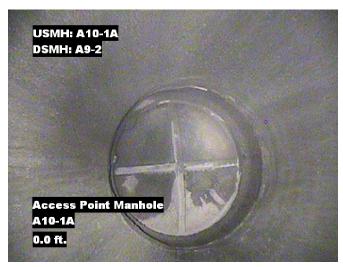
Distance: 0.0 ft. Grade: 0

Condition: Access Point Manhole

Remarks: A10-1A

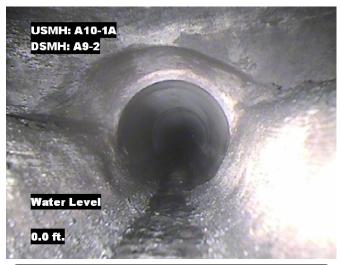
Distance: 0.0 ft. Grade: 0

Condition: Water Level

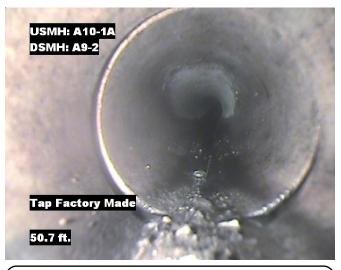
Distance: 50.7 ft. Grade: 0

Condition: Tap Factory Made

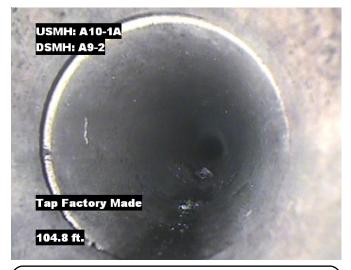
Distance: 104.8 ft. Grade: 0

Condition: Tap Factory Made

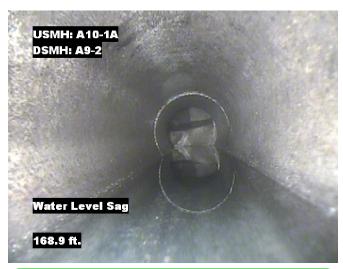
Distance: 168.9 ft. Grade:

Condition: Water Level Sag

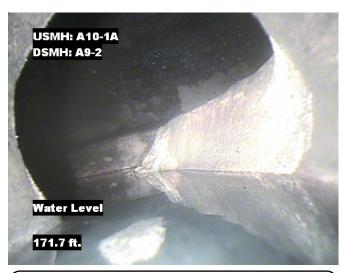
Distance: 171.7 ft. Grade: 0

Condition: Water Level
