## **Defect Listing**

Pipe Segment Refere		City		Street	Mat	Material		Sewer Use	
A11-1_A9-3		Oliver Springs		Kingston Ave	Fibreglass	Fibreglass Reinforc		Sanitary	
Up	Upstream MH		Length	Year Laid	Sh	ape	Location Details		
	A11-1	307.4			Circ	cular			
D	S Manhole	Length surveyed		Year Renewed	Height	Width	Pipe Joint		
	A9-3	307.4			8	8	N/A		
SPR	N/A	MPR	N/A	PO Number		Customer			
			-	4397-03			GRW		
SPRI	N/A	MPRI	N/A	Work Order		Purpose			
QSR	N/A	QMR	N/A	4397-02		Pre-Rehabilitation Survey			
	OPR	Surveyed By		Direction	Da	Date		alabel	
	N/A	Charlie Gordon		Downstream	2015	20150817			
	OPRI	Certificate Number		Pre-Cleaning	Time		Weather		
	N/A		7000491	Jetting	09:29		Dry		
		Date C	leaned		End Time		Additional Info		
		2015	0817		09	09:47

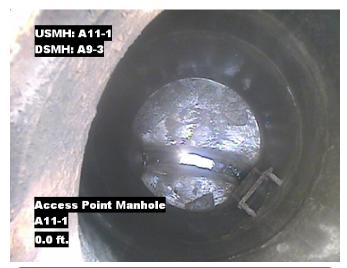
Distance: 0.0 ft. Grade: 0

Condition: Access Point Manhole

Remarks: A11-1

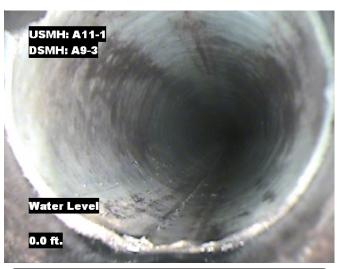
Distance: 0.0 ft. Grade: 0

Condition: Water Level

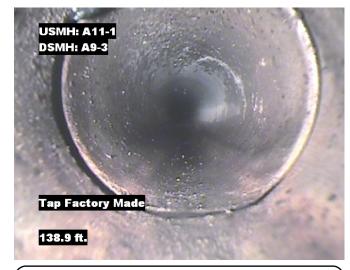
Distance: 138.9 ft. Grade: 0

Condition: Tap Factory Made

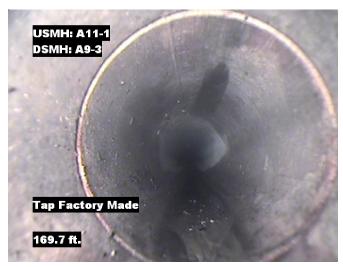
Distance: 169.7 ft. Grade: 0

Condition: Tap Factory Made

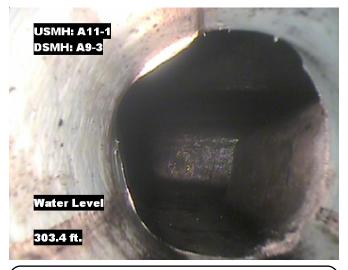
Distance: 303.4 ft. Grade:

Condition: Water Level

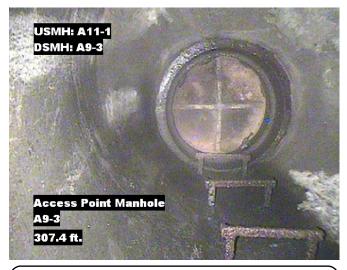
Distance: 307.4 ft. Grade: 0

Condition: Access Point Manhole

Remarks: A9-3
